## Update on Estates Issues

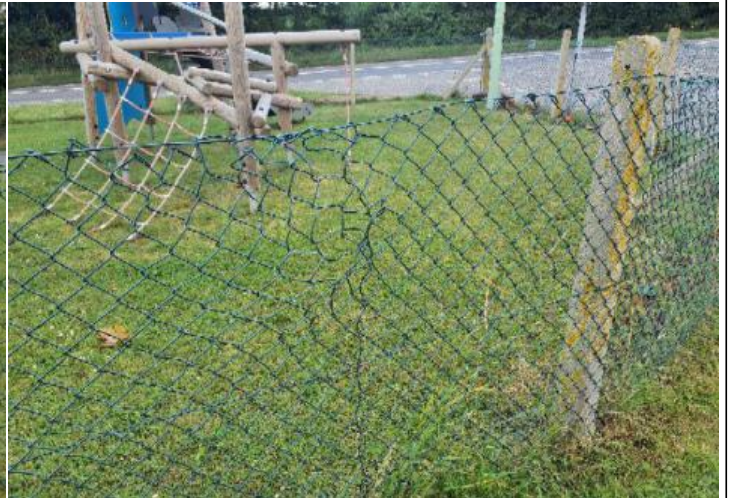
**Finding:** There is some damage to the fence sections

**Action:** Monitor for any further deterioration and repair as required

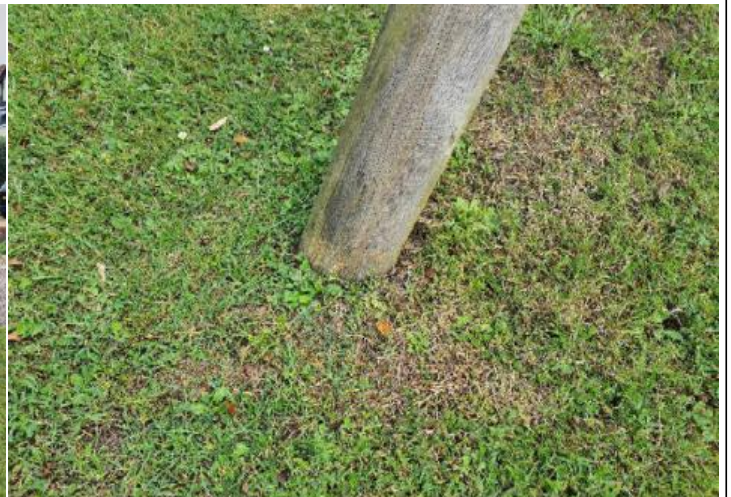
**Finding:** There is some strimmer / machinery damage apparent on the posts, this can penetrate the preservative applied to the timber and accelerate the rotting process

**Action:** Monitor for any deterioration (rot) and replace as required

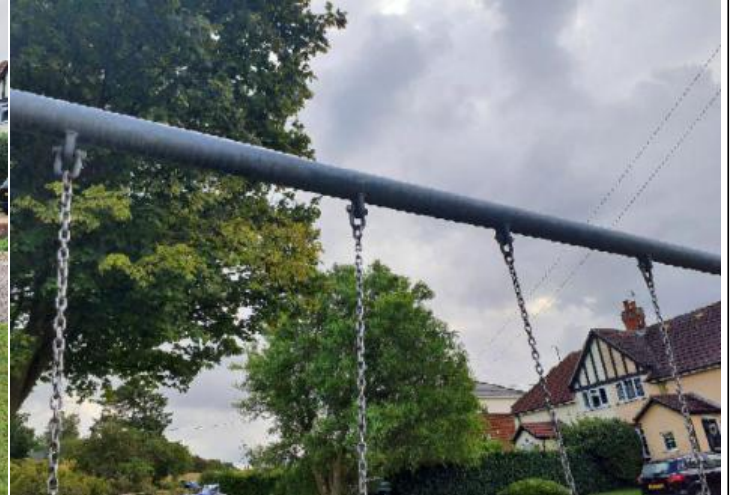
**Finding:** There is some wear to the shackles

**Action:** Monitor for any further deterioration and replace when 40% worn

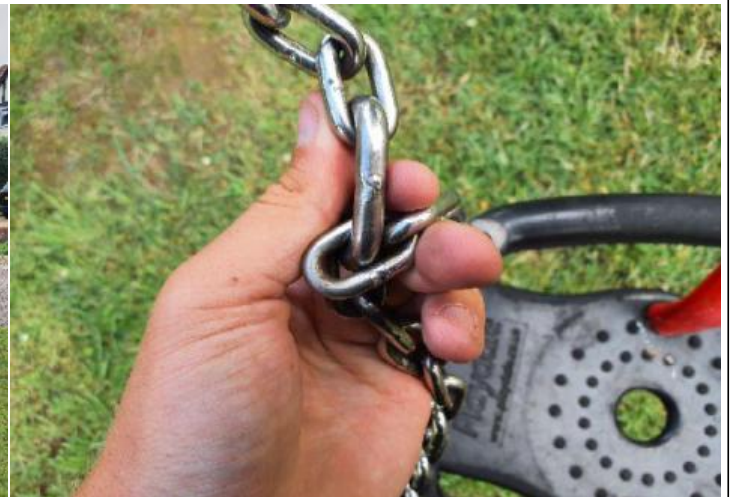
**Finding:** There is some notable evidence of chain wear

**Action:** Monitor for any further deterioration and replace when 40% worn

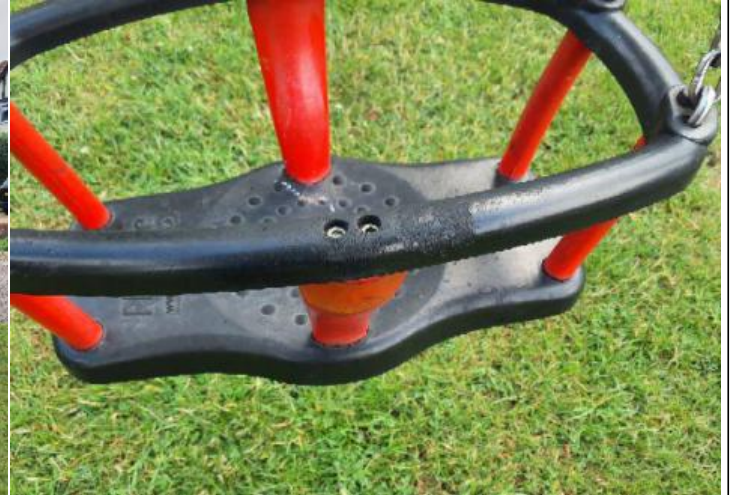
**Finding:** The seat has minor damage or wear

**Action:** Monitor for any further deterioration and replace as required

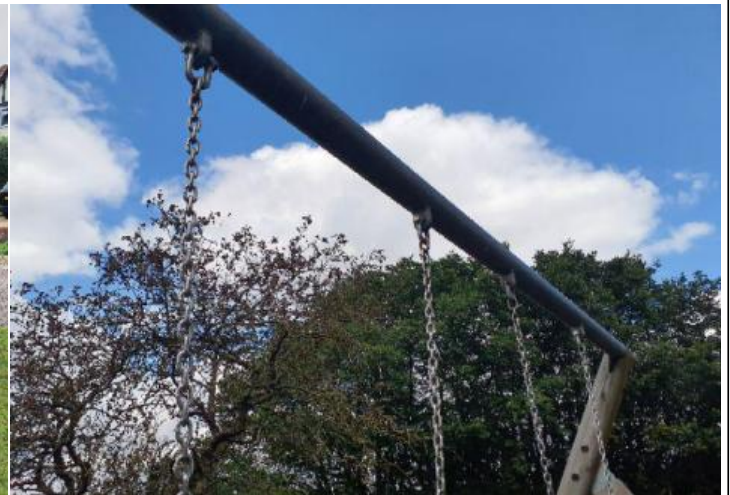
**Finding:** The bushes are showing signs of wear

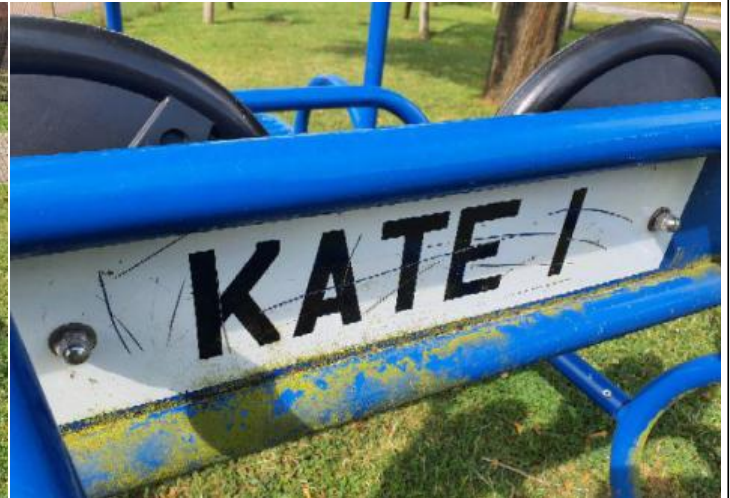
**Finding:** There is some damage to the item

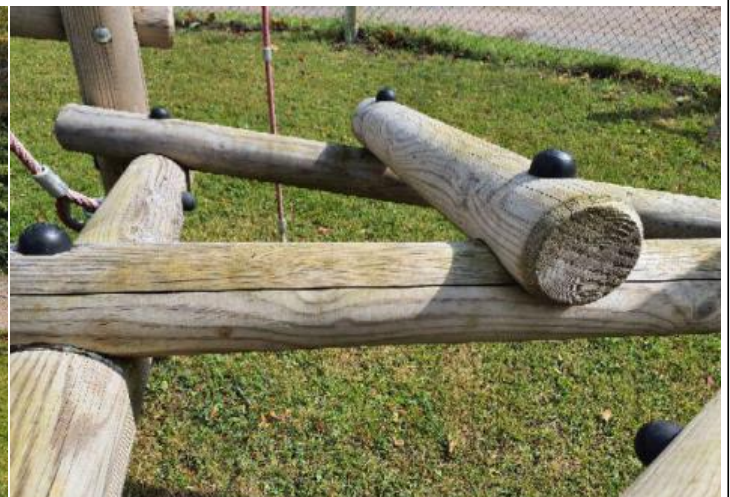
**Finding:** The timber has a number of splits/shakes or air cracks and this may affect the stability or allow water ingress which will accelerate the rotting process

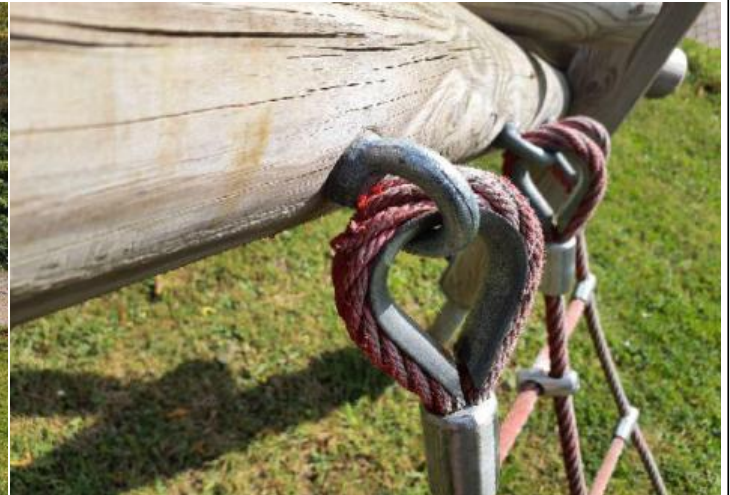
**Finding:** The ropes/nets are worn/damaged in places

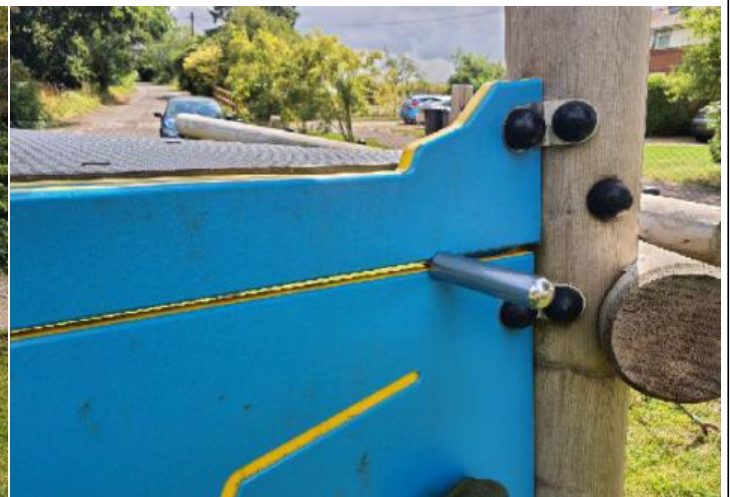
**Finding:** There is/are finger entrapment/s in the climbing wall and the item fails to meet the requirements of BS EN 1176 Part 1 4.2.7.6 Entrapment of fingers

**Action:** Monitor - No remedial work recommended

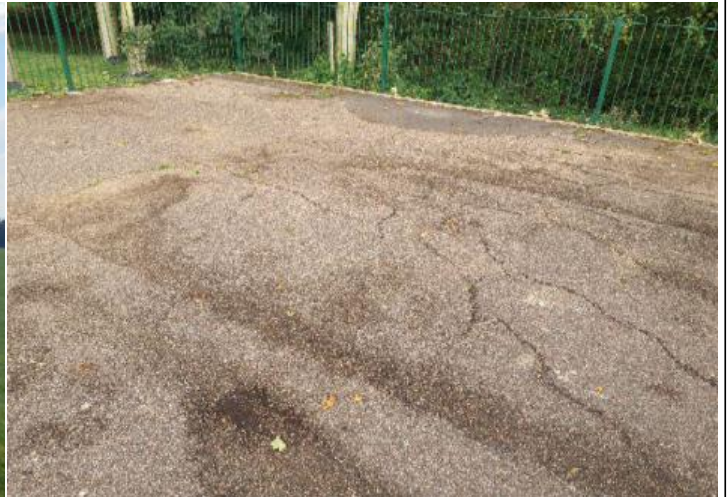
**Finding:** There is moderate damage to the surface

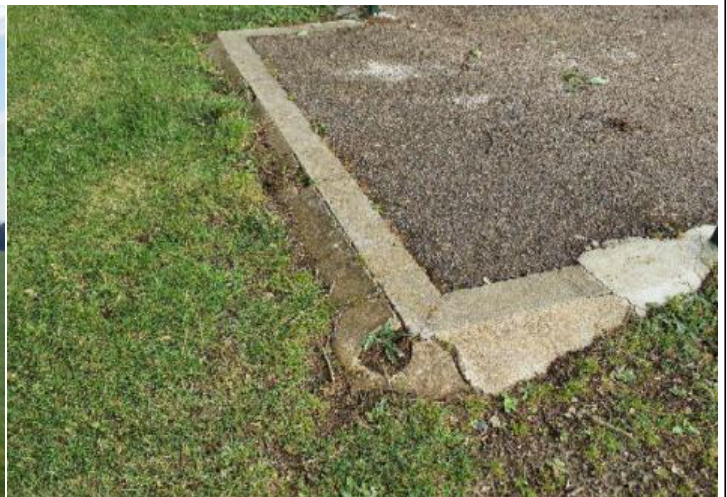
**Finding:** The concrete is breaking up around the edges of the surface

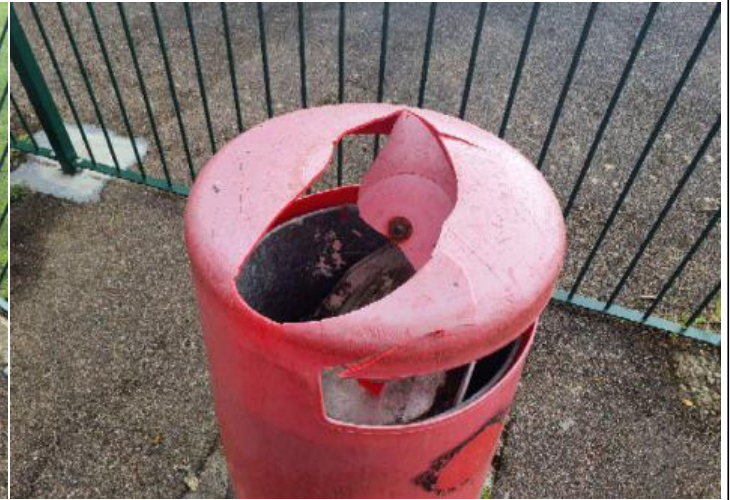
**Finding:** The bin is severely damaged

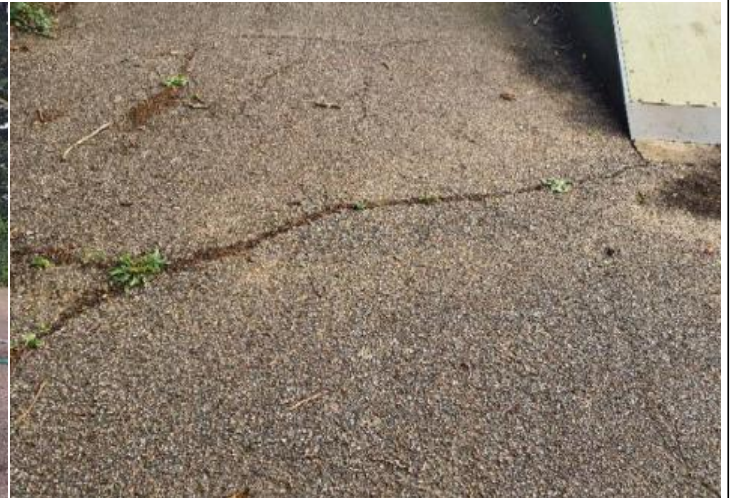
**Finding:** There is root damage to the surfacing creating unforeseen changes in levels

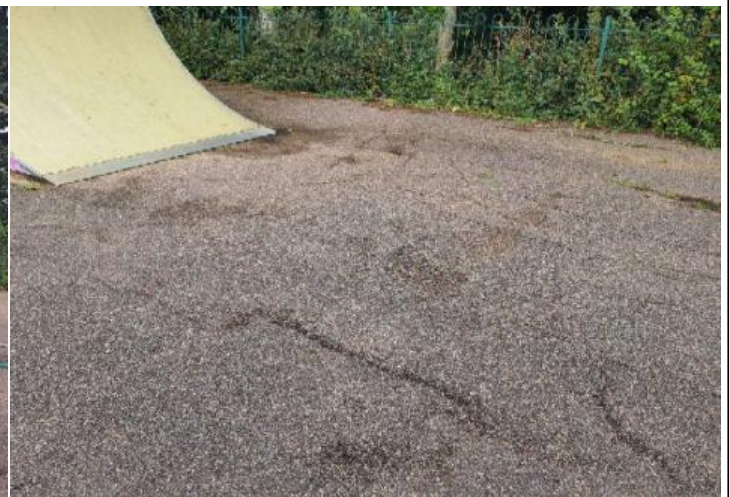
**Finding:** There is some damage apparent to the riding surface

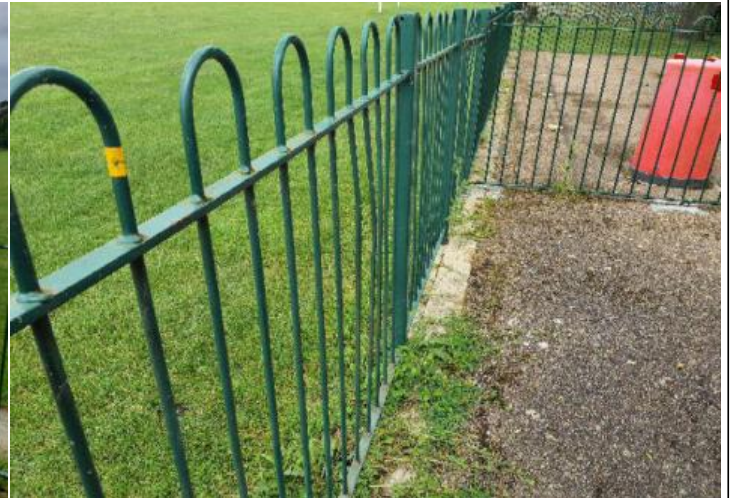
**Finding:** There is some damage to the fence sections

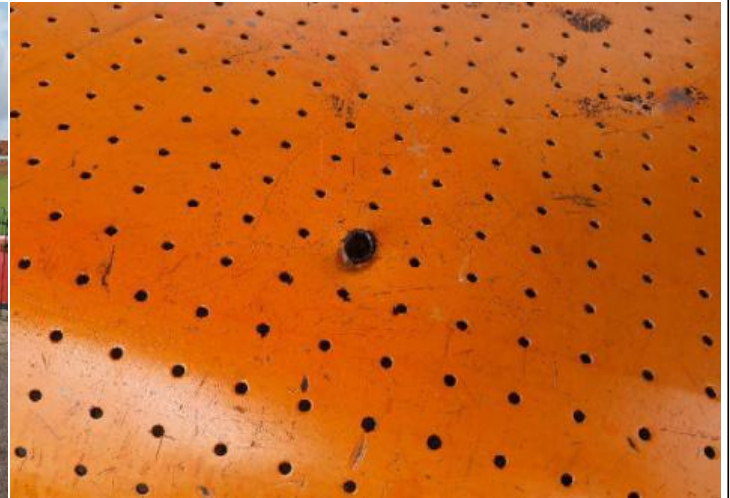
**Finding:** There is some evidence of fire damage to the item **Action:** Monitor for any further deterioration and repair as required

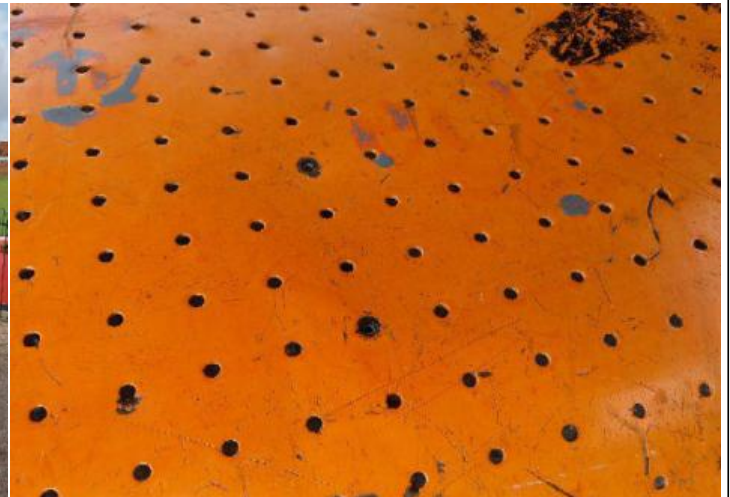
**Finding:** Pop rivet fixings have failed on the seat **Action:** Replace the failed pop rivets

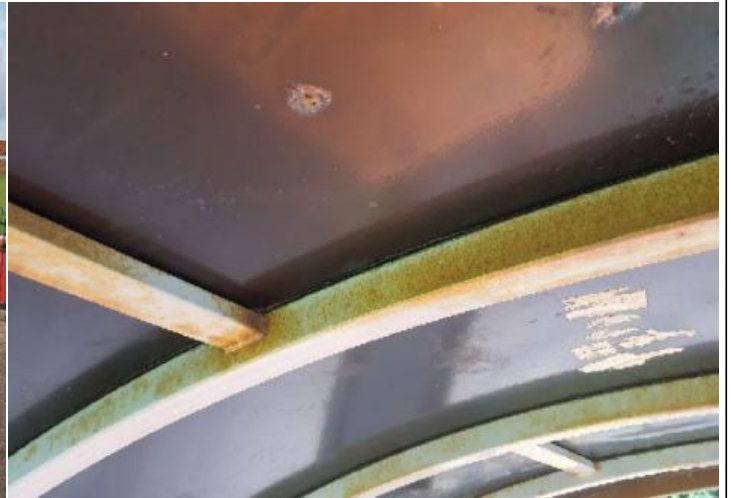
**Finding:** There is surface corrosion / rust present on the item

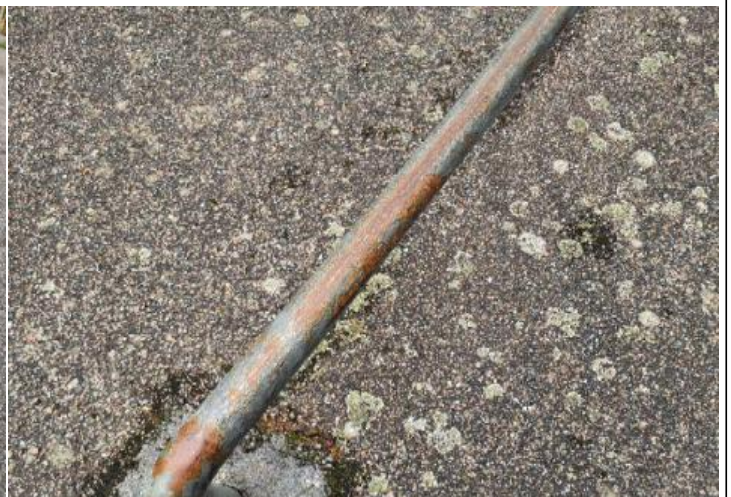
**Finding:** There is surface corrosion / rust present on the item

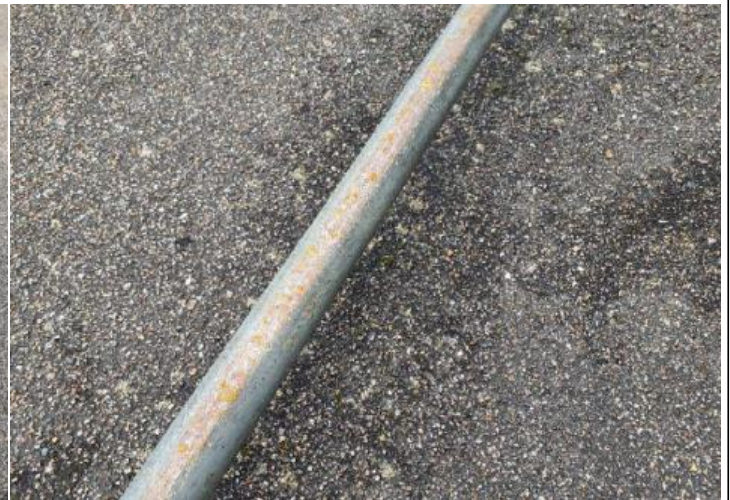
**Finding:** There is surface corrosion / rust present on the item  
**Action:** Consider treating the item

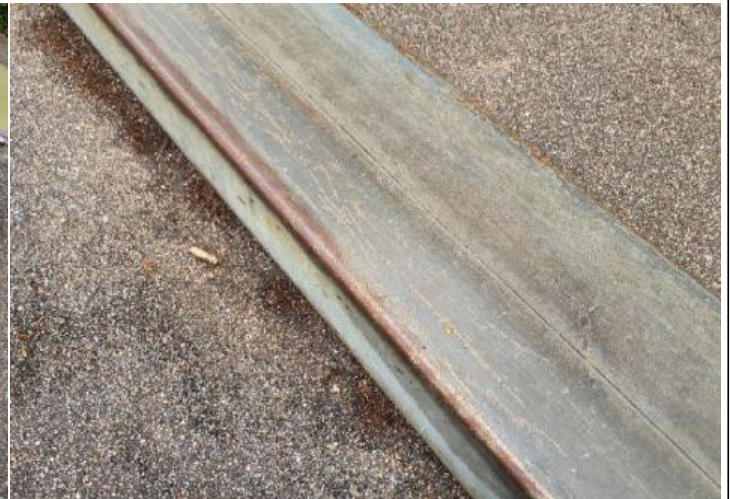
**Finding:** There is surface corrosion / rust present on the item  
**Action:** Consider treating the item

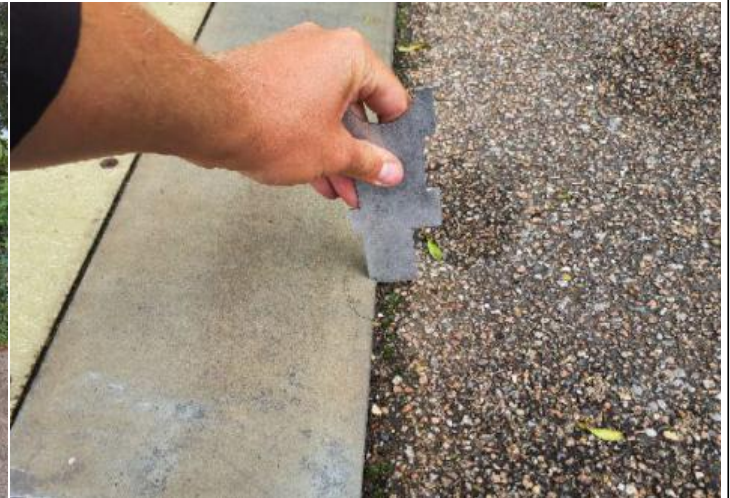
**Finding:** The kicker plate protrudes more than 5mm above the surrounding surface level, BS EN 14974 recommends a maximum of 5mm with 3mm preferred

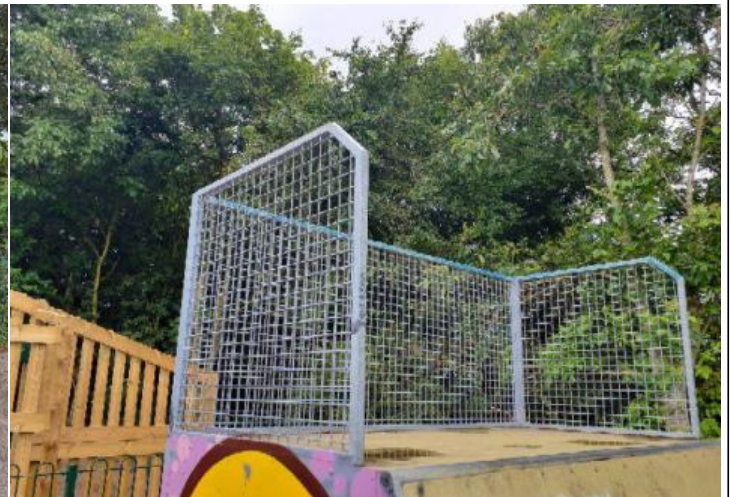
**Finding:** The height of the barrier is less than 1200mm and fails the requirements of BS EN 14974

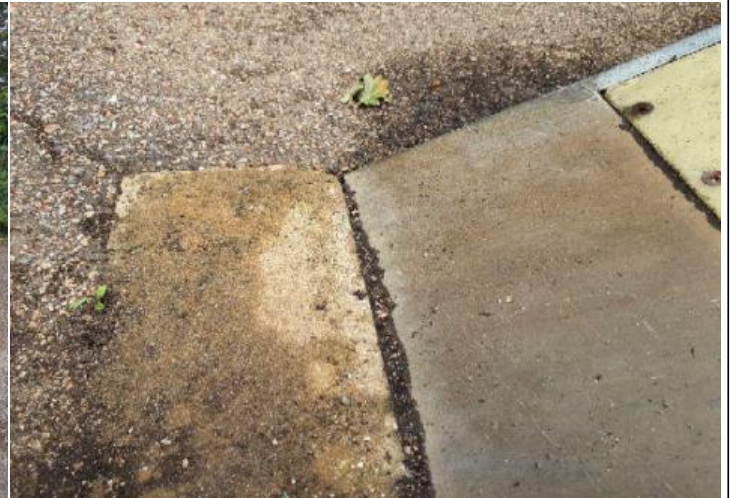
**Finding:** The kicker plate has sunk more than 5mm below the surrounding surface level, BS EN 14974 recommends a maximum of 5mm with 3mm preferred

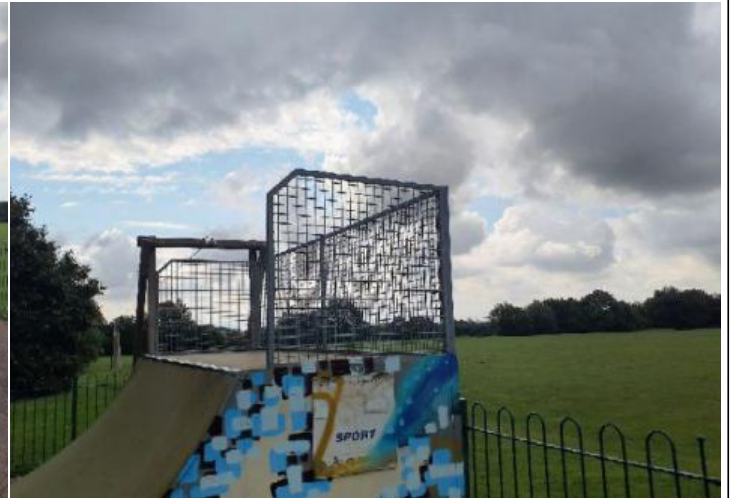
**Finding:** The height of the barrier is less than 1200mm and fails the requirements of BS EN 14974  
**Action:** Monitor - No remedial work recommended

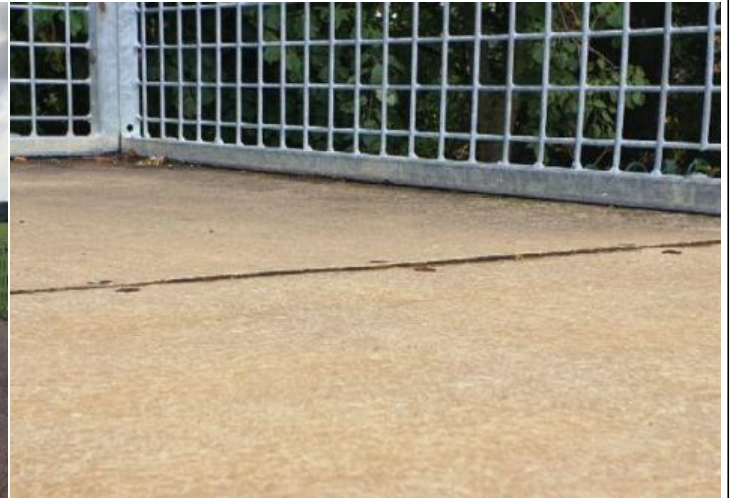
**Finding:** There is a change in the level of the rolling surface in excess of 3mm and the item fails the requirements of BS EN 14974 Clause 5.1.2.3 **Action:** Monitor - No remedial work recommended

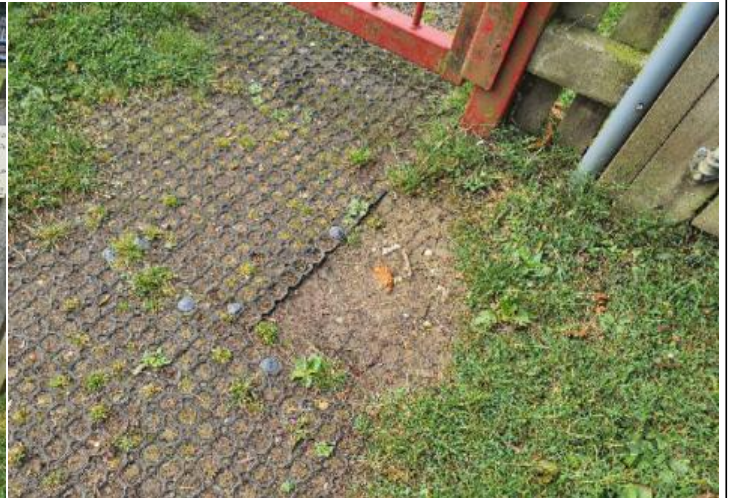
**Finding:** There are trip hazards at the edges of the surface

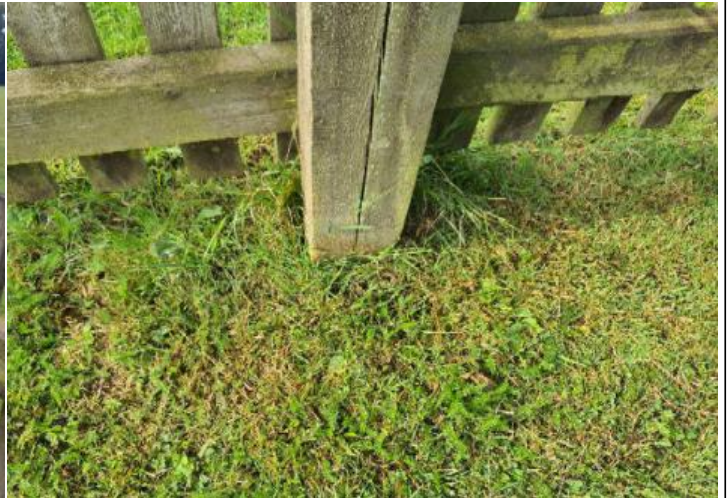
**Finding:** There is some strimmer / machinery damage apparent on the posts, this can penetrate the preservative applied to the timber and accelerate the rotting process

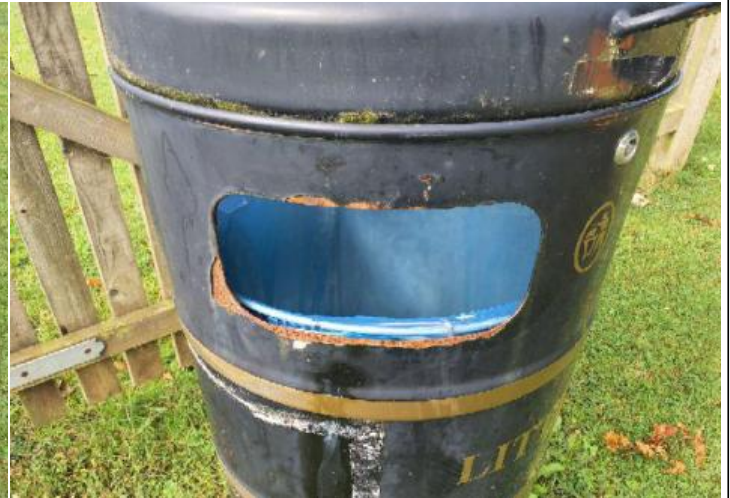
**Finding:** The paintwork on this item has been damaged or worn exposing the metal underneath which is rusting / corroding

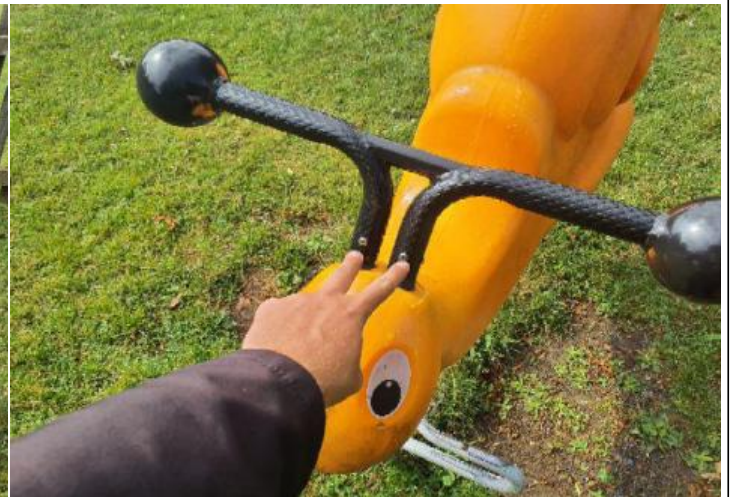
**Finding:** A number of fixing(s) have worked loose

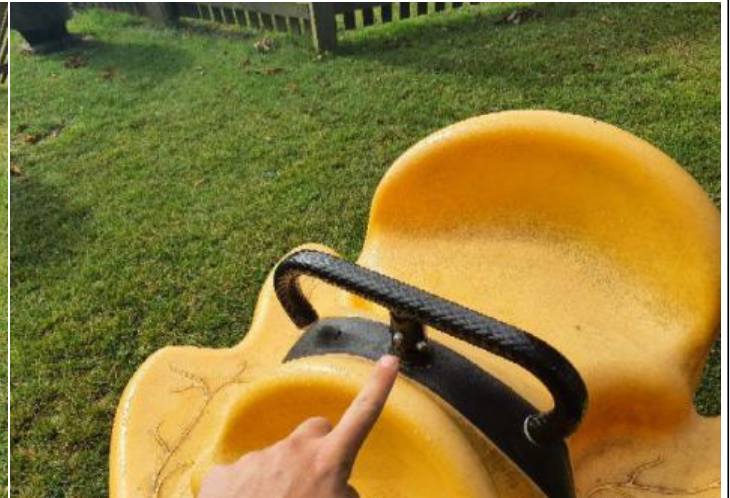
**Finding:** A number of fixing(s) have worked loose

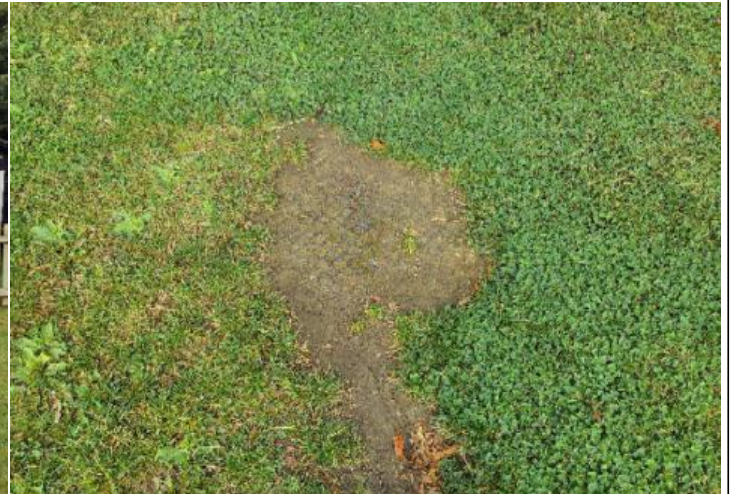
**Finding:** The grass mats are silted up and the soil is compacted; this may have an effect on the impact absorbing properties of the surface

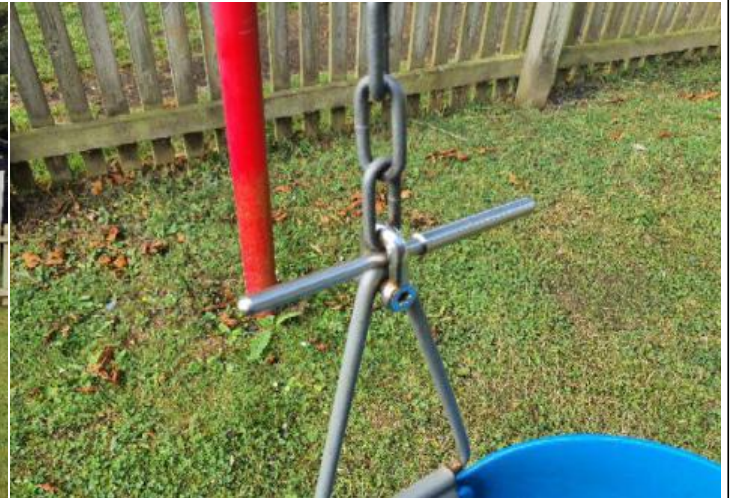
**Finding:** The connecting links are in excess of 8.6mm and less than 12mm and fail the requirements of BS EN 1176 Part 1; clause 4.2.13, Chains

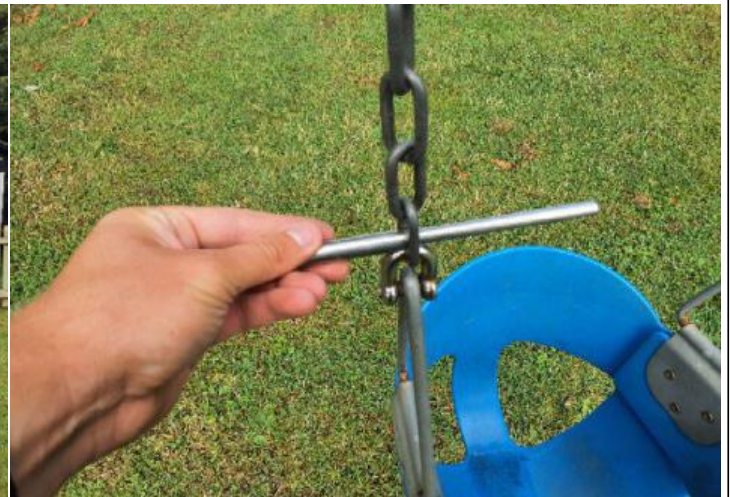
**Finding:** The chain openings are in excess of 8.6mm and do not meet the recommendations of BS EN 1176 Part 1

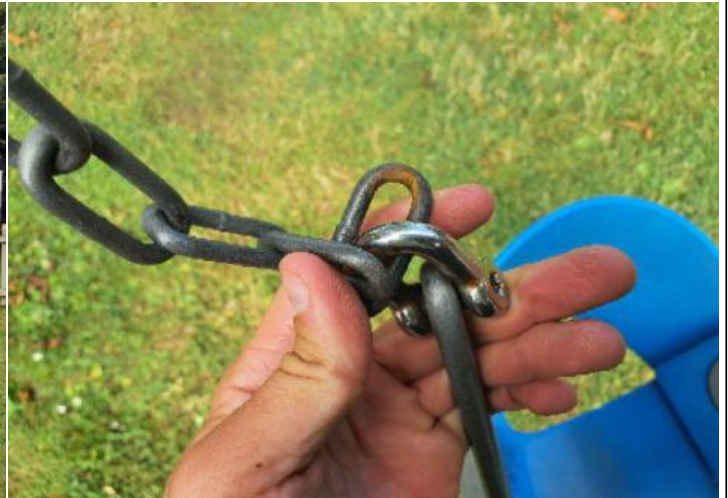
**Finding:** There is some notable evidence of chain wear

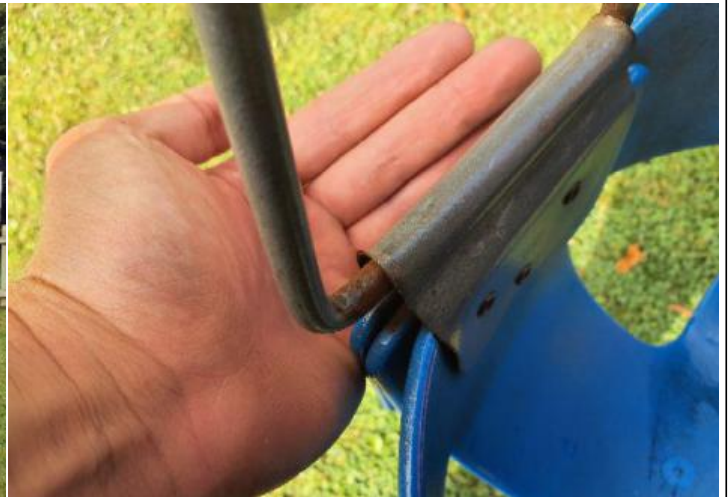
**Finding:** The swing seat connectors have some wear present

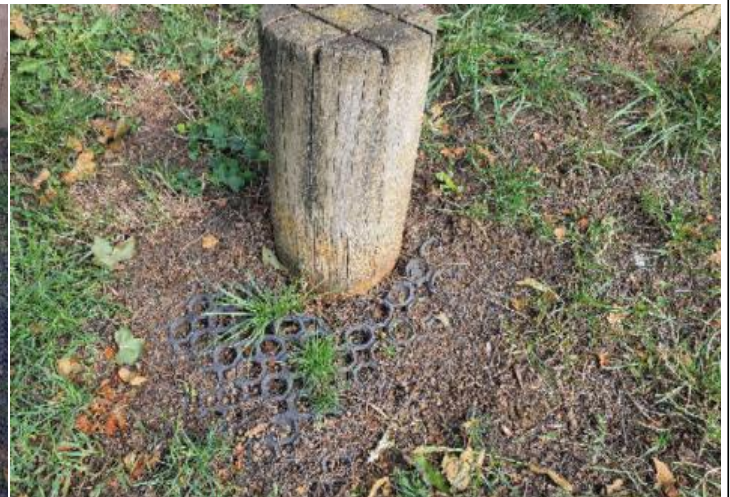
**Finding:** There is some strimmer / machinery damage apparent on the posts, this can penetrate the preservative applied to the timber and accelerate the rotting process

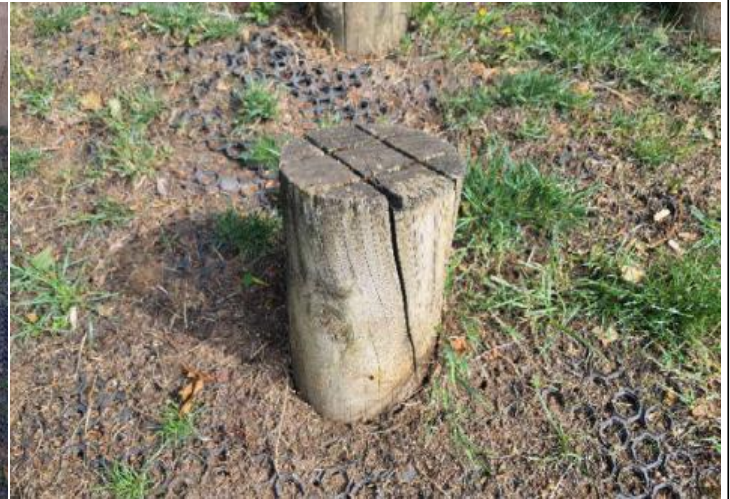
**Finding:** The timber has a number of splits/shakes or air cracks and this may affect the stability or allow water ingress which will accelerate the rotting process  
**Action:** Monitor to ensure the splits do not cross through fixing points of the structure and/or cause any instability

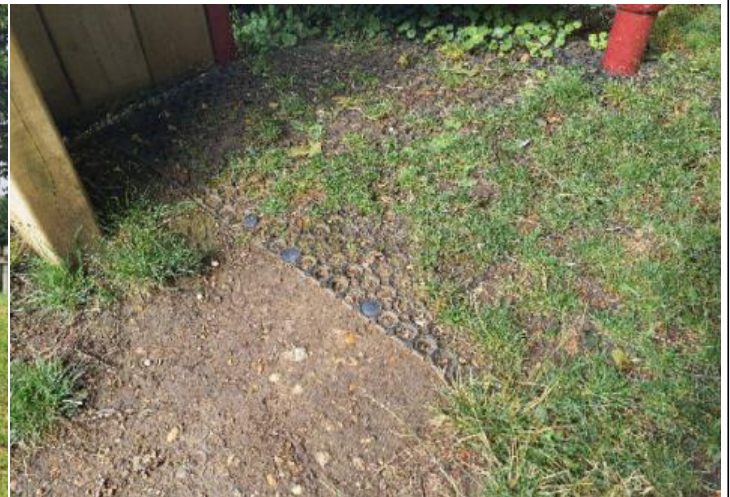
**Finding:** The edges of the grass mat surface have not been installed in accordance with the API Code of Practice  
**Action:** Tuck in edges of grass mat to remove trip hazards

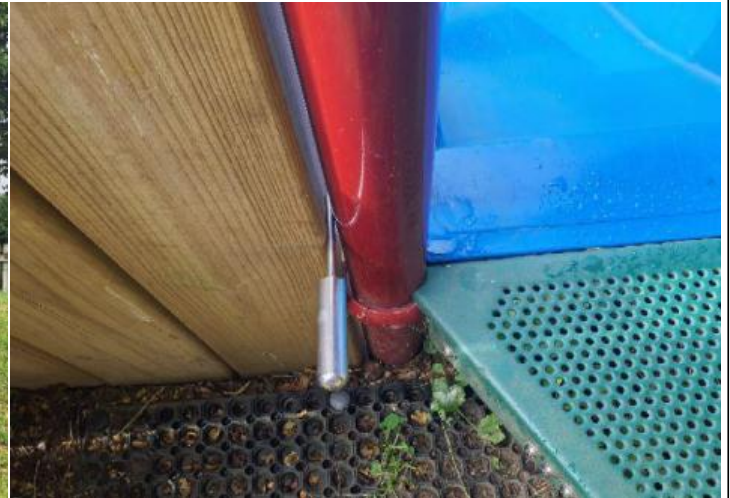
**Finding:** There is/are finger entrapment/s in the slide starting section and the item fails to meet the requirements of BS EN 1176 Part 1 4.2.7.6 Entrapment of fingers

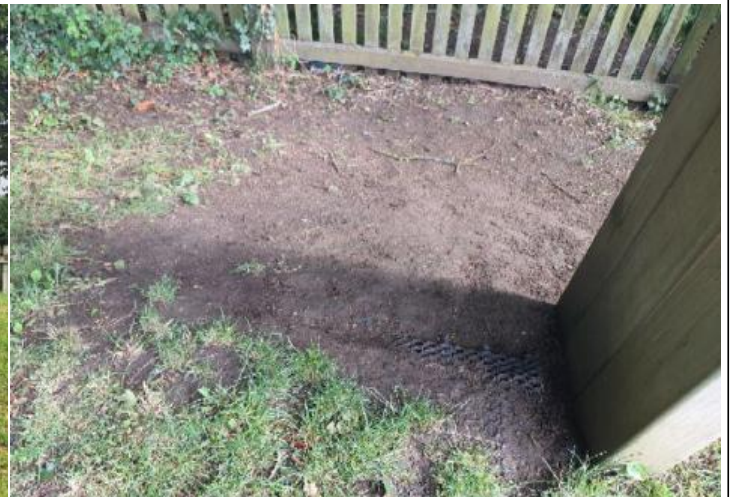
**Finding:** The surface has eroded in some areas and may be slippery in wet conditions

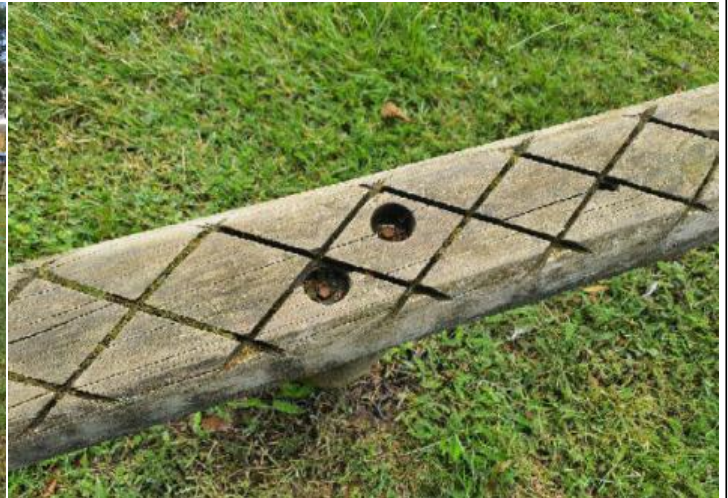
**Finding:** There is/are bolt cap covers missing or damaged on the item

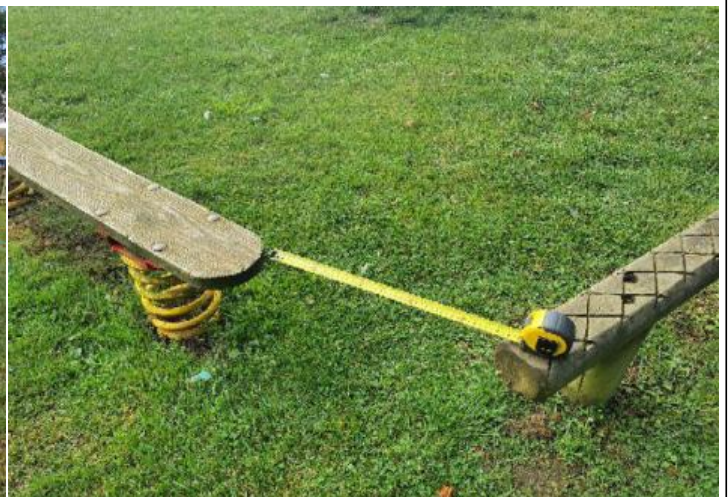
**Finding:** The step between the items is quite large and users may not be able to complete the step without touching ground, the items could therefore be considered to be within the falling space of each other, however the intention of the play activity continuity is easily apparent and foreseeable to the user

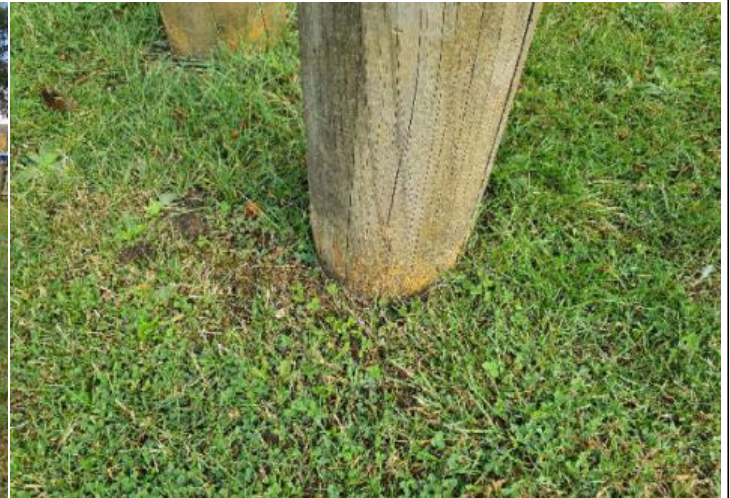
**Finding:** There is some strimmer / machinery damage apparent on the posts, this can penetrate the preservative applied to the timber and accelerate the rotting process

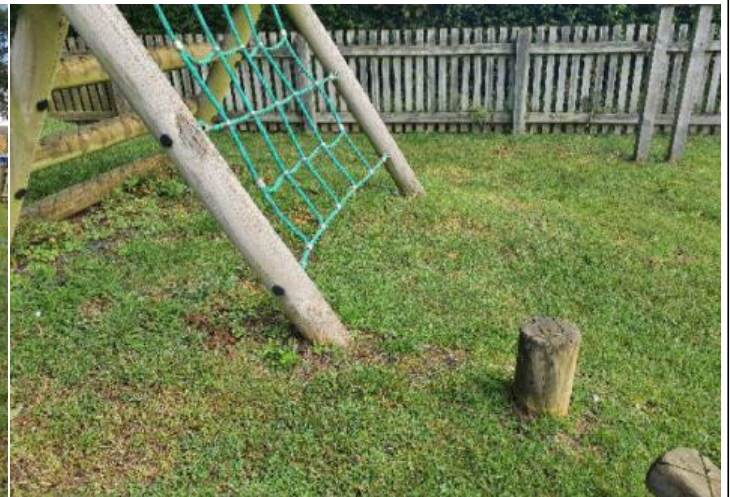
**Finding:** The timber stepping post forms a hard object within the falling space of the A frame climber in contravention of the requirements of BS EN 1176 Part 1

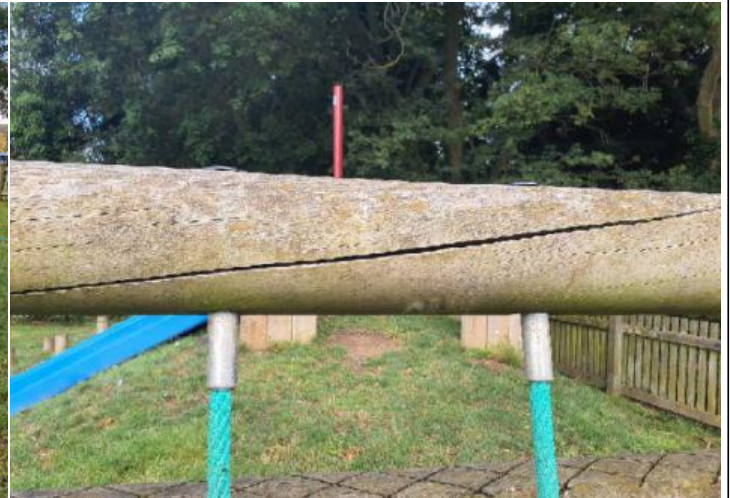
**Finding:** The timber has a number of splits/shakes or air cracks and this may affect the stability or allow water ingress which will accelerate the rotting process  
**Action:** Monitor to ensure the splits do not cross through fixing points of the structure and/or cause any instability

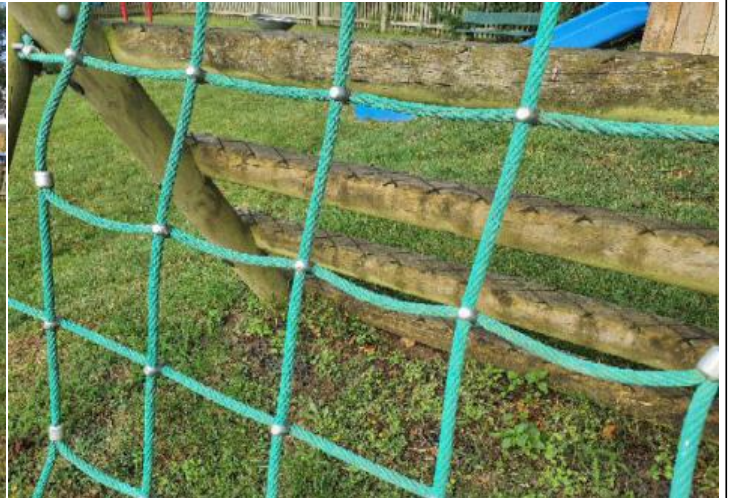
**Finding:** The ropes/nets are worn/damaged in places

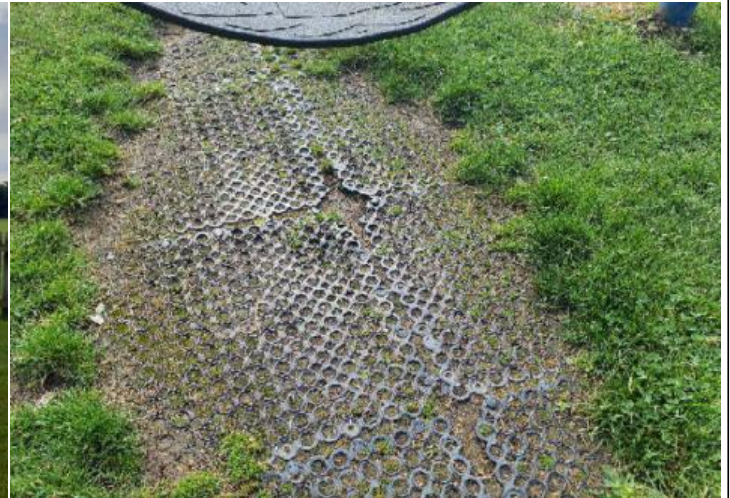
**Finding:** There is moderate damage to the surface

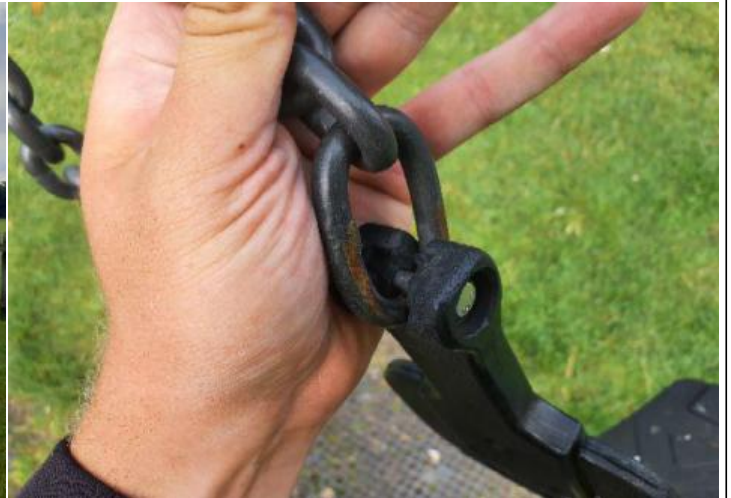
**Finding:** The swing seat connectors have some wear present

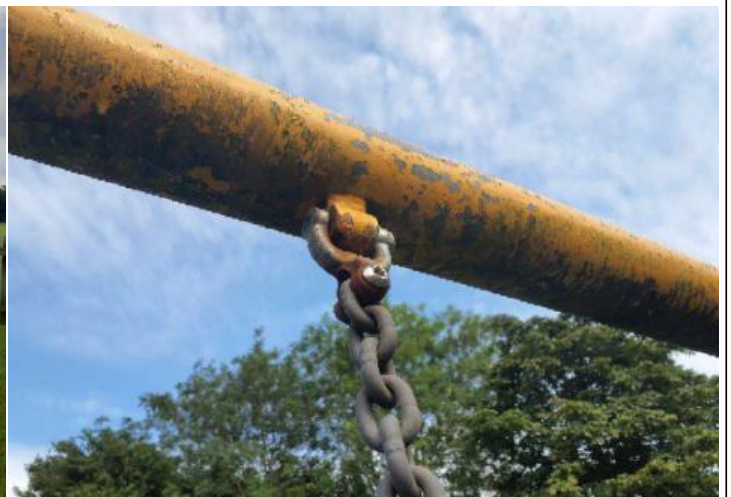
**Finding:** There is some notable evidence of chain wear

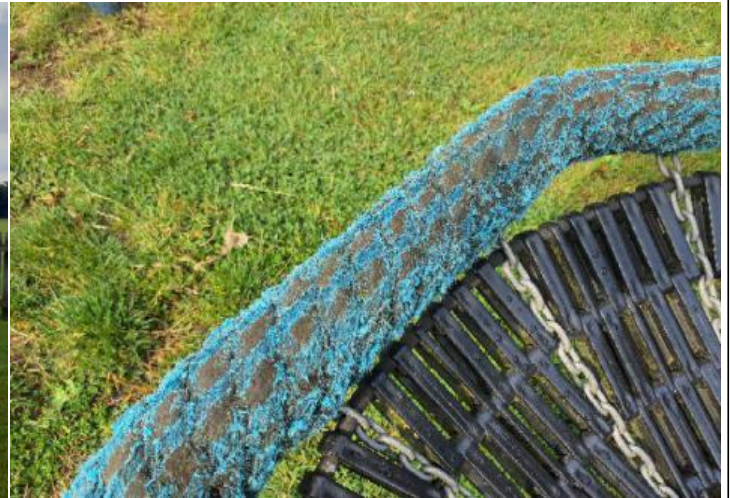
**Finding:** The seat has minor damage or wear

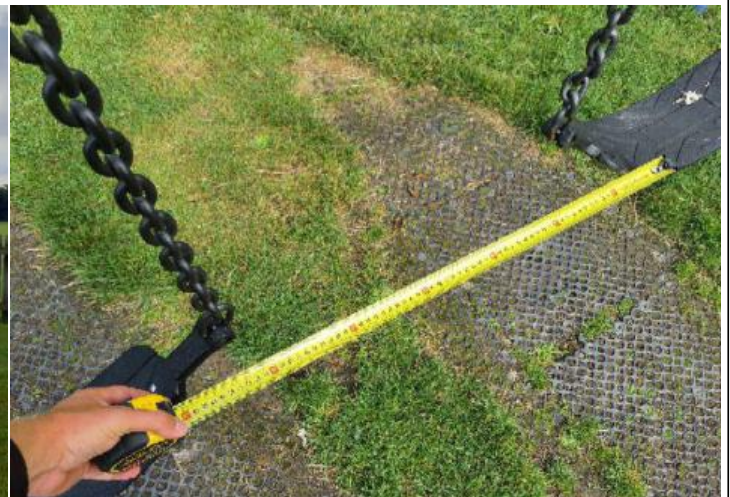
**Finding:** The seats are too close to each other as defined in BS EN 1176 Part 2; this is a low risk failure and no remedial action is required  
**Action:** Monitor - No remedial work recommended

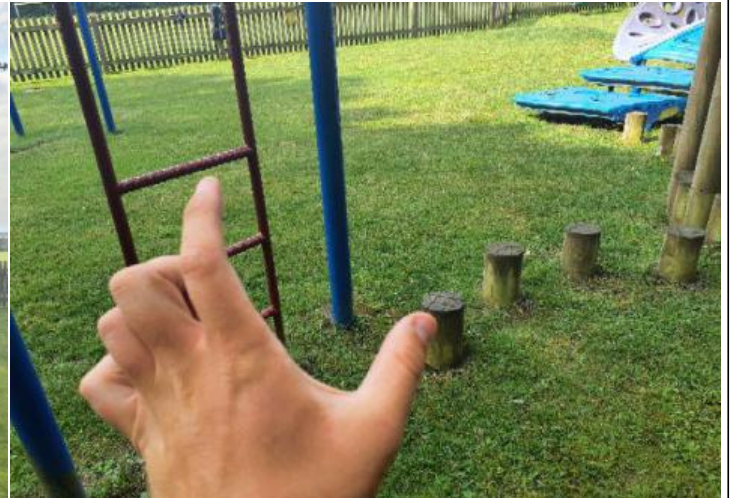
**Finding:** There are falls in excess of 600mm between adjacent components on the structure, in contravention of the recommendations set out in BS EN 1176 Part 1; 4.2.8.4

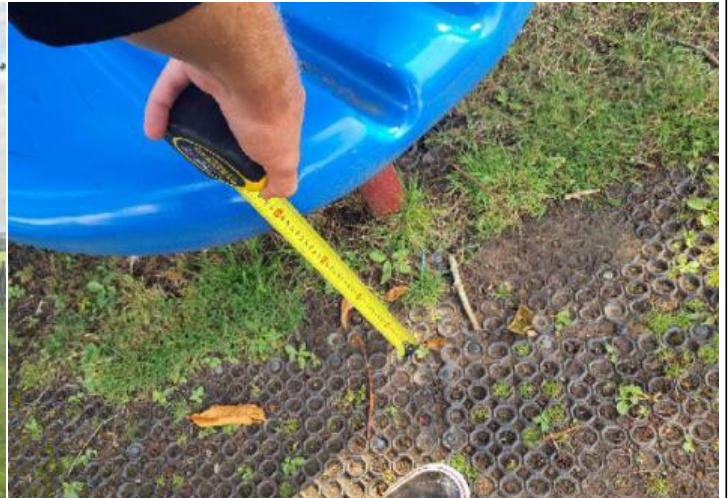
**Finding:** The height of the slide runout is in excess of 350mm and does not meet the requirements of BS EN 1176: Part 3

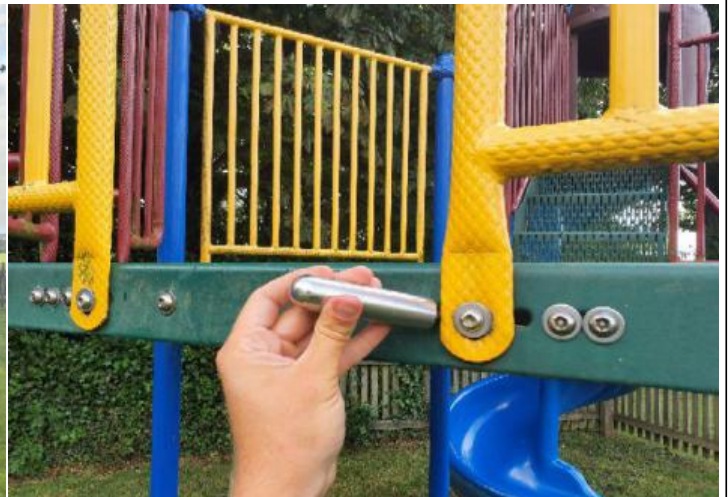
**Finding:** There is/are finger entrapment/s in the frame and the item fails to meet the requirements of BS EN 1176 Part 1 4.2.7.6 Entrapment of fingers

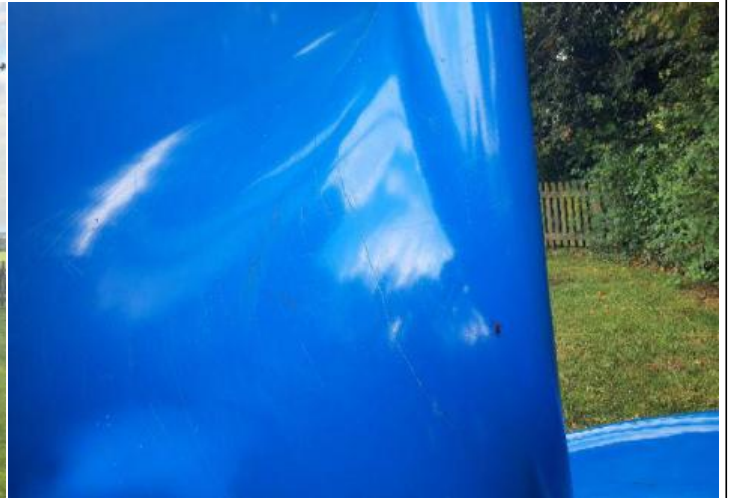
**Finding:** There are a number of dents in the slide surface

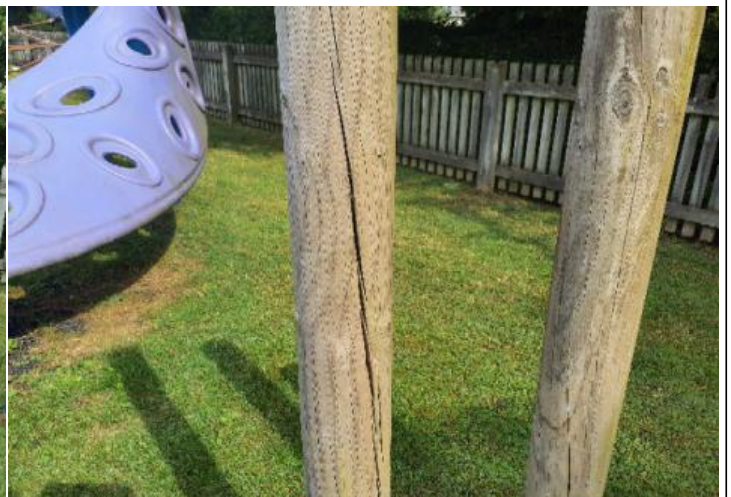
**Finding:** The timber has a number of splits/shakes or air cracks and this may affect the stability or allow water ingress which will accelerate the rotting process
