## Update on Estates Issues

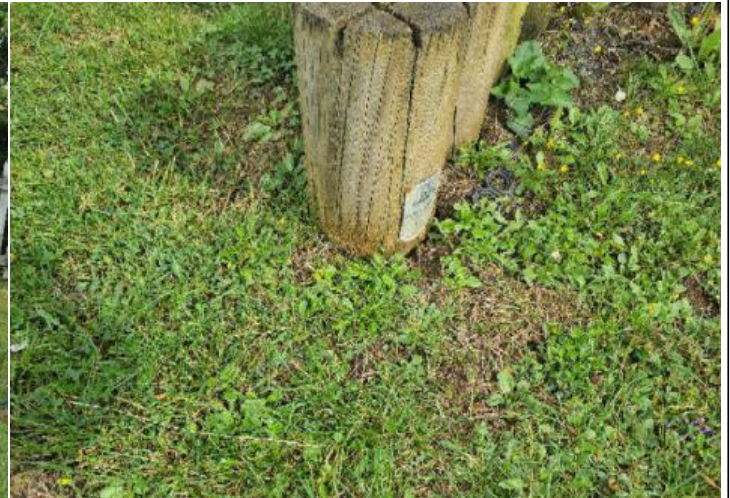
**Finding:** There is some strimmer / machinery damage apparent on the posts, this can penetrate the preservative applied to the timber and accelerate the rotting process

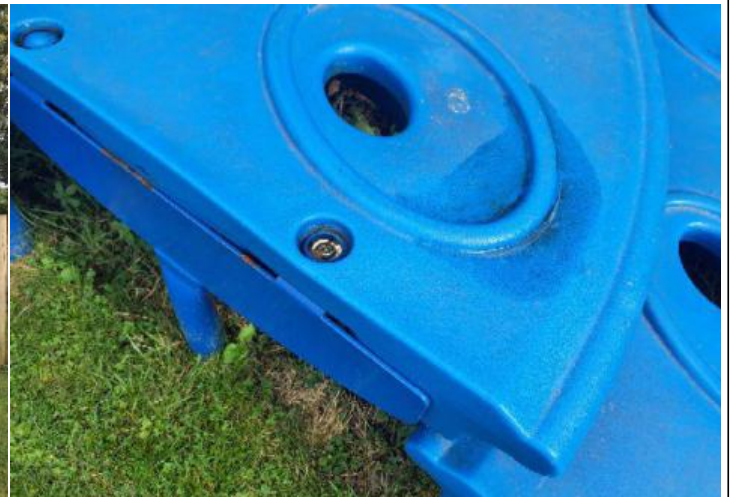
**Finding:** There is/are bolt cap covers missing or damaged on the item

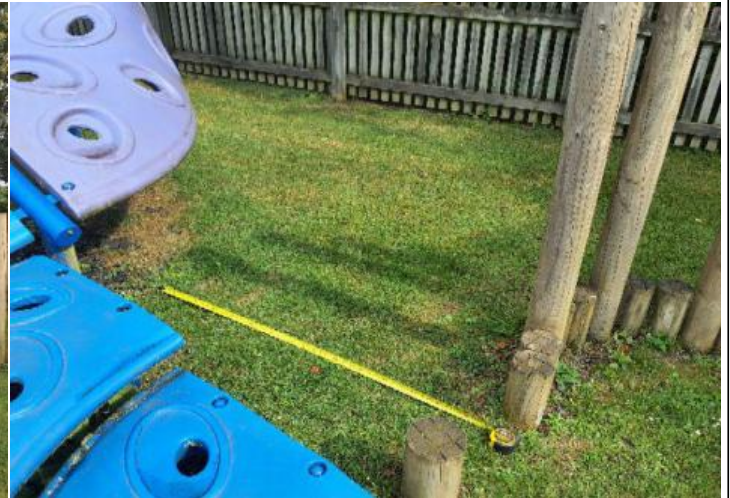
**Finding:** The log walk forms a hard object within the falling space of the equipment in contravention of the requirements of BS EN 1176 Part 1

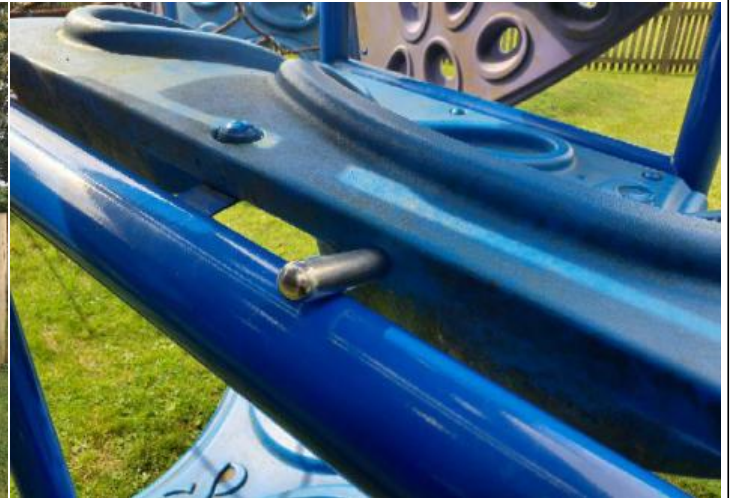
**Finding:** There is/are finger entrapment/s in the frame and the item fails to meet the requirements of BS EN 1176 Part 1 4.2.7.6 Entrapment of fingers  
**Action:** Monitor - No remedial work recommended

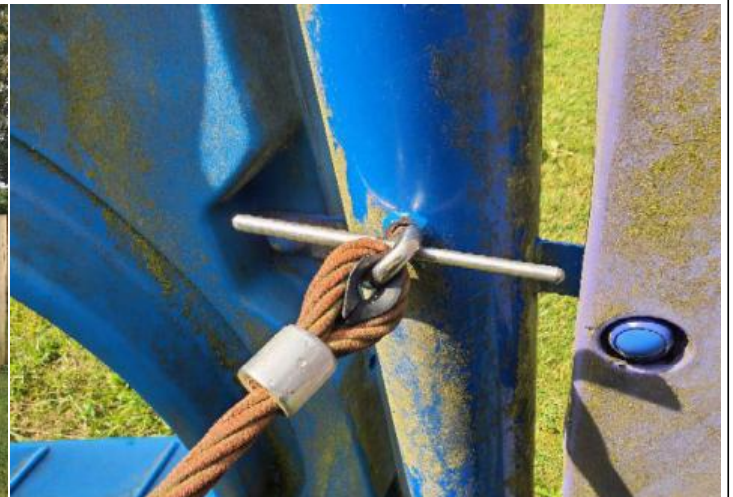
**Finding:** The connecting links are in excess of 8.6mm and less than 12mm and fail the requirements of BS EN 1176 Part 1; clause 4.2.13, Chains  
**Action:** Monitor use and replace with compliant links at the next maintenance cycle

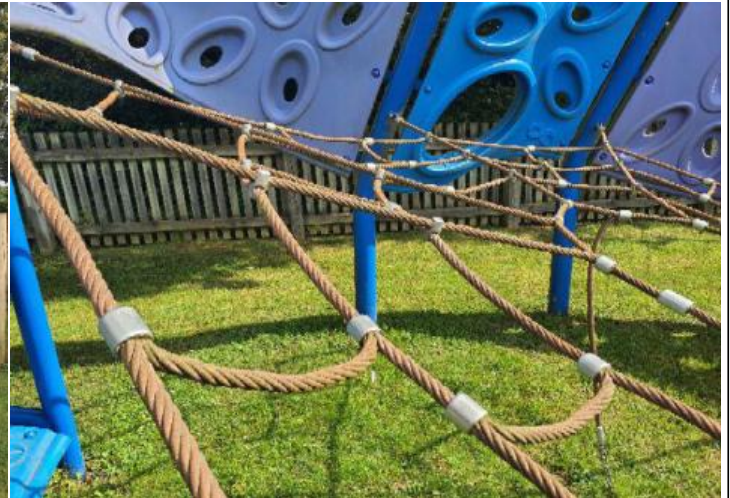
**Finding:** The ropes/nets are worn/damaged in places

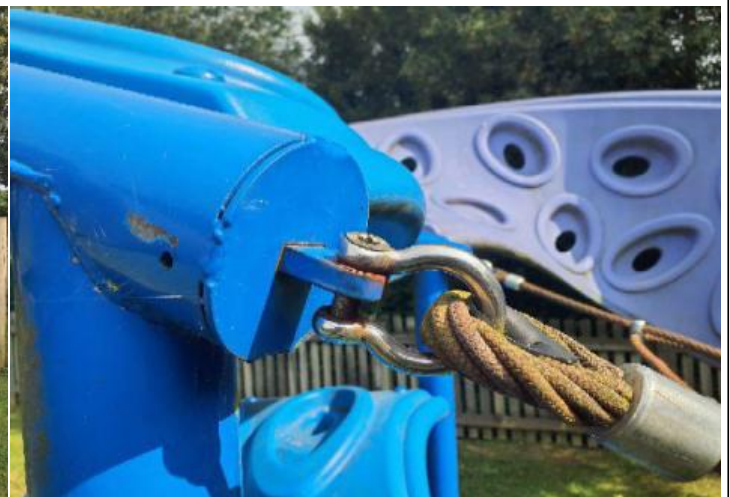
**Finding:** The connecting lugs are showing signs of wear

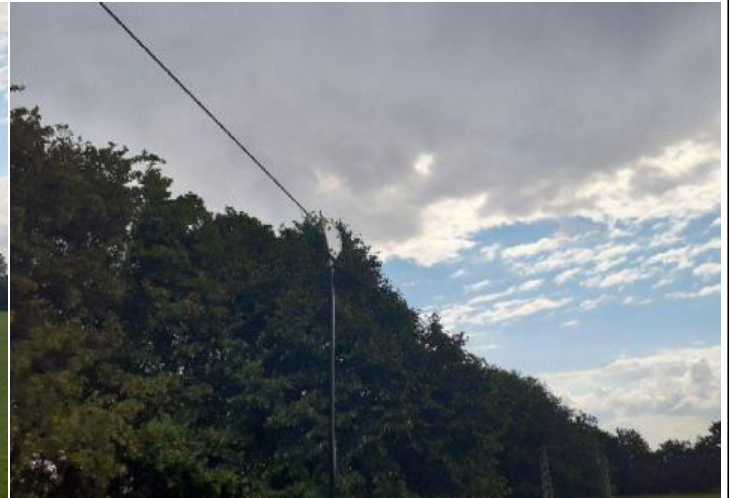
**Finding:** We have completed a visual inspection of the suspension links, cable and fixing points from ground level, however it is not possible to fully inspect these areas without either hiring equipment to gain access or removing the cable and suspension and inspecting at ground level. We recommend that the main cable and fixing security is thoroughly inspected at least in accordance with the manufacturers recommendations to check for wear, damage, security or internal rusting; this will help to ensure the continued safe use of the equipment

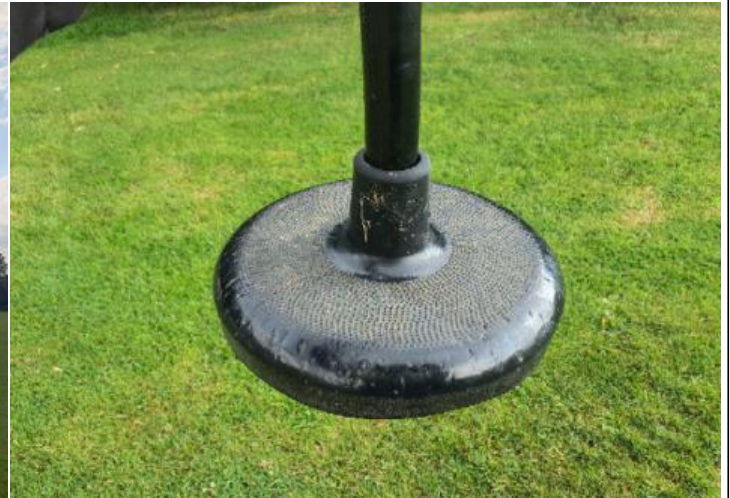
**Finding:** The seat connection cannot be inspected without dismantling the seat

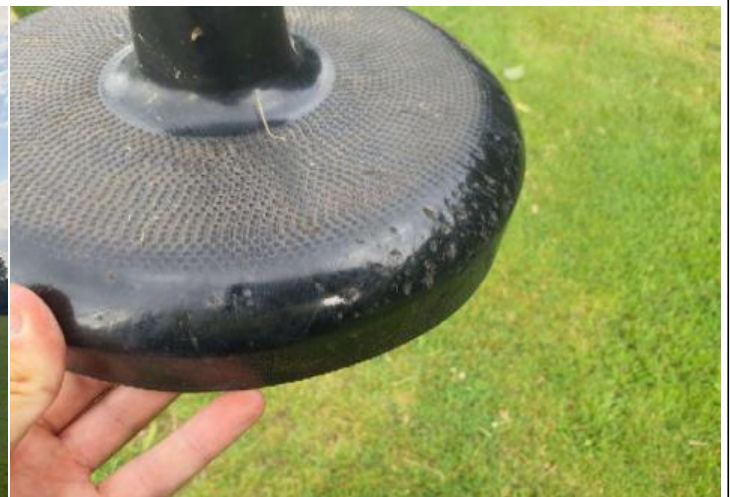
**Finding:** The cableway seat has been damaged

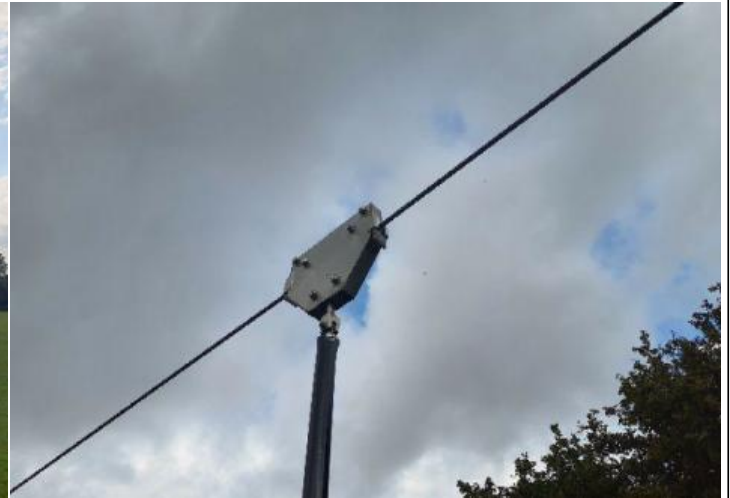
**Finding:** The nylon inserts are worn or missing at the point the cable enters the traveller

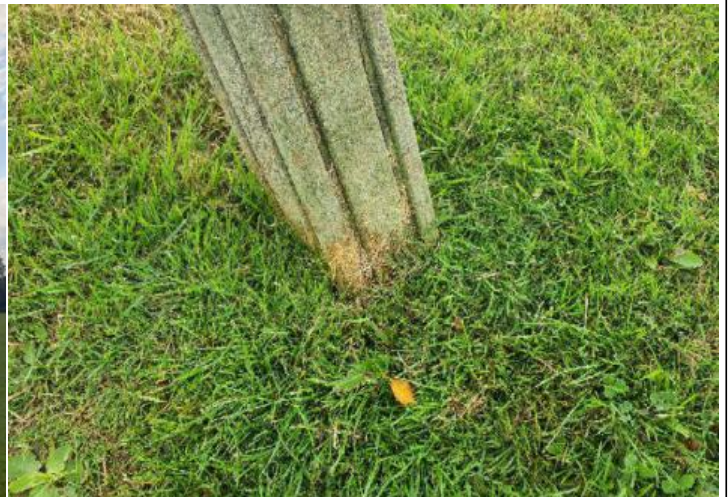
**Finding:** There is some strimmer / machinery damage apparent on the posts, this can penetrate the preservative applied to the timber and accelerate the rotting process  
**Action:** Monitor for any deterioration (rot) and replace as required
