WPC.EC.24.02.03 – Play Inspection Reports & Remedial Work

Play Area Inspection Reports & Remedial Work

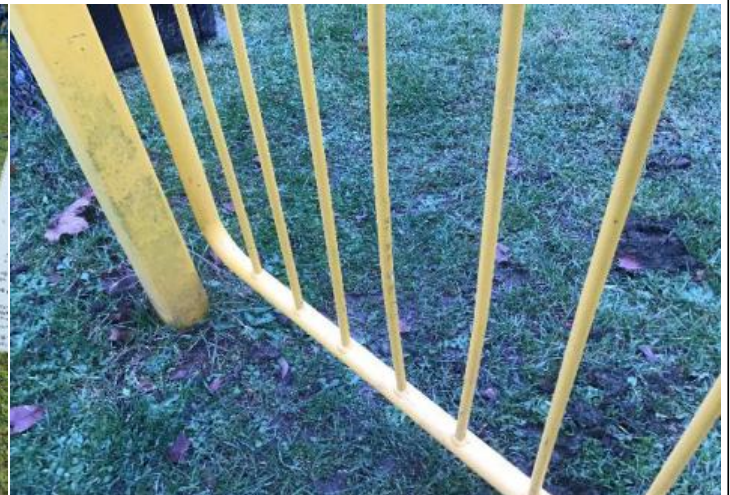
Finding: There is some damage to the item

Action: Monitor for any further deterioration and repair as required

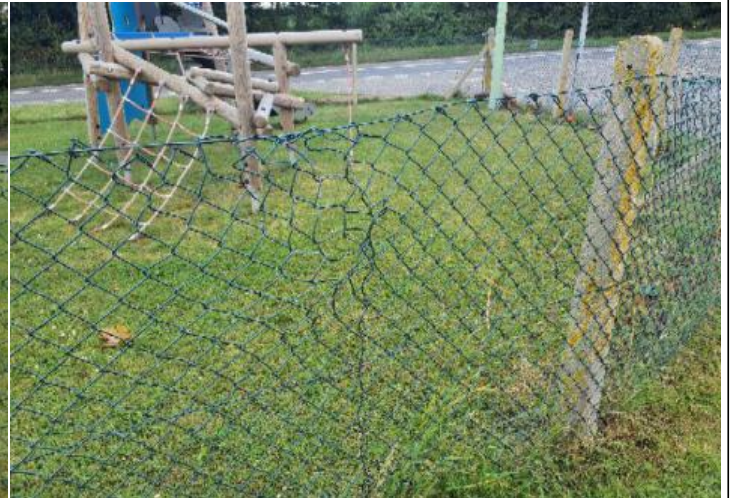
Finding: There is some damage to the fence sections

Action: Monitor for any further deterioration and repair as required

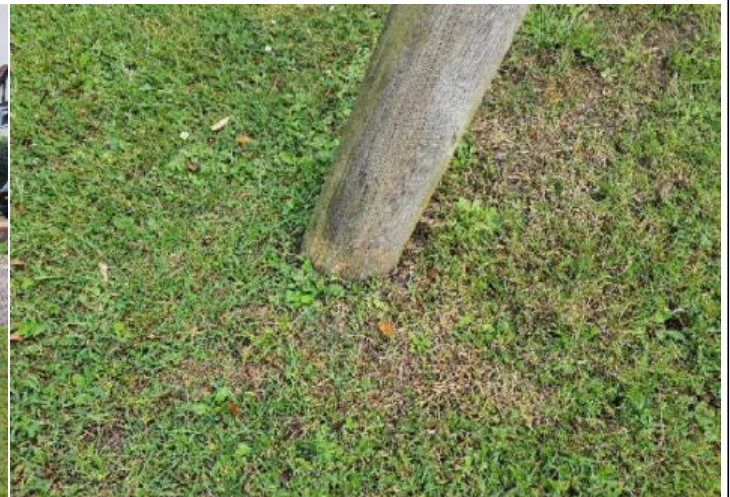
Finding: There is some strimmer / machinery damage apparent on the posts, this can penetrate the preservative applied to the timber and accelerate the rotting process

Action: Monitor for any deterioration (rot) and replace as required

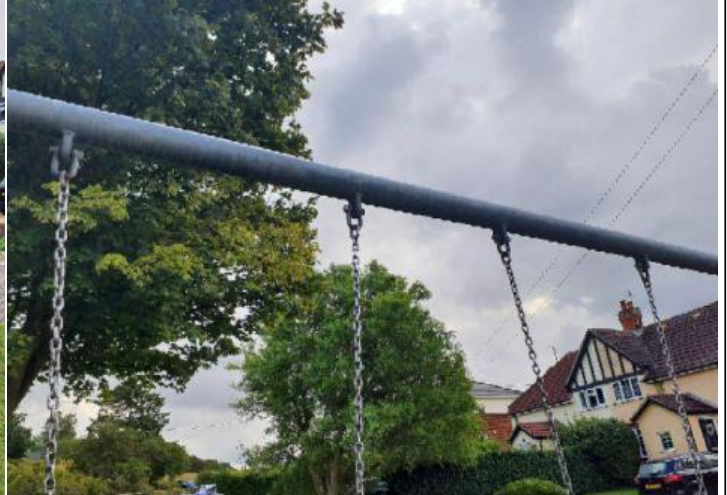
Finding: There is some wear to the shackles

Action: Monitor for any further deterioration and replace when 40% worn

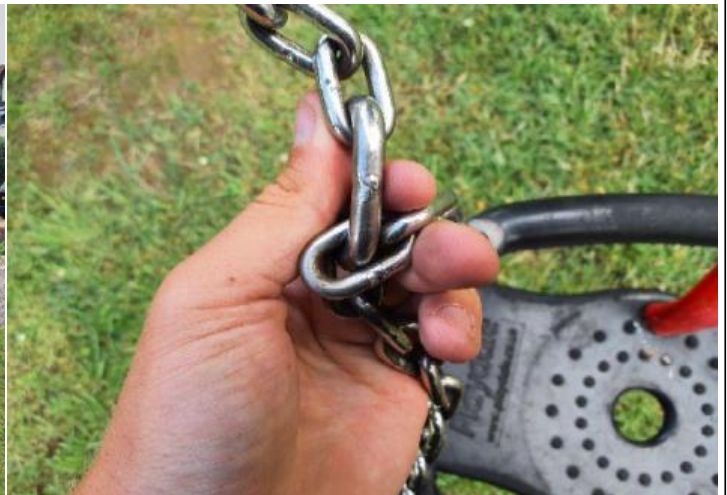
Finding: There is some notable evidence of chain wear

Action: Monitor for any further deterioration and replace when 40% worn

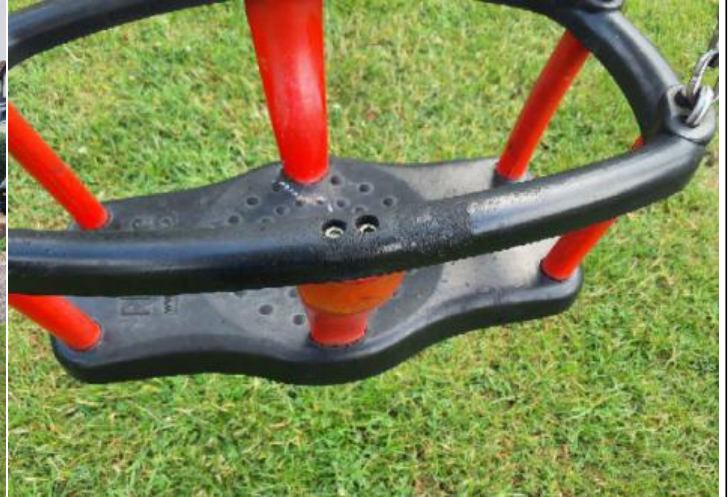
Finding: The seat has minor damage or wear

Action: Monitor for any further deterioration and replace as required

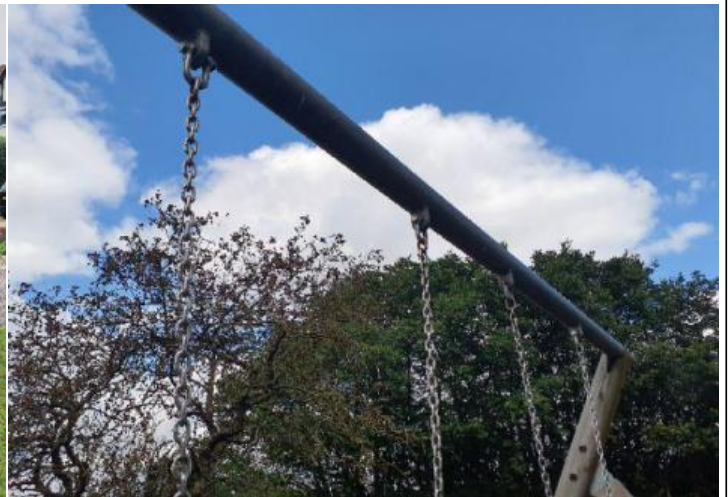
Finding: The bushes are showing signs of wear

Action: Monitor for any further deterioration and replace as required

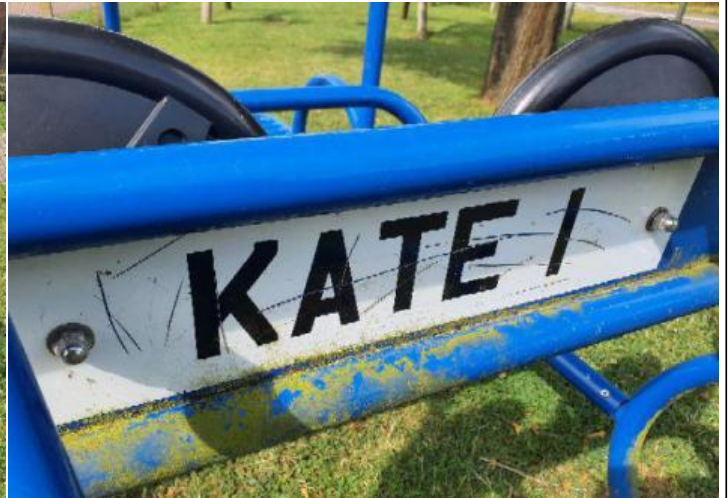
Finding: There is some damage to the item

Action: Monitor for any further deterioration and repair as required

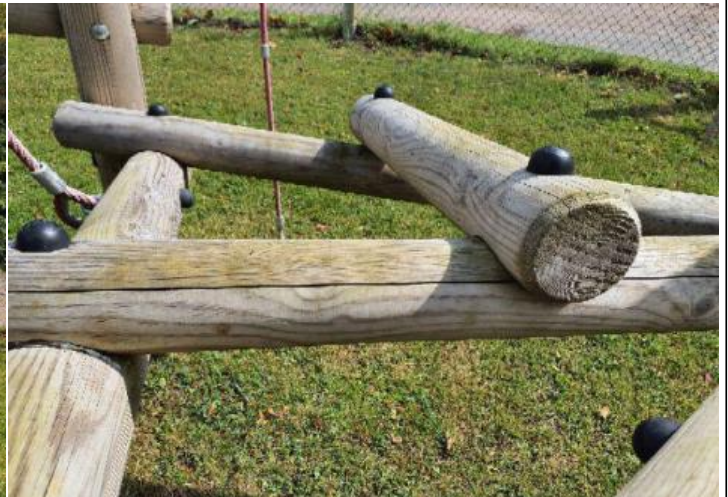
Finding: The timber has a number of splits/shakes or air cracks and this may affect the stability or allow water ingress which will accelerate the rotting process

Action: Monitor to ensure the splits do not cross through fixing points of the structure and/or cause any instability

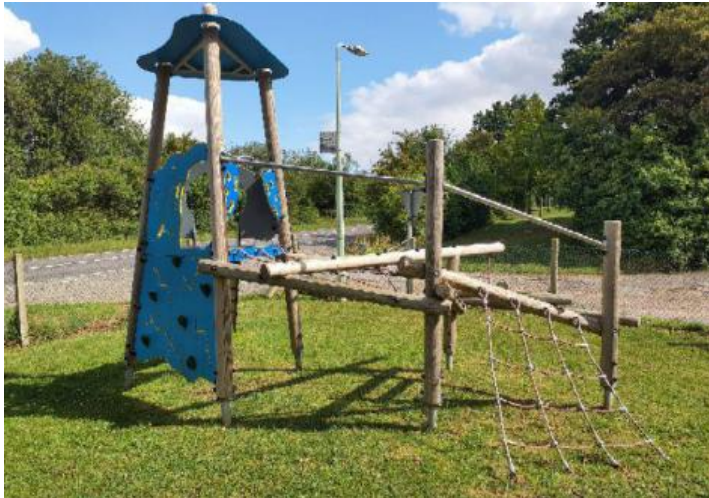
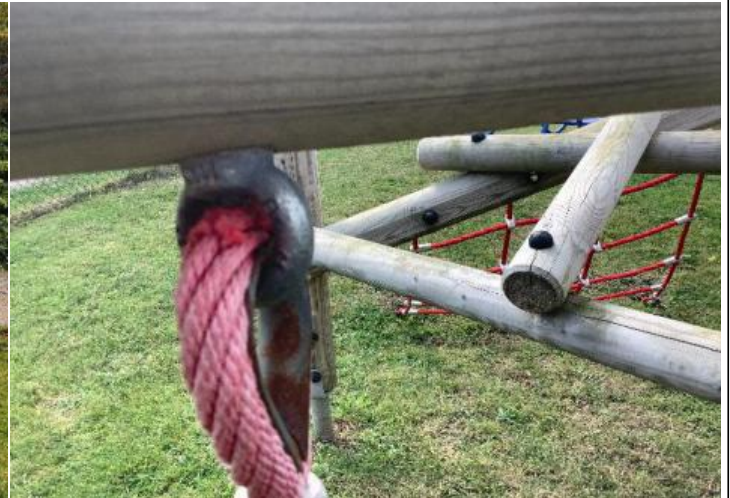
Finding: The ropes/nets are worn/damaged in places

Action: Monitor for any further deterioration and repair or replace as required

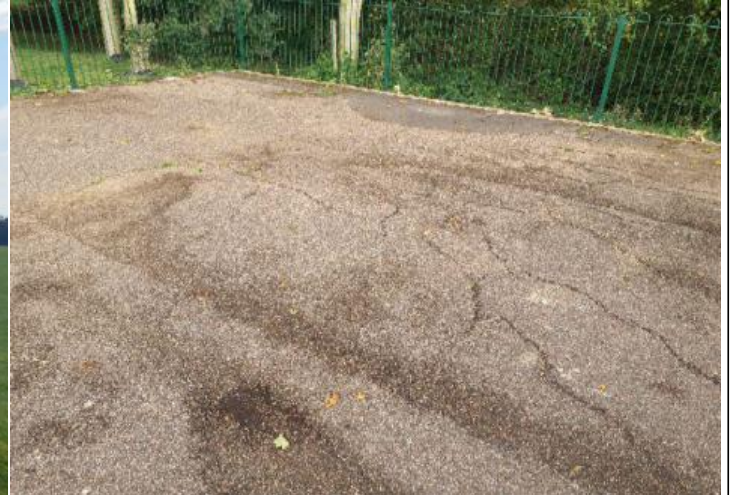
Finding: There is moderate damage to the surface

Action: Repair the damaged areas of surfacing

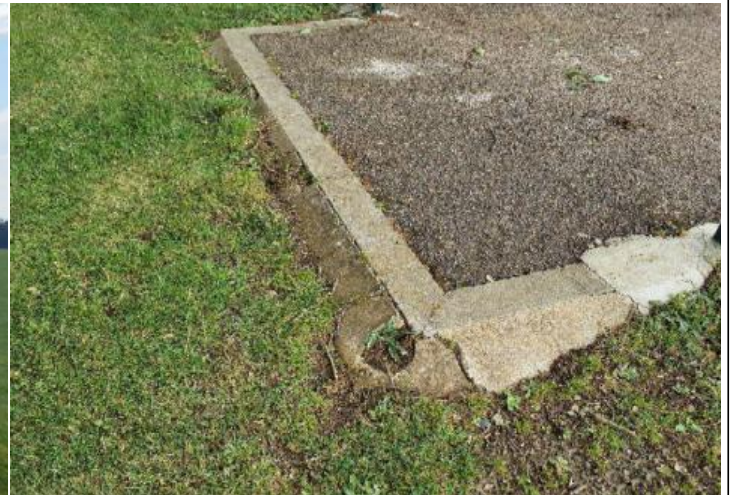
Finding: The concrete is breaking up around the edges of the surface

Action: Repair the damaged concrete

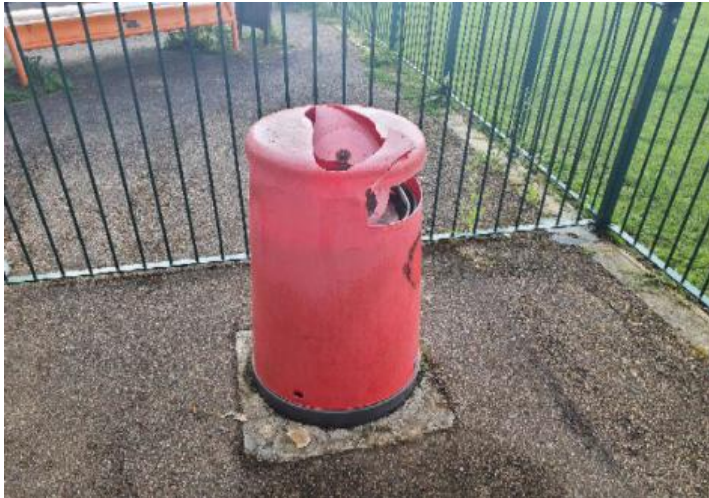
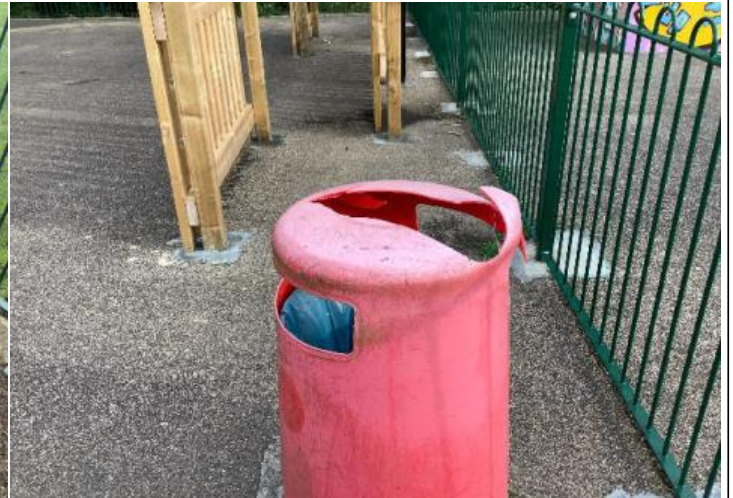
Finding: There is some damage to the item exposing sharp edges
Action: Replace

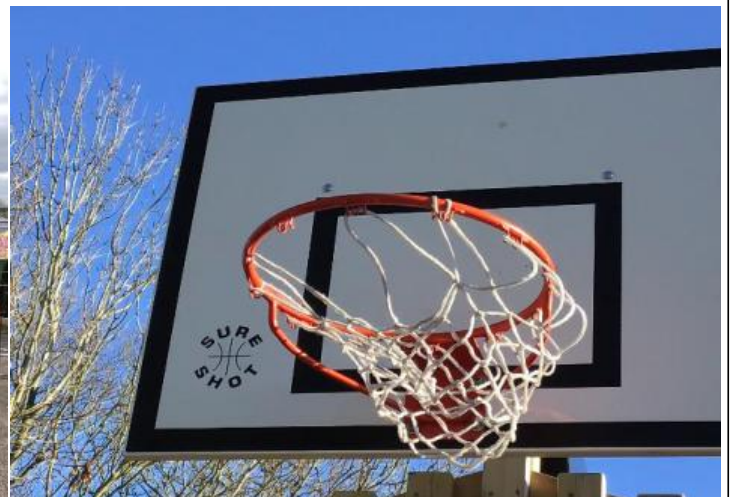
Finding: The net has become detached
Action: Repair

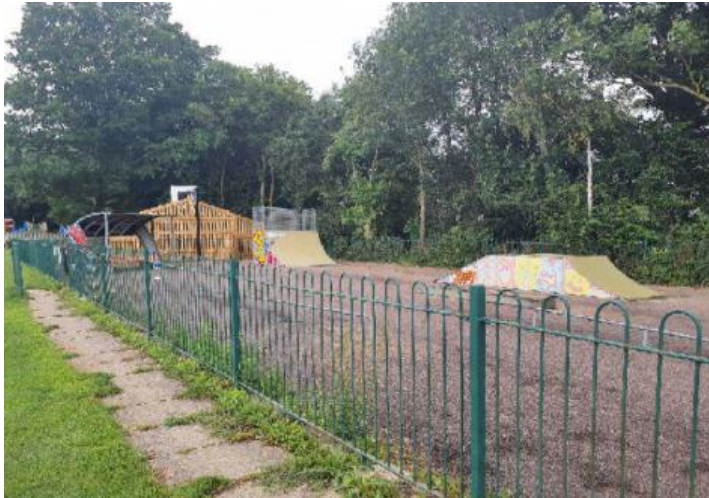
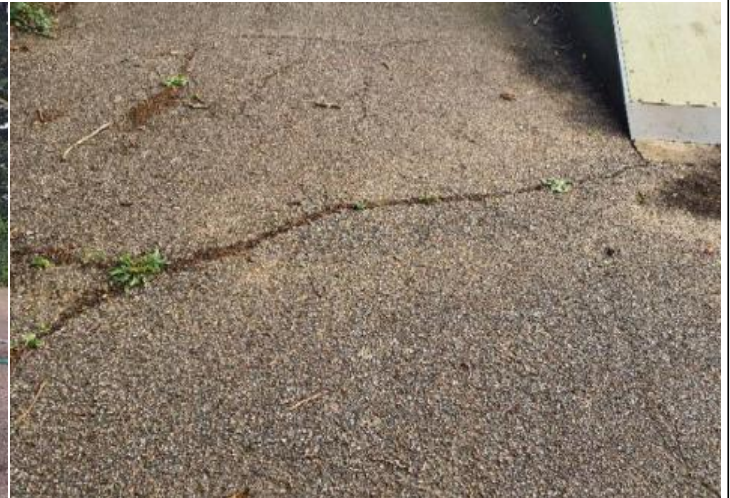
Finding: There is root damage to the surfacing creating unforeseen changes in levels

Action: Repair the damaged areas of tarmac to provide a uniform surface

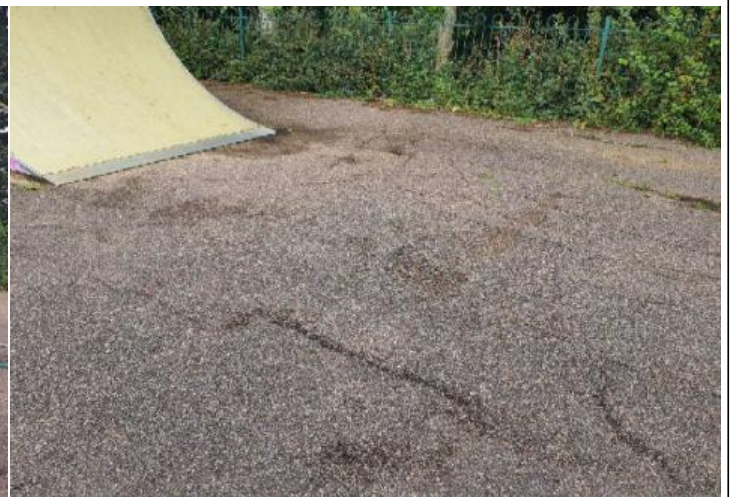
Finding: There is some damage apparent to the riding surface

Action: Monitor for any further deterioration and repair as required

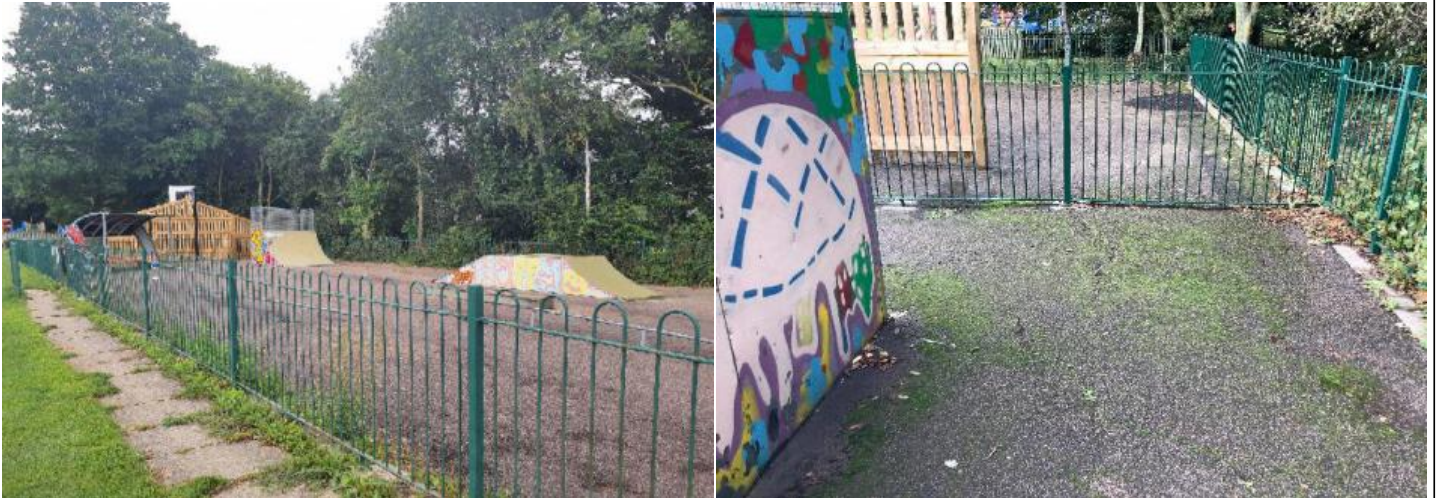
Finding: There is algae, silt or moss growth on the surface resulting in slippery conditions
Action: Clean and treat appropriately

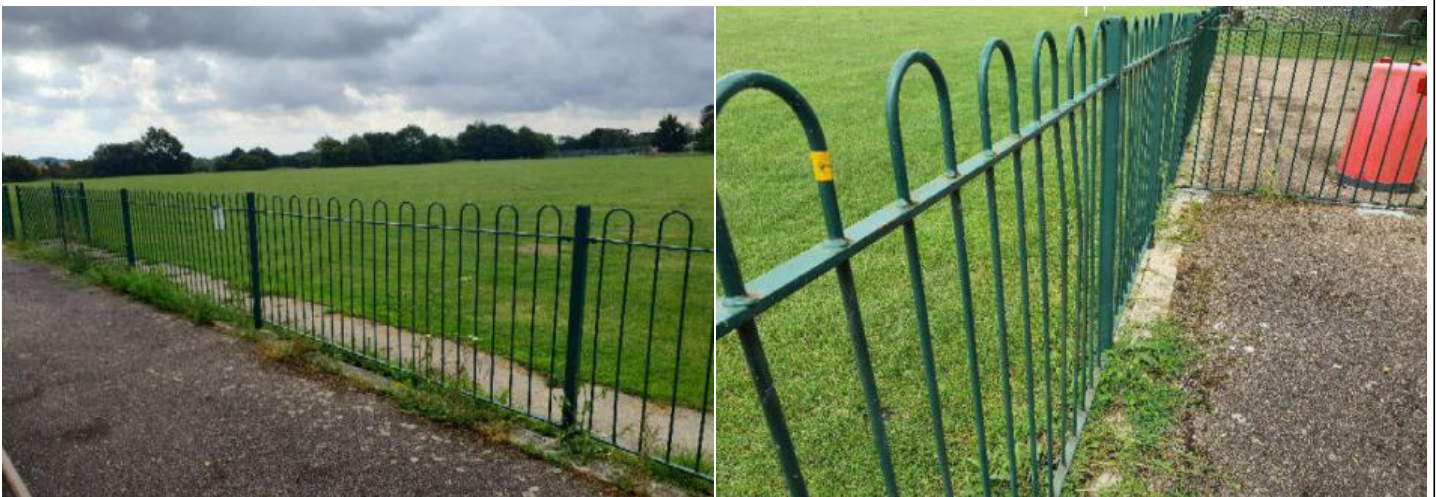
Finding: There is some damage to the fence sections
Action: Monitor for any further deterioration and repair as required

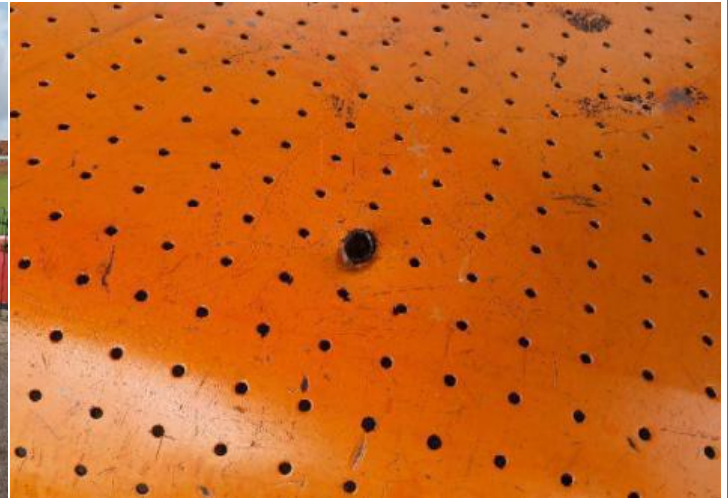
Finding: There is some evidence of fire damage to the item **Action:** Monitor for any further deterioration and repair as required

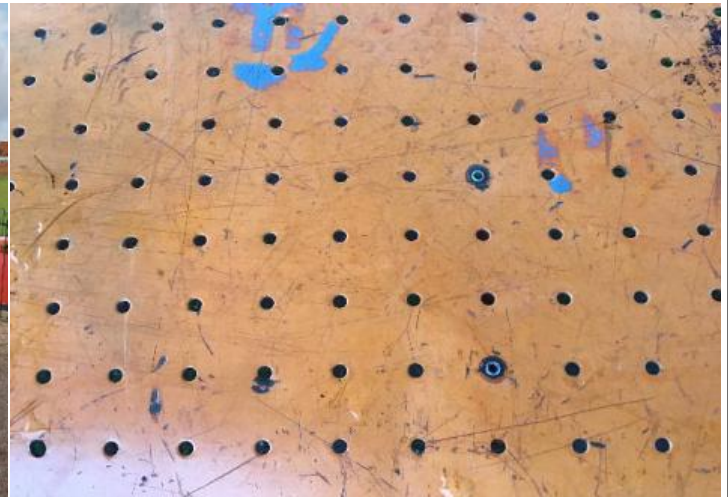
Finding: Pop rivet fixings have failed on the seat **Action:** Replace the failed pop rivets

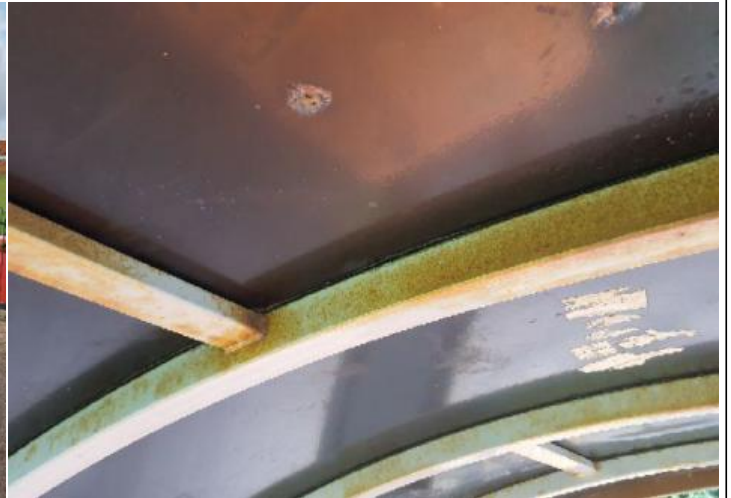
Finding: There is surface corrosion / rust present on the item

Action: Consider treating the item

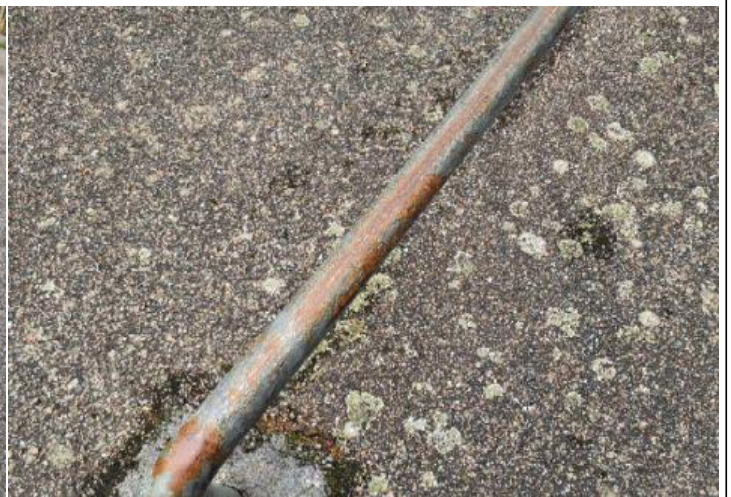
Finding: There is surface corrosion / rust present on the item

Action: Consider treating the item

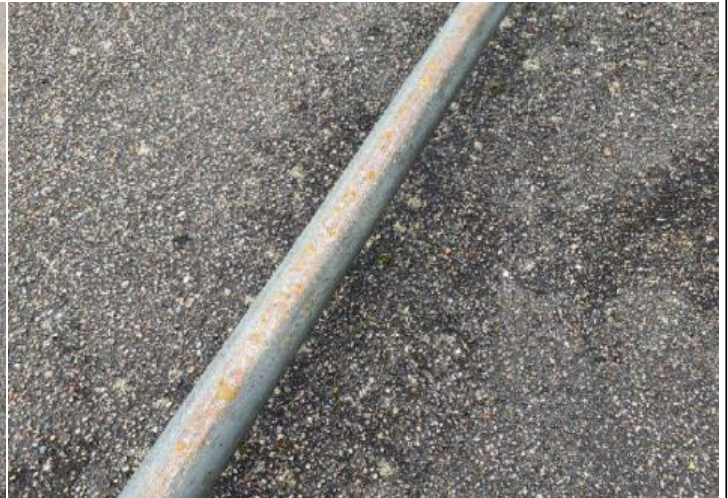
Finding: There is surface corrosion / rust present on the item

Action: Consider treating the item

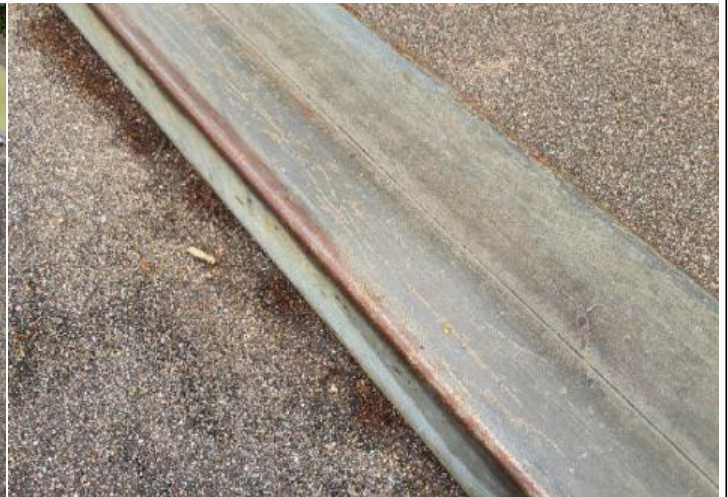
Finding: There is surface corrosion / rust present on the item

Action: Consider treating the item

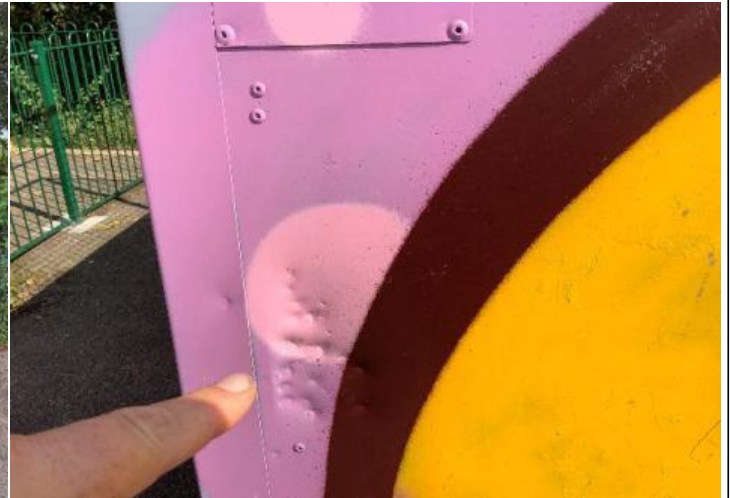
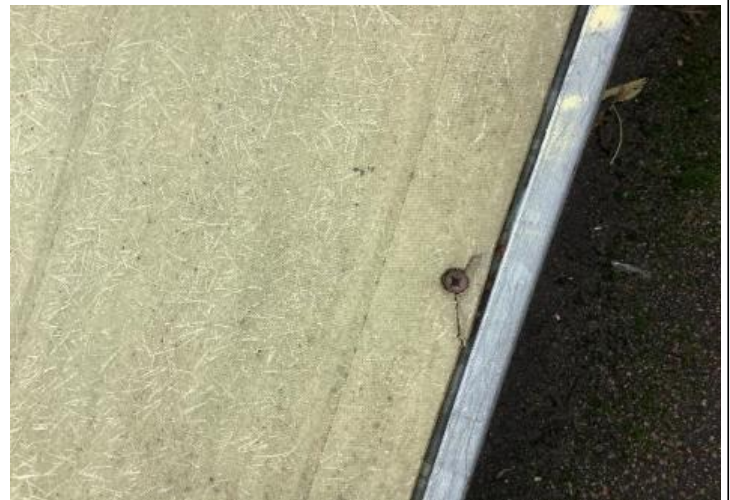
Finding: The item has been damaged

Action: Monitor for any further deterioration and replace as required

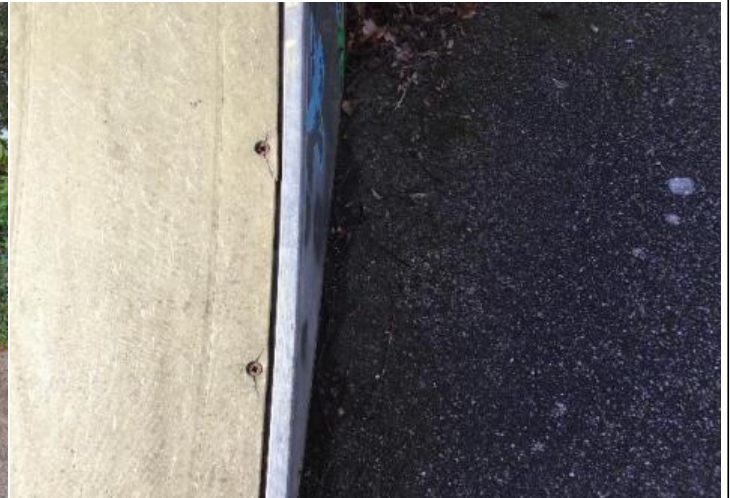
Finding: The riding surface of the ramp has some damage apparent

Action: Monitor for any further deterioration and repair as required

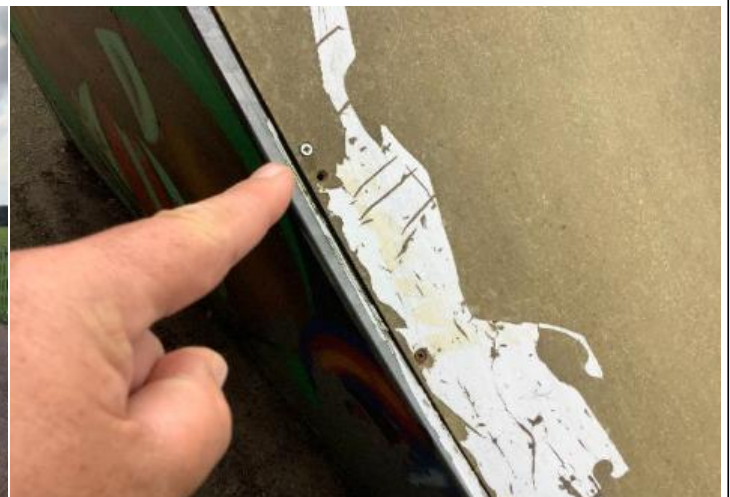
Finding: A number of fixing(s) have worked loose

Action: Secure all loose fixings

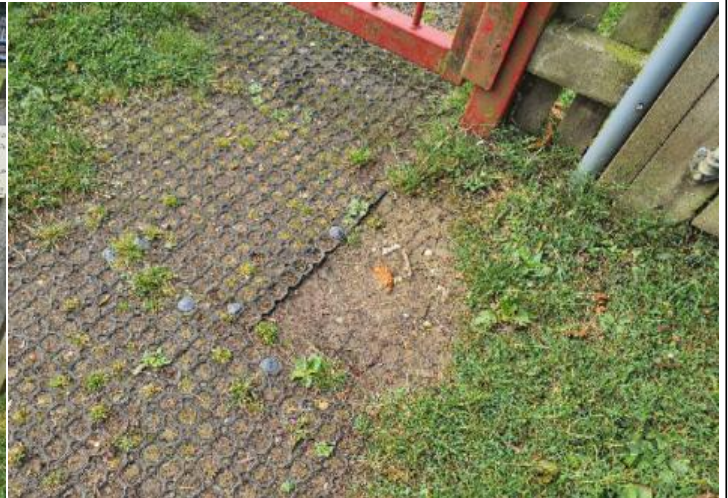
Finding: There are trip hazards at the edges of the surface

Action: Reinstate surrounding surface levels to remove the trip points

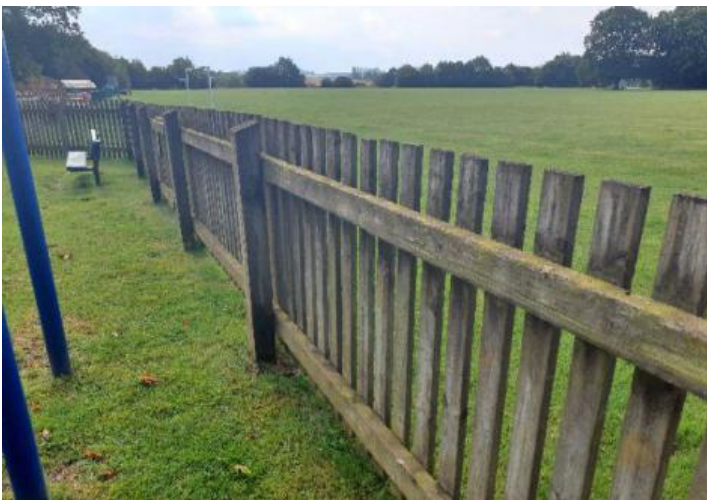
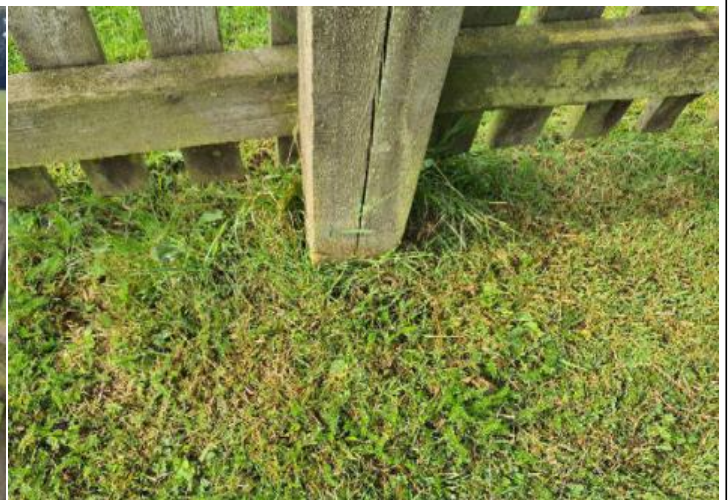
Finding: There is some strimmer / machinery damage apparent on the posts, this can penetrate the preservative applied to the timber and accelerate the rotting process

Action: Monitor for any deterioration (rot) and replace as required

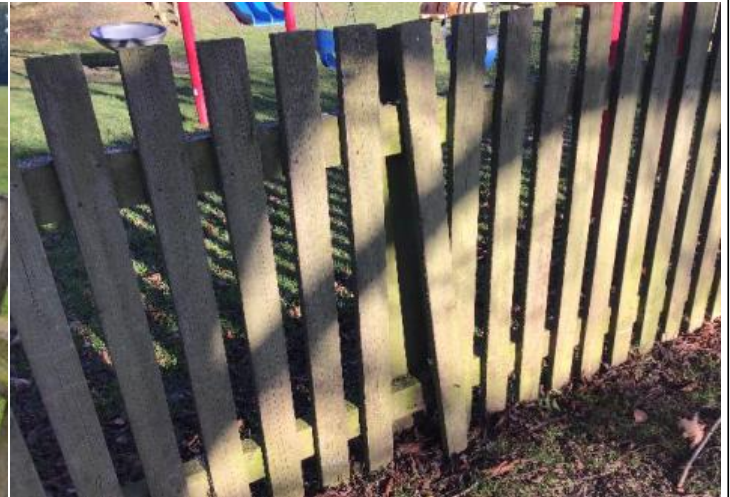
Finding: There is some damage to the item

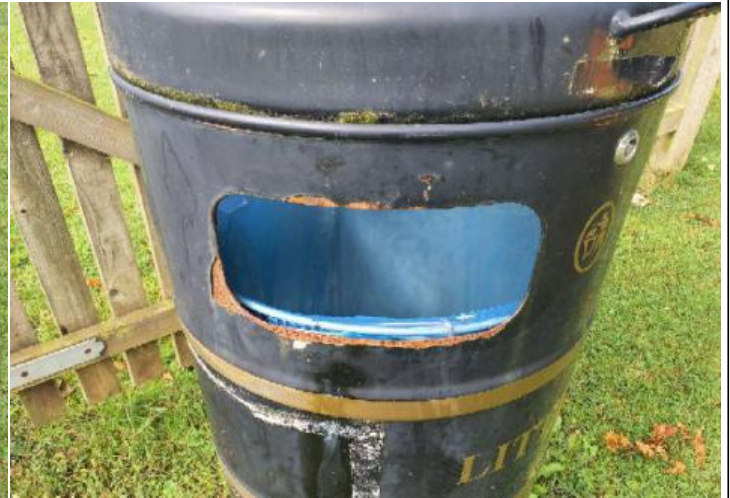
Finding: The paintwork on this item has been damaged or worn exposing the metal underneath which is rusting / corroding

Action: Treat affected areas and repaint

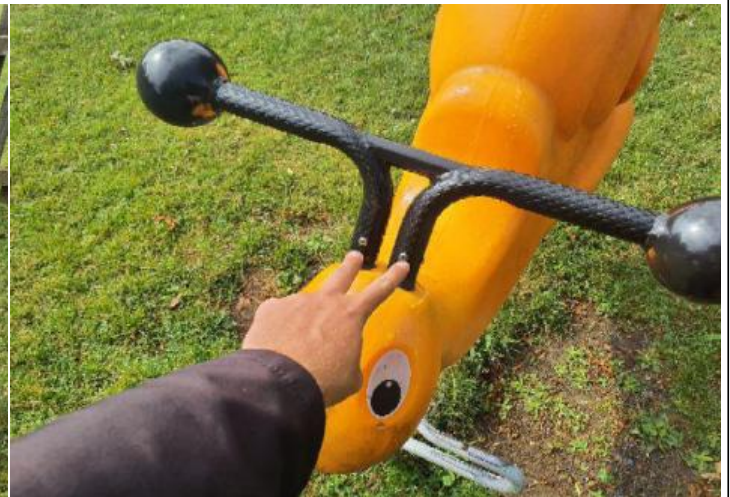
Finding: A number of fixing(s) have worked loose

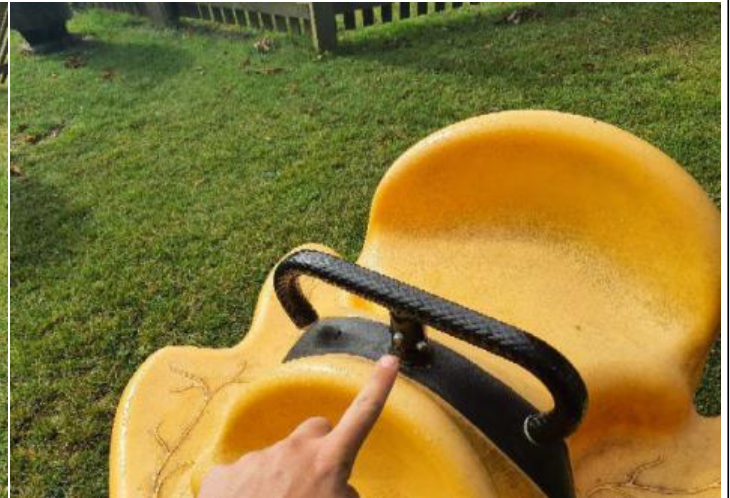
Finding: A number of fixing(s) have worked loose

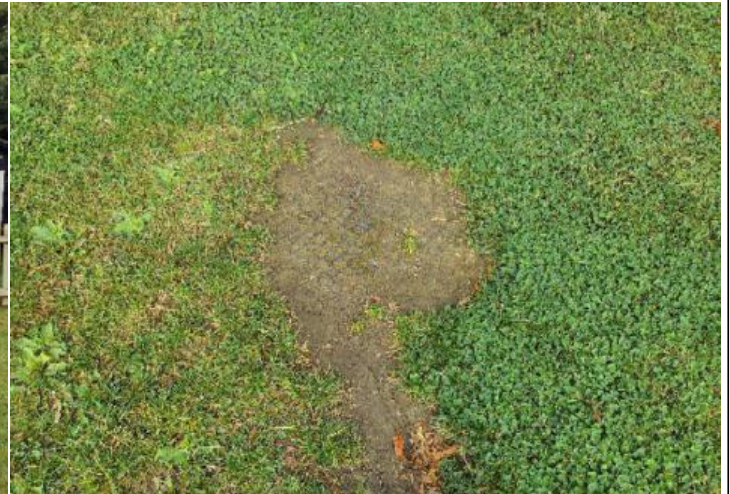
Finding: The grass mats are silted up and the soil is compacted; this may have an effect on the impact absorbing properties of the surface

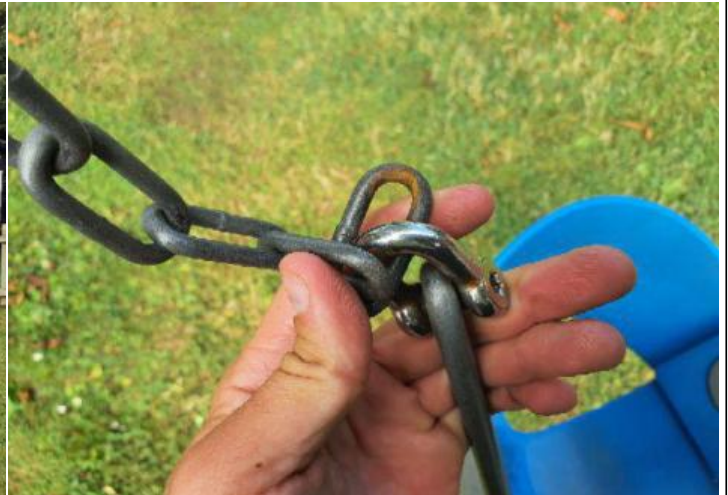
Finding: There is some notable evidence of chain wear

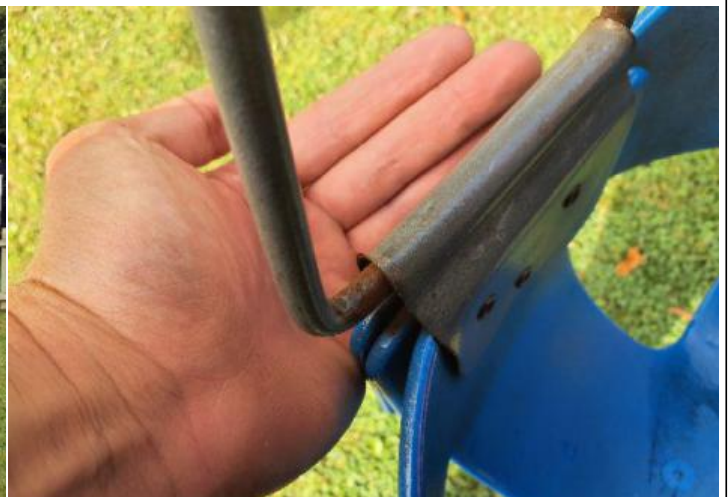
Finding: The swing seat connectors have some wear present

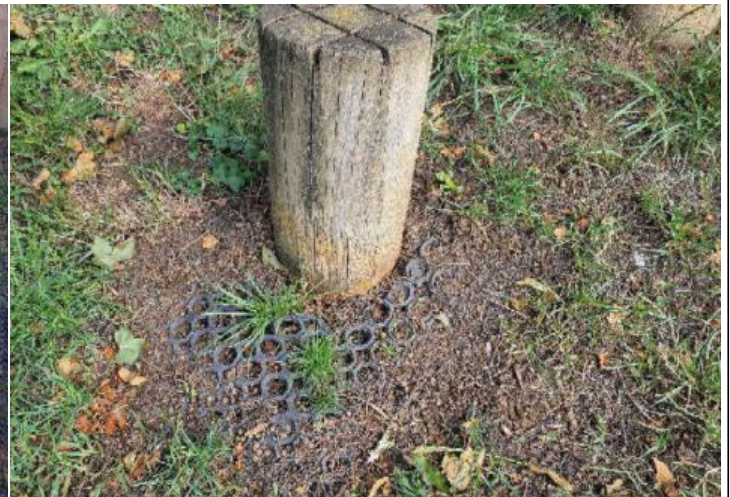
Finding: There is some strimmer / machinery damage apparent on the posts, this can penetrate the preservative applied to the timber and accelerate the rotting process

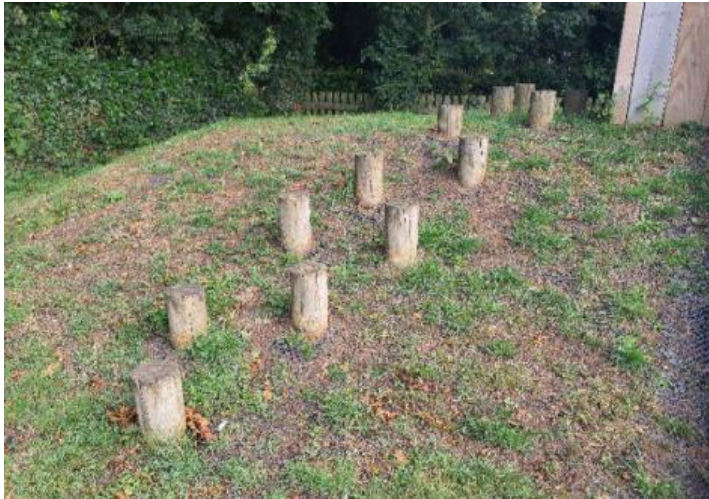
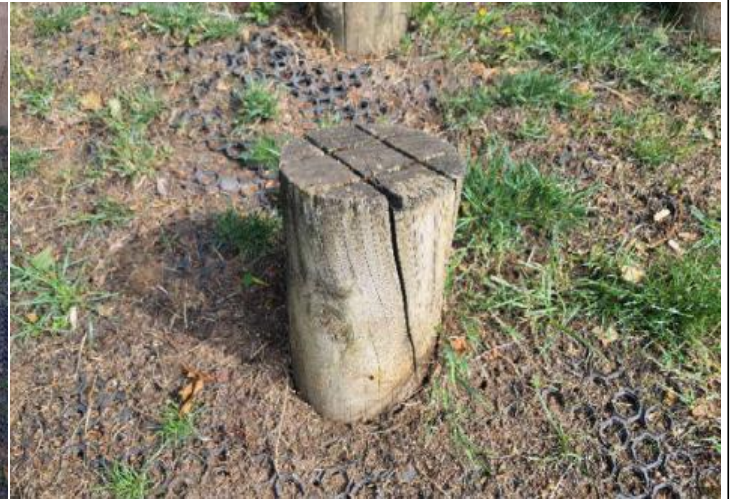
Finding: The timber has a number of splits/shakes or air cracks and this may affect the stability or allow water ingress which will accelerate the rotting process
Action: Monitor to ensure the splits do not cross through fixing points of the structure and/or cause any instability

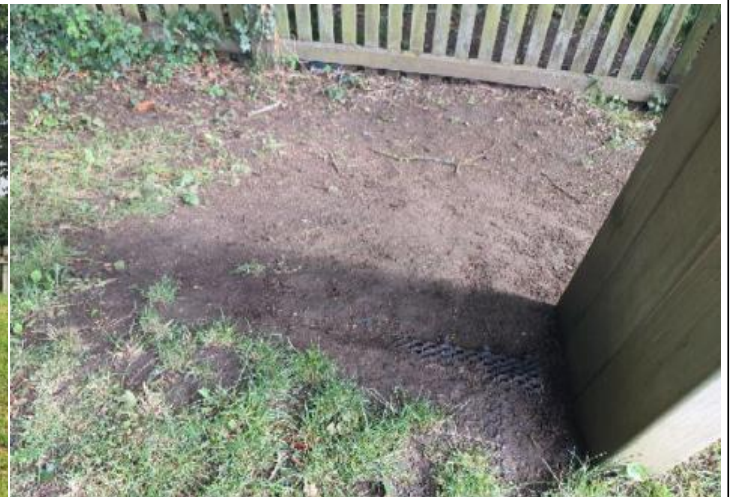
Finding: The surface has eroded in some areas and may be slippery in wet conditions
Action: Reinststate the surface

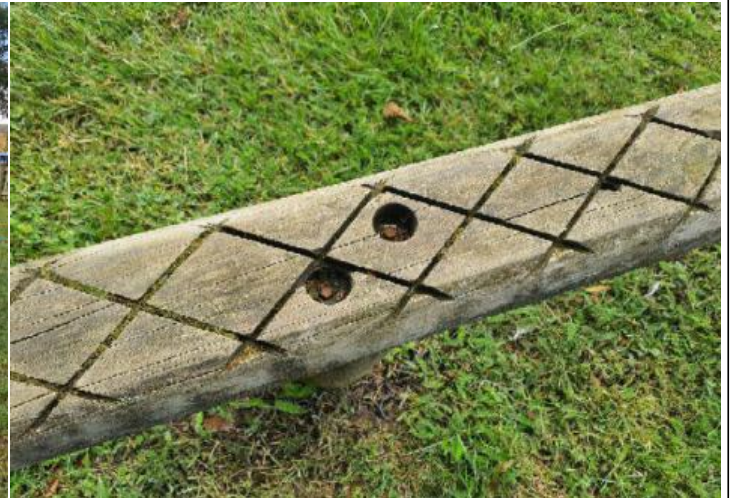
Finding: There is/are bolt cap covers missing or damaged on the item

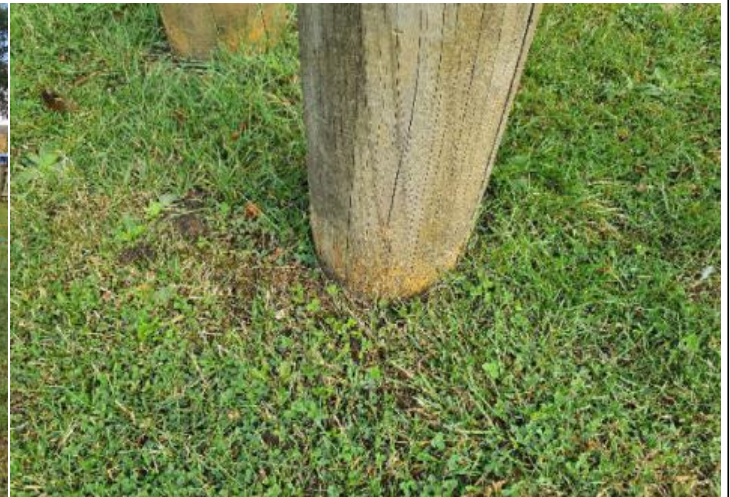
Finding: There is some strimmer / machinery damage apparent on the posts, this can penetrate the preservative applied to the timber and accelerate the rotting process

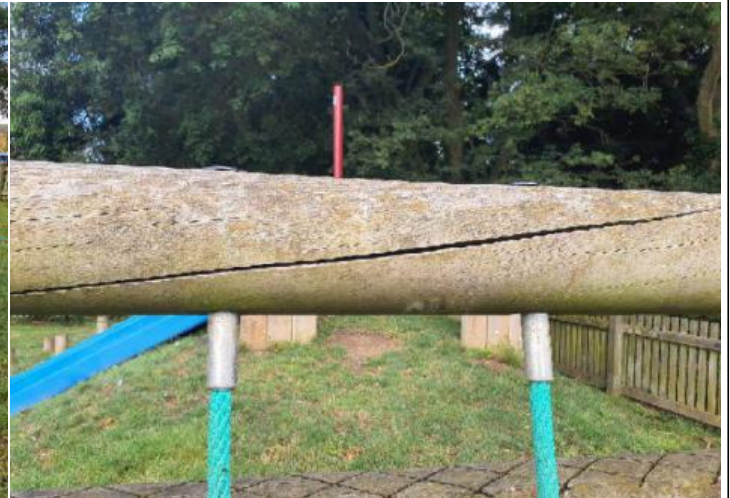
Finding: The timber has a number of splits/shakes or air cracks and this may affect the stability or allow water ingress which will accelerate the rotting process
Action: Monitor to ensure the splits do not cross through fixing points of the structure and/or cause any instability

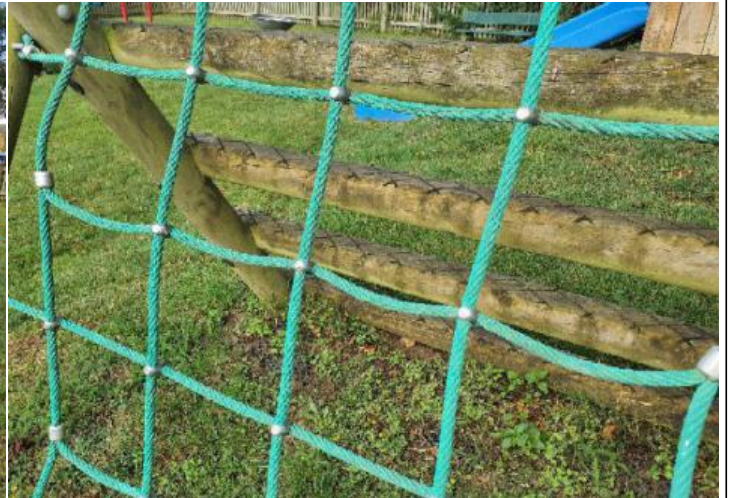
Finding: The ropes/nets are worn/damaged in places

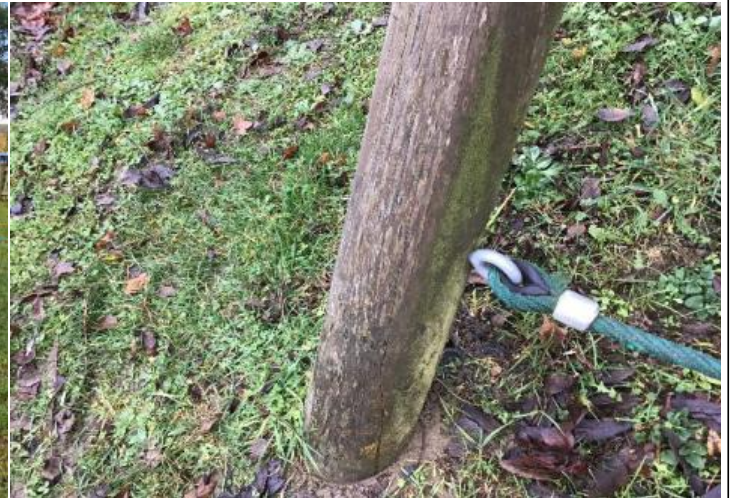
Finding: A number of fixing(s) have worked loose

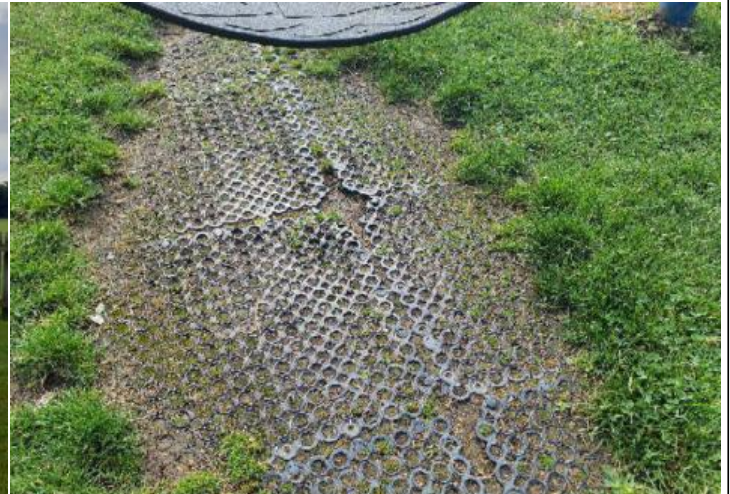
Finding: There is moderate damage to the surface

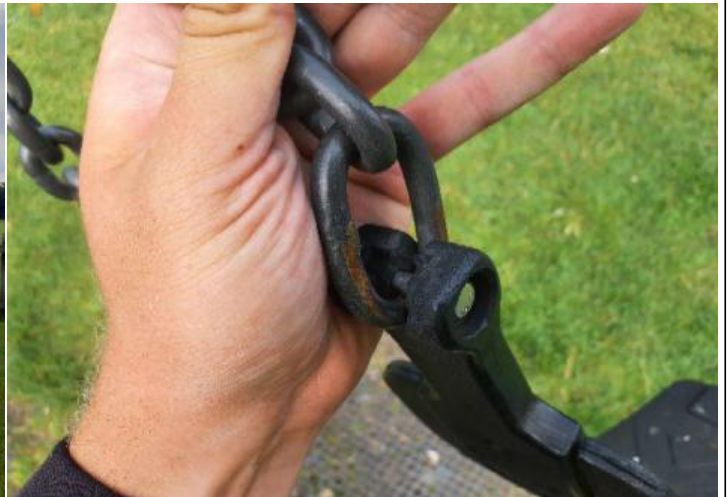
Finding: The swing seat connectors have some wear present

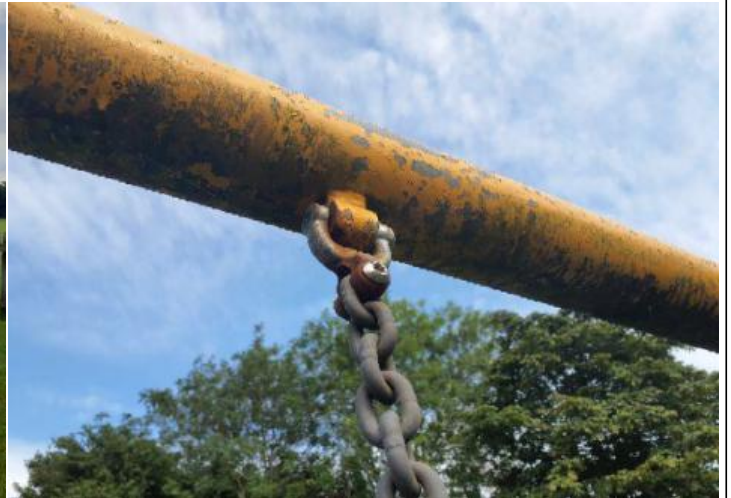
Finding: There is some notable evidence of chain wear

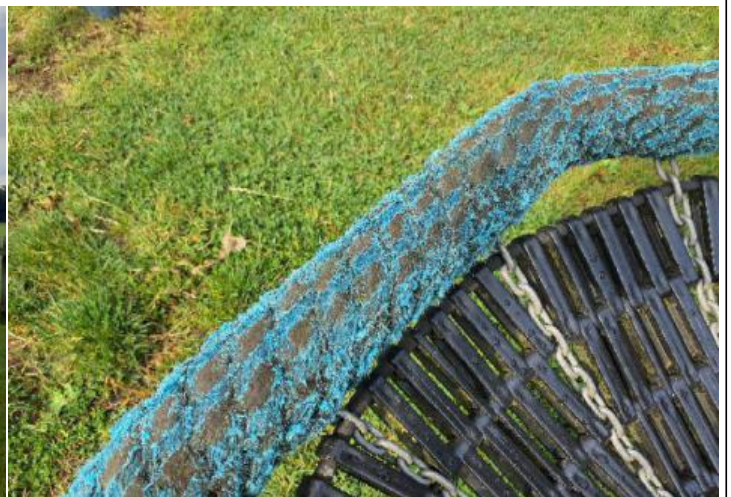
Finding: The seat has minor damage or wear

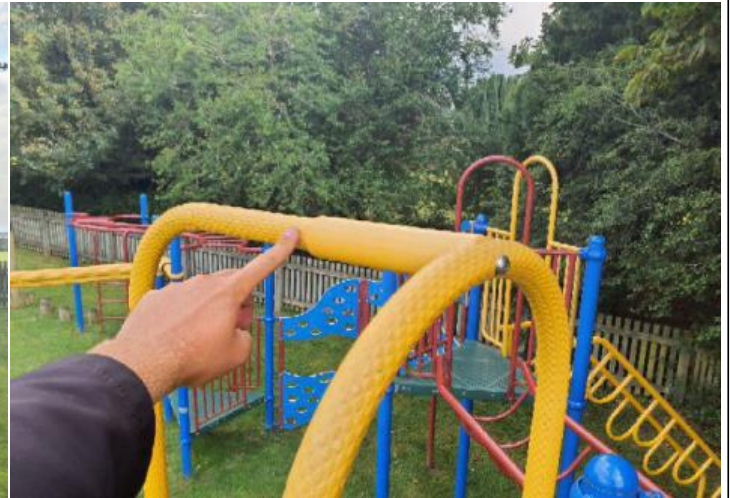
Finding: A number of fixing(s) have worked loose

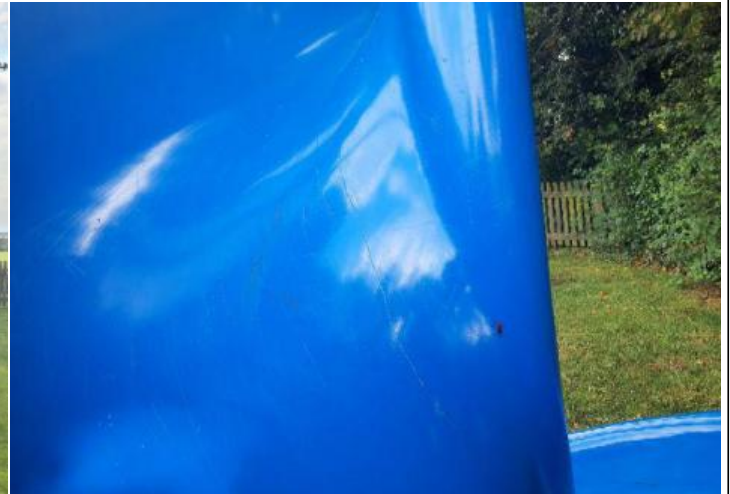
Finding: There are a number of dents in the slide surface
