WPC.EC.24.02.03 – Play Inspection Reports & Remedial Work

Play Area Inspection Reports & Remedial Work

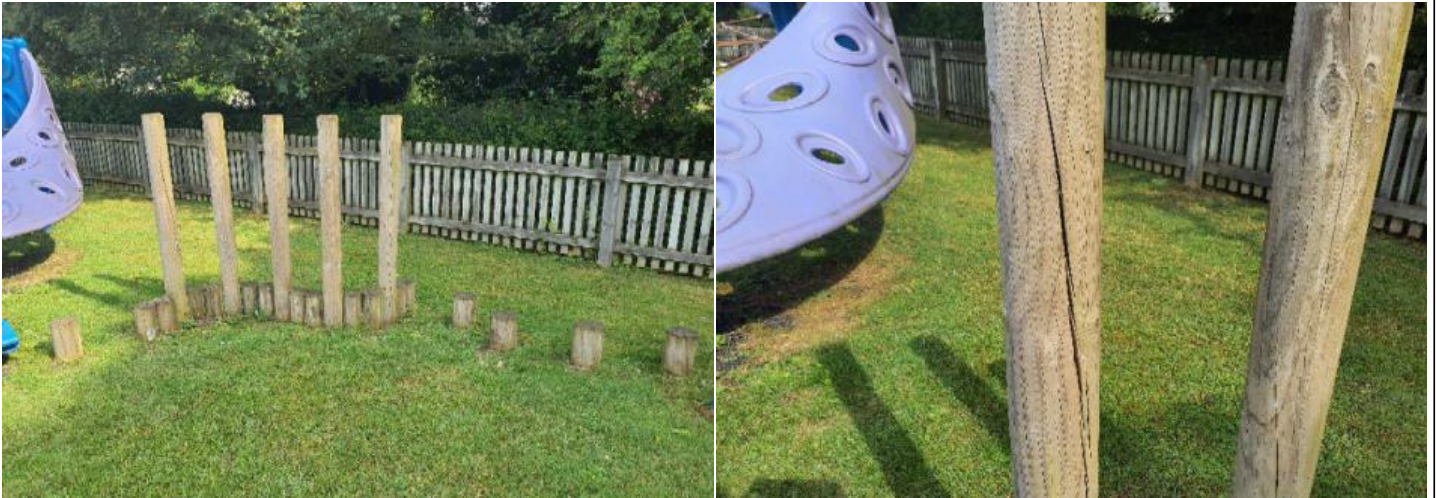
Finding: The timber has a number of splits/shakes or air cracks and this may affect the stability or allow water ingress which will accelerate the rotting process
Action: Monitor to ensure the splits do not cross through fixing points of the structure and/or cause any instability

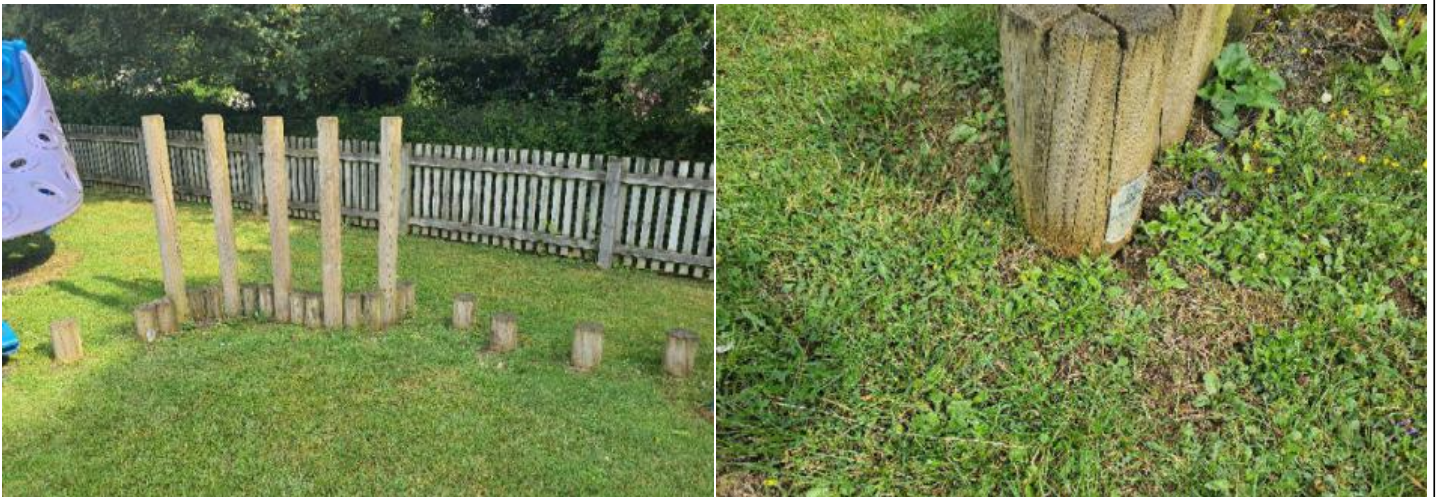
Finding: There is some strimmer / machinery damage apparent on the posts, this can penetrate the preservative applied to the timber and accelerate the rotting process
Action: Monitor for any deterioration (rot) and replace as required

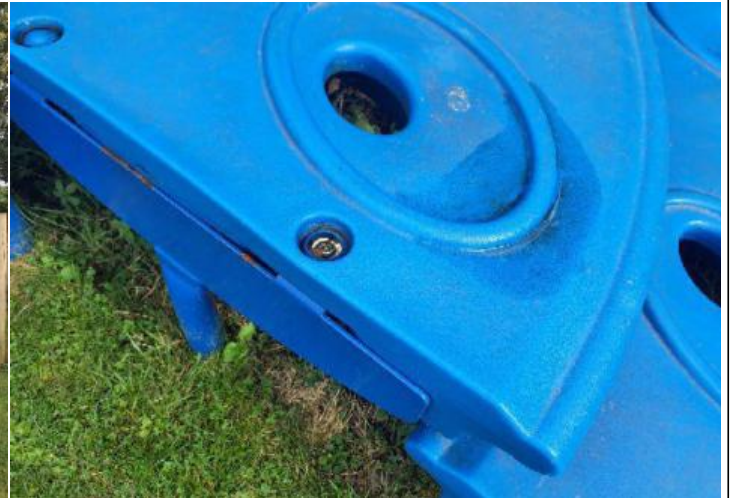
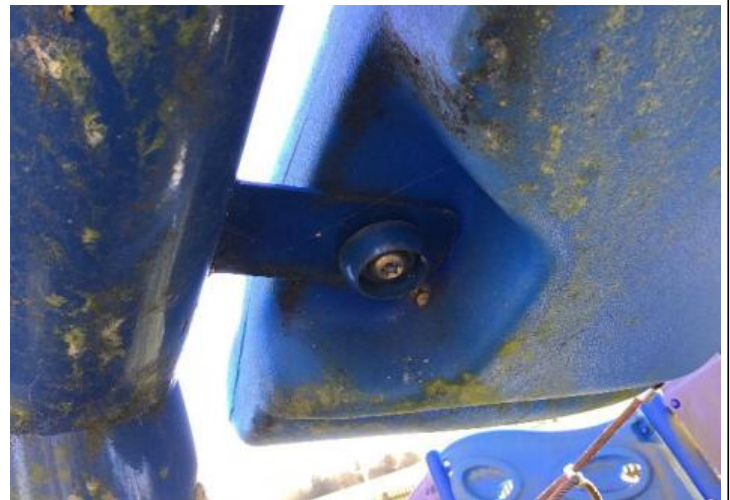
Finding: There is/are bolt cap covers missing or damaged on the item

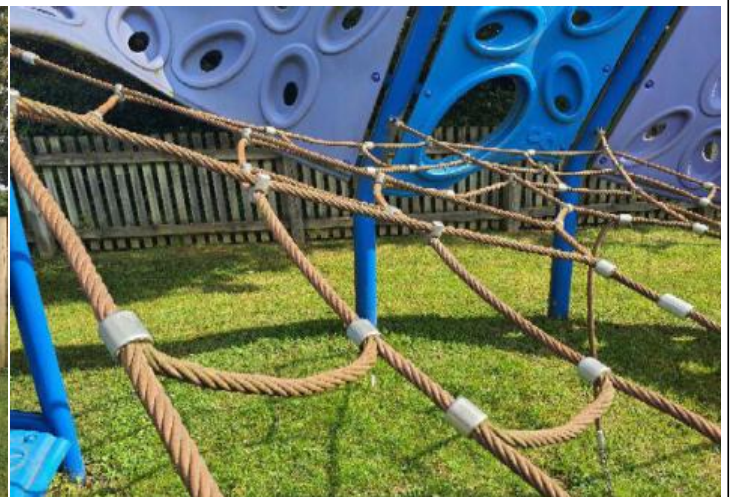
Finding: The ropes/nets are worn/damaged in places

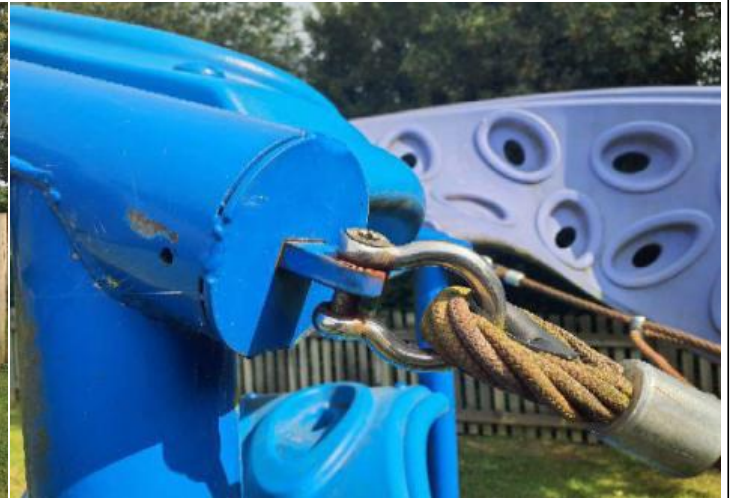
Finding: The connecting lugs are showing signs of wear

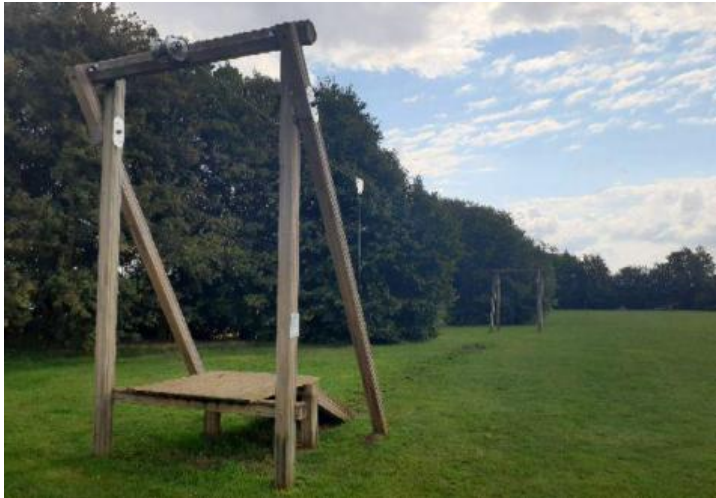
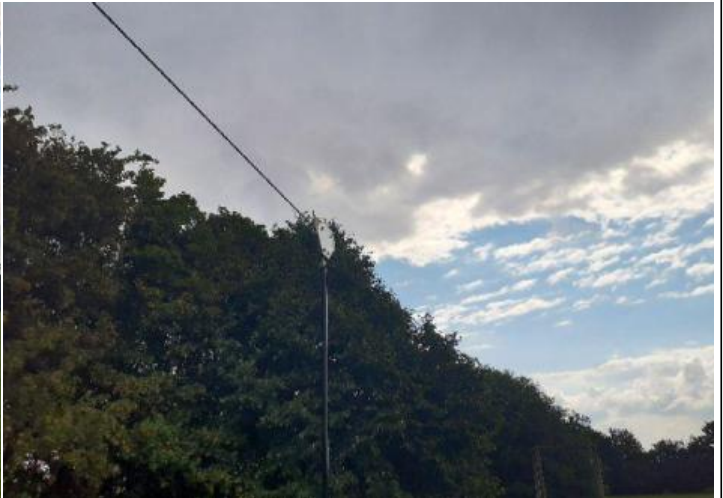
Finding: We have completed a visual inspection of the suspension links, cable and fixing points from ground level, however it is not possible to fully inspect these areas without either hiring equipment to gain access or removing the cable and suspension and inspecting at ground level. We recommend that the main cable and fixing security is thoroughly inspected at least in accordance with the manufacturers recommendations to check for wear, damage, security or internal rusting; this will help to ensure the continued safe use of the equipment

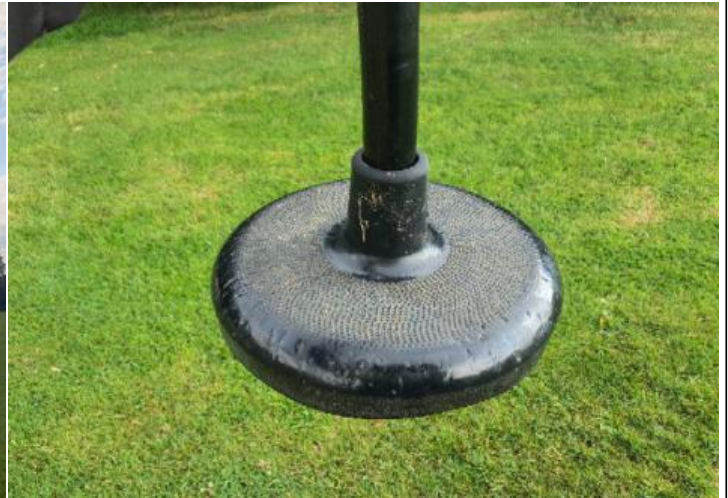
Finding: The seat connection cannot be inspected without dismantling the seat

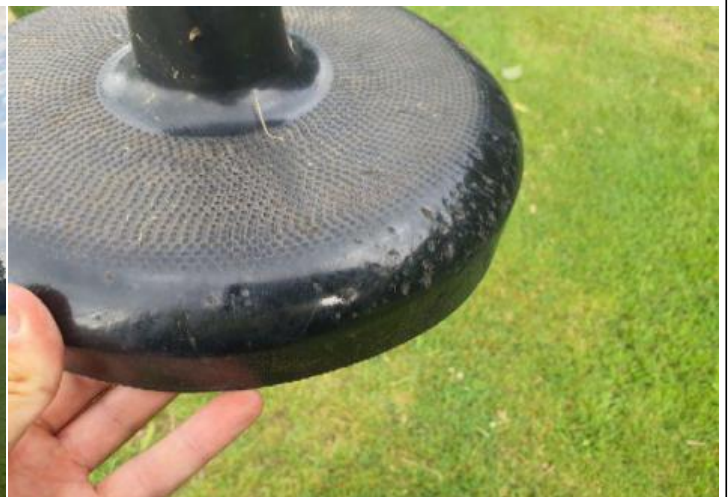
Finding: The cableway seat has been damaged

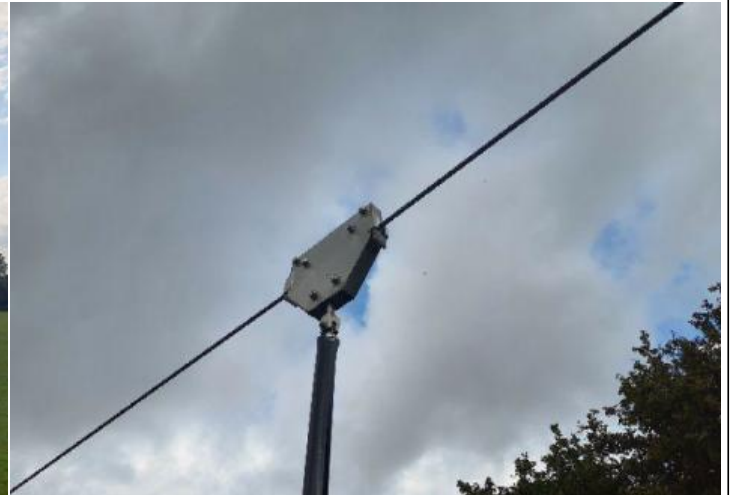
Finding: The nylon inserts are worn or missing at the point the cable enters the traveller

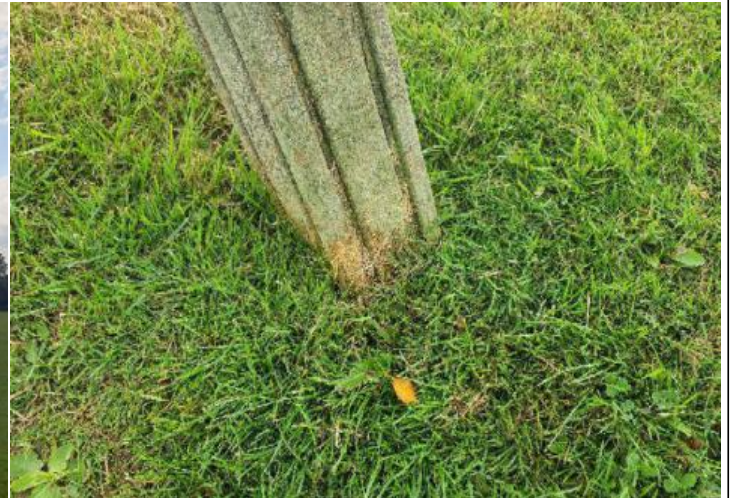
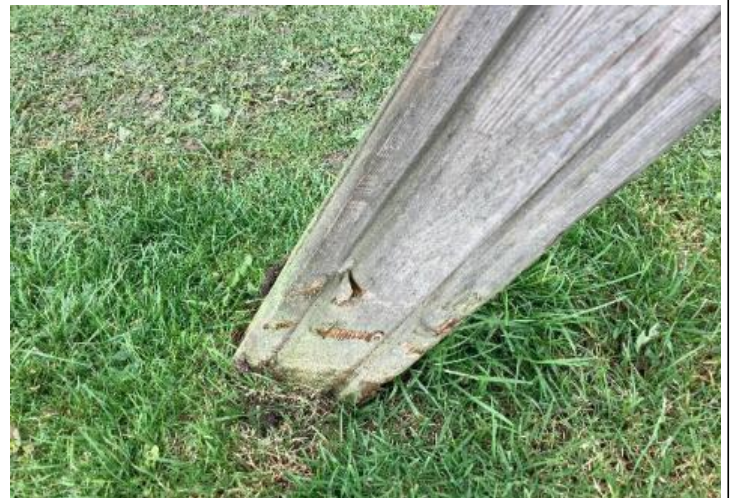
Finding: There is some strimmer / machinery damage apparent on the posts, this can penetrate the preservative applied to the timber and accelerate the rotting process

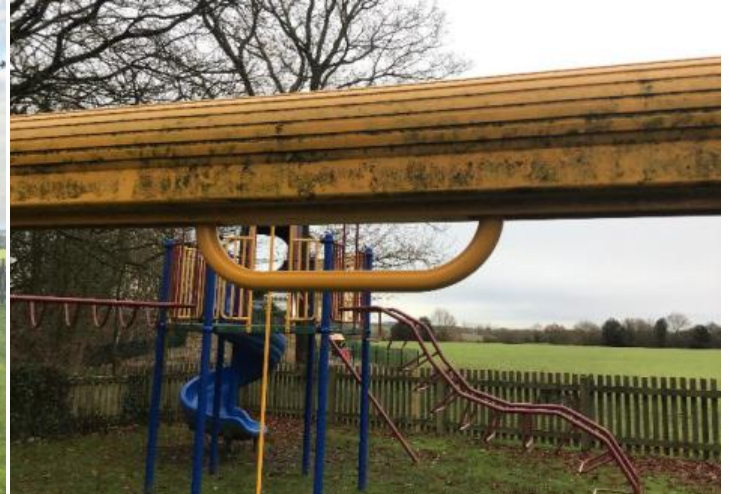
Finding: Sliding handle on monorail is stiff and hard to move **Action:** Investigate cause
