## Update on Estates Issues

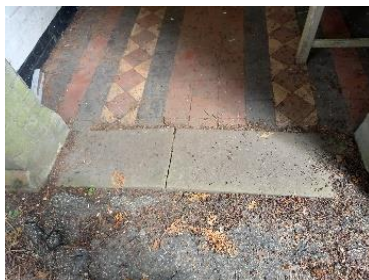
Following work to the Drive at Chapel of Rest in 2021, some worn areas of macadam, particularly outside the Chapel of Rest, have been identified which will require remedial work in the longer term.

Additionally, there is a crack to the outer door lintel which may require work, and it should be investigated as to whether this is being caused by roots from nearby trees. This may affect how the trees immediately adjacent to the Chapel of Rest are managed. Advice from Suffolk Tree Surgery and Landscape, who undertake the work to parish trees, is attached as **Appendix B**.

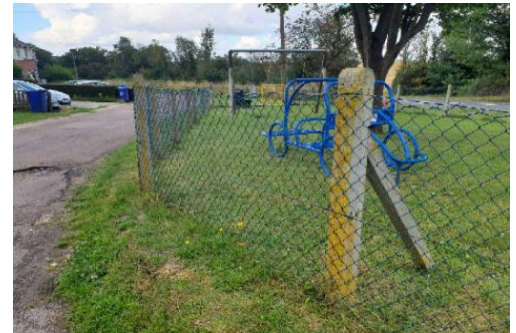
**Item:** Fence - Chainlink  
**Manufacturer:** Not Identified  
**Surface Type:** Grass  
**Item Quantity:** 1  
**Equipment Compliance:** N/A  
**Surface Area Compliance:** N/A

There is some damage to the fence sections - Monitor for any further deterioration and repair as required

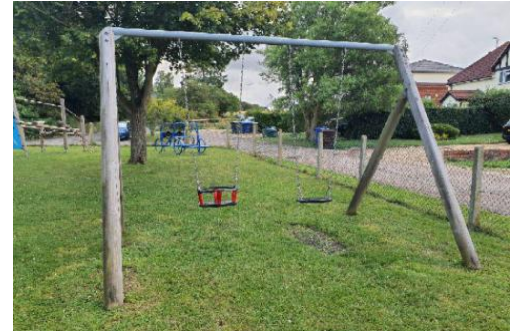
**Item:** 1 Bay Mixed Seat, 1 Cradle, 1 Flat  
**Manufacturer:** Playdale Playgrounds Ltd  
**Surface Type:** Grass Matrix Tiles  
**Item Quantity:** 1  
**Equipment Compliance:** Yes  
**Surface Area Compliance:** Yes

There is some strimmer / machinery damage apparent on the posts, this can penetrate the preservative applied to the timber and accelerate the rotting process - Monitor for any deterioration (rot) and replace as required

There is some wear to the shackles - Monitor for any further deterioration and replace when 40% worn

There is some notable evidence of chain wear - Monitor for any further deterioration and replace when 40% worn

The seat has minor damage or wear - Monitor for any further deterioration and replace as required

The bushes are showing signs of wear - Monitor for any further deterioration and replace as required

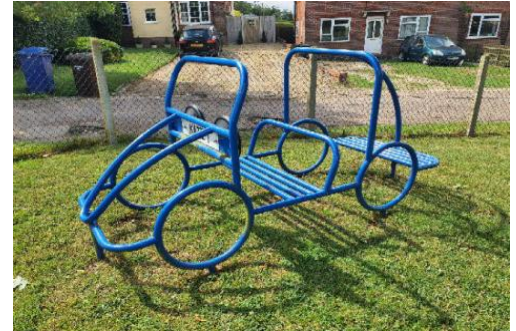
**Item:** Jeep  
**Manufacturer:** Not Identified  
**Surface Type:** Grass  
**Item Quantity:** 1  
**Equipment Compliance:** Yes  
**Surface Area Compliance:** Yes

There is some damage to the item - Monitor for any further deterioration and repair as required

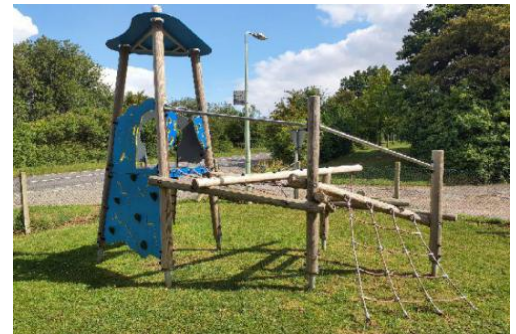
**Item:** Multi Play (Junior)  
**Manufacturer:** Playforce  
**Surface Type:** Grass Matrix Tiles  
**Item Part Number:** Jungle tops  
**Item Quantity:** 1  
**Equipment Compliance:** No  
**Surface Area Compliance:** Yes

The timber has a number of splits/shakes or air cracks and this may affect the stability or allow water ingress which will accelerate the rotting process - Monitor to ensure the splits do not cross through fixing points of the structure and/or cause any instability

The ropes/nets are worn/damaged in places - Monitor for any further deterioration and repair or replace as required

There is/are finger entrapment/s in the climbing wall and the item fails to meet the requirements of BS EN 1176 Part 1 4.2.7.6 Entrapment of fingers - Monitor - No remedial work recommended

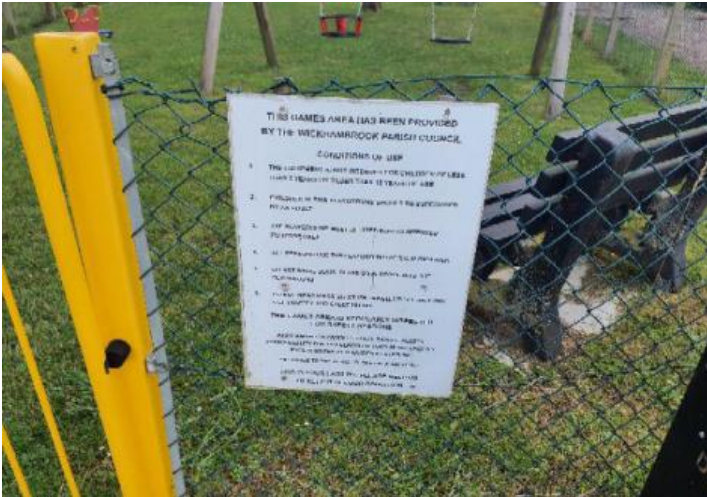
**Item:** Ancillary Items - Sign  
**Manufacturer:** Owner/Operator

**Finding:** It is recommended that signage, with information including the site address, contact information for maintenance issues and emergency contact details are provided for the facility

**Action:** Provide in accordance with the recommendations

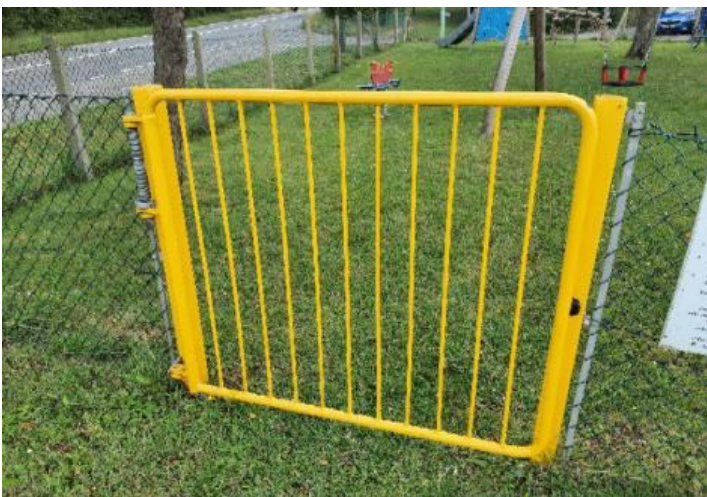
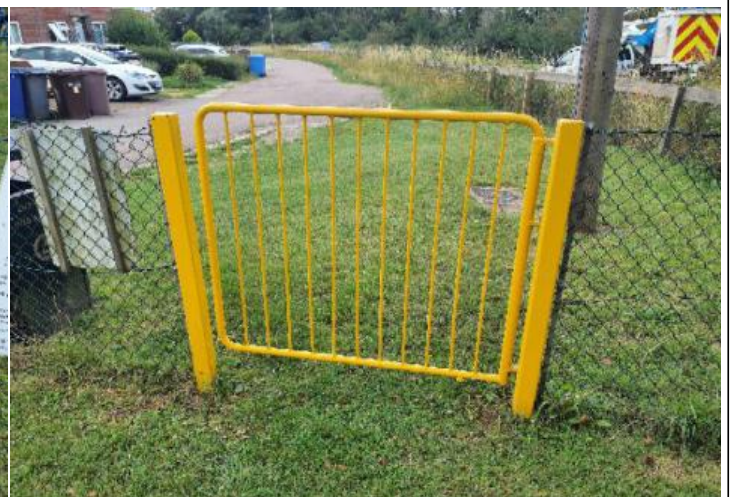
**Item:** Gates - Gate - Self Closing  
**Manufacturer:** Not Identified

**Finding:** The gate is closing too quickly (less than 4 seconds)

**Action:** Take corrective action to ensure that the gate closes in 4-8 seconds

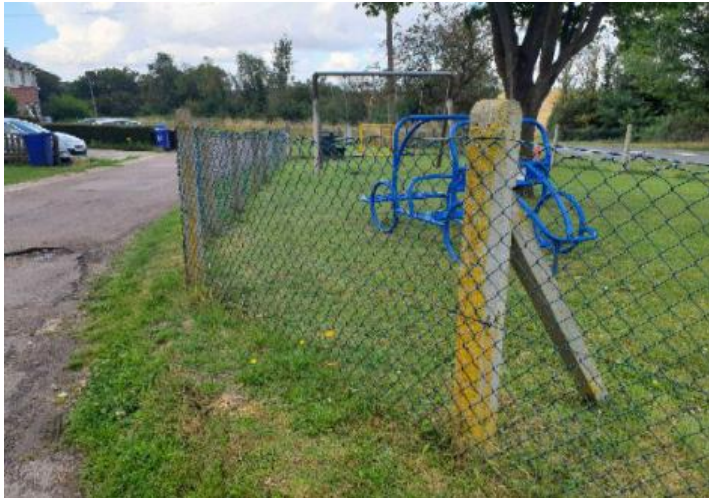
**Item:** Fences - Fence - Chainlink  
**Manufacturer:** Not Identified

**Finding:** There is some damage to the fence sections

**Action:** Monitor for any further deterioration and repair as required

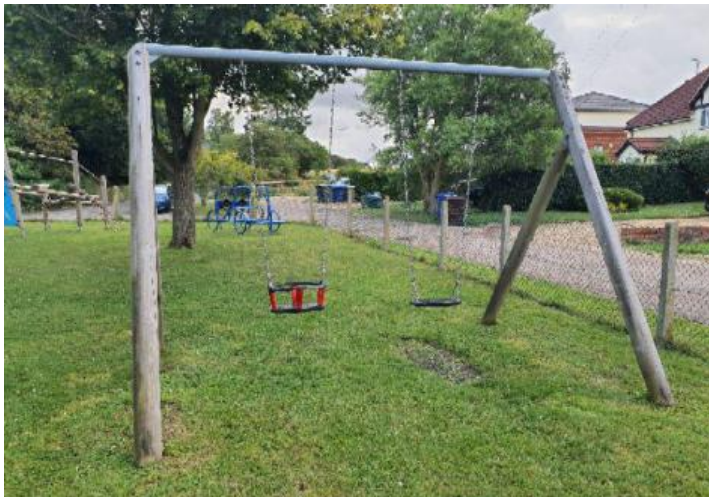
**Item:** Swings - 1 Bay Mixed Seat, 1 Cradle, 1 Flat  
**Manufacturer:** Playdale Playgrounds Ltd

**Finding:** There is some strimmer / machinery damage apparent on the posts, this can penetrate the preservative applied to the timber and accelerate the rotting process

**Action:** Monitor for any deterioration (rot) and replace as required

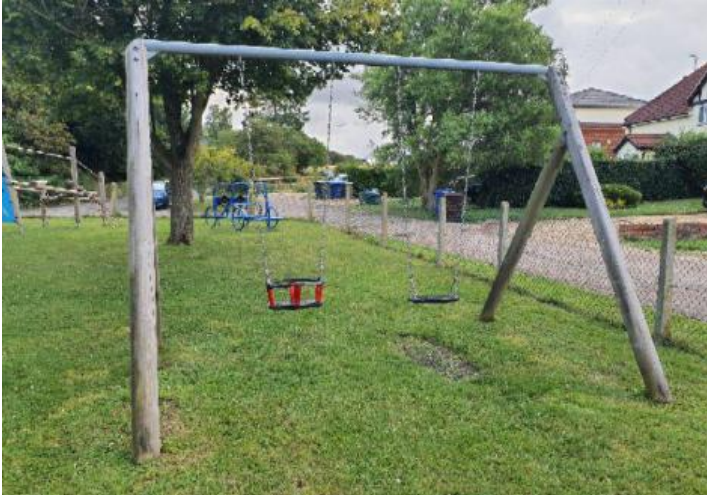
**Item:** Swings - 1 Bay Mixed Seat, 1 Cradle, 1 Flat  
**Manufacturer:** Playdale Playgrounds Ltd

**Finding:** There is some wear to the shackles

**Action:** Monitor for any further deterioration and replace when 40% worn

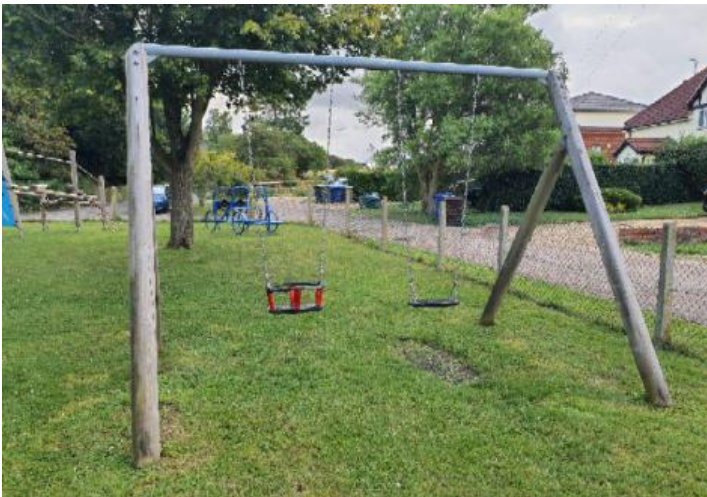
**Item:** Swings - 1 Bay Mixed Seat, 1 Cradle, 1 Flat  
**Manufacturer:** Playdale Playgrounds Ltd

**Finding:** There is some notable evidence of chain wear

**Action:** Monitor for any further deterioration and replace when 40% worn

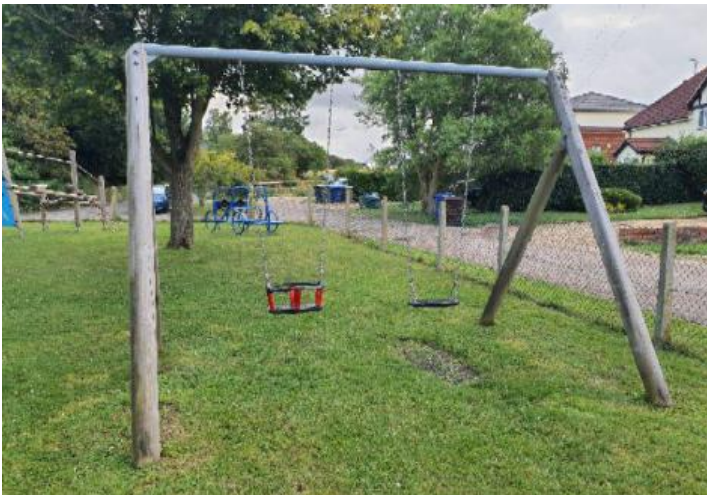
**Item:** Swings - 1 Bay Mixed Seat, 1 Cradle, 1 Flat  
**Manufacturer:** Playdale Playgrounds Ltd

**Finding:** The bushes are showing signs of wear

**Action:** Monitor for any further deterioration and replace as required

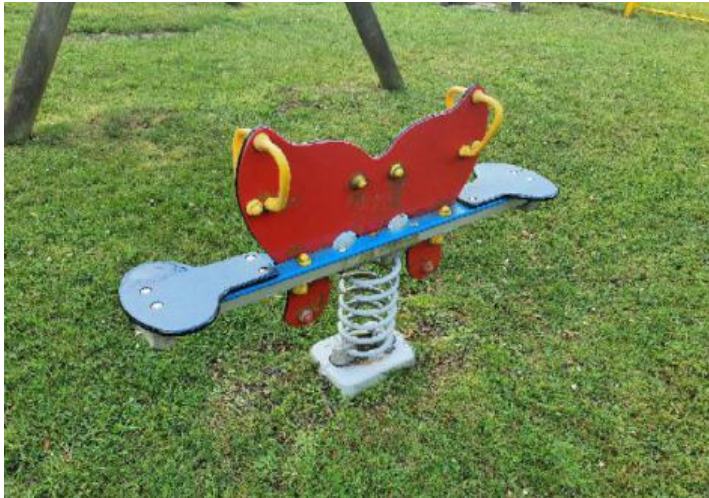
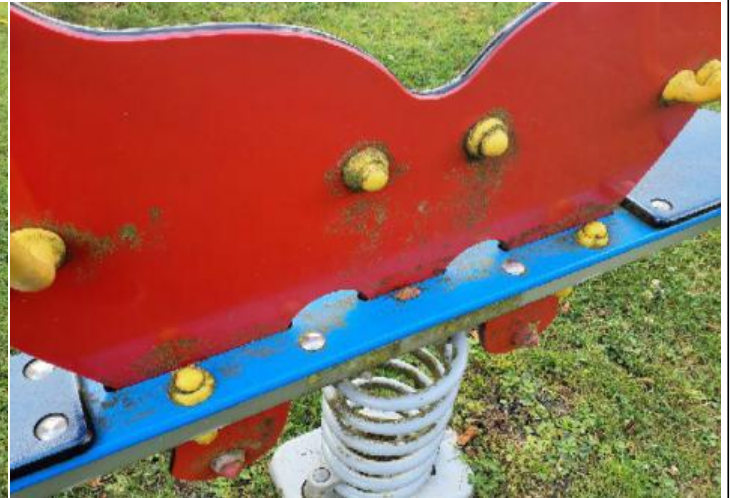
**Item:** Rocking Equipment - Spring See-Saw  
**Manufacturer:** Ledon

**Finding:** There is algae or moss on the surface of the equipment

**Action:** Clean and treat appropriately

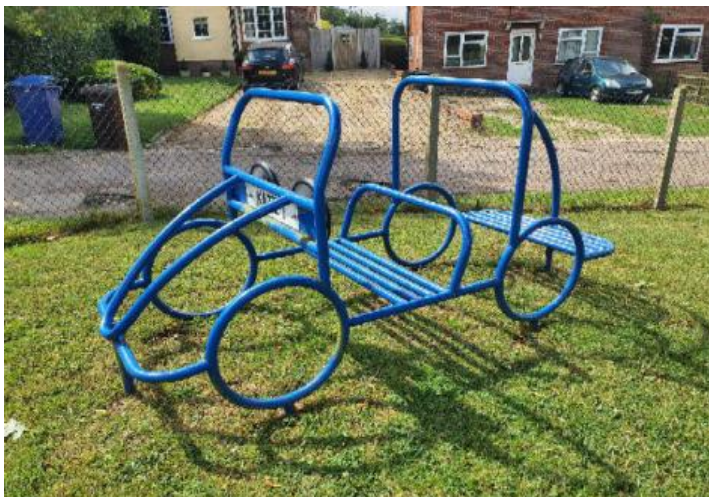
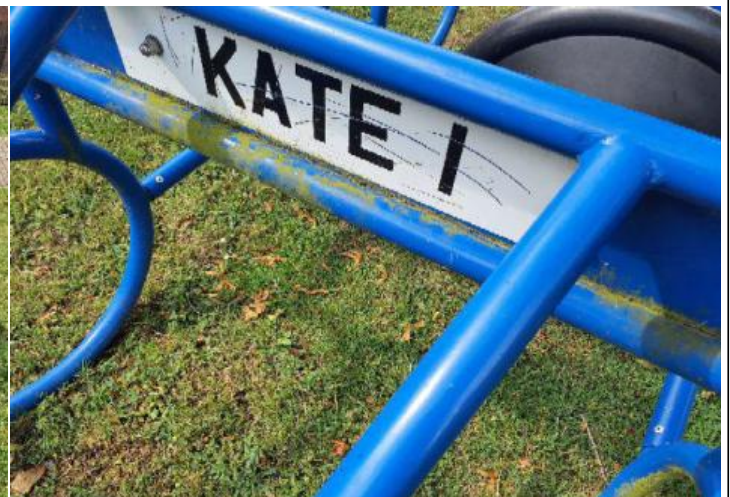
**Item:** Other - Jeep  
**Manufacturer:** Not Identified

**Finding:** There is algae or moss on the surface of the equipment

**Action:** Clean and treat appropriately

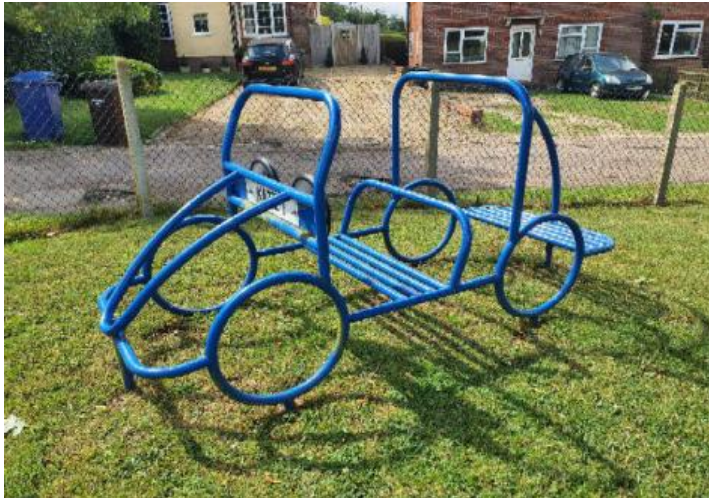
**Item:** Other - Jeep  
**Manufacturer:** Not Identified

**Finding:** There is some damage to the item

**Action:** Monitor for any further deterioration and repair as required

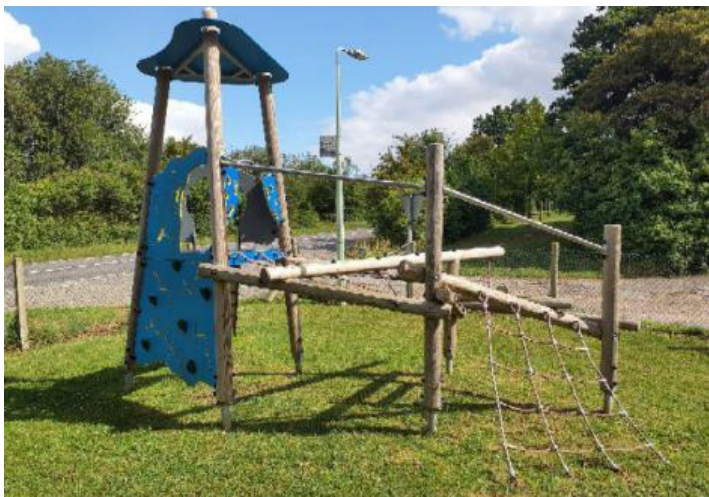
**Item:** Activity Equipment - Multi Play (Junior)  
**Manufacturer:** Playforce

**Finding:** The timber has a number of splits/shakes or air cracks and this may affect the stability or allow water ingress which will accelerate the rotting process

**Action:** Monitor to ensure the splits do not cross through fixing points of the structure and/or cause any instability

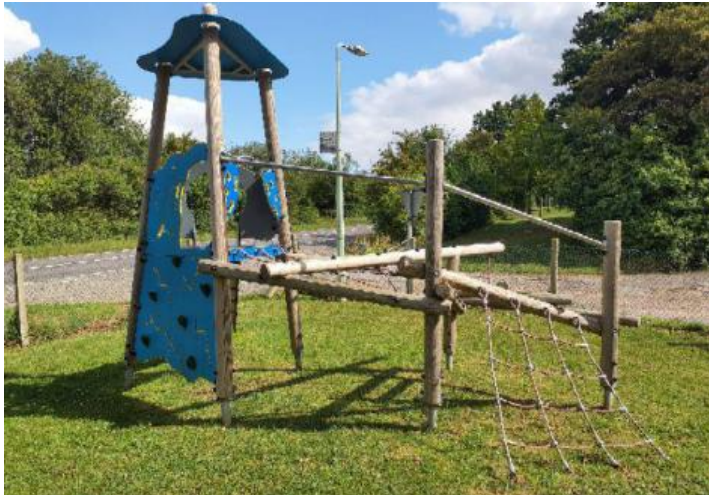
**Item:** Activity Equipment - Multi Play (Junior)  
**Manufacturer:** Playforce

**Finding:** The ropes/nets are worn/damaged in places

**Action:** Monitor for any further deterioration and repair or replace as required

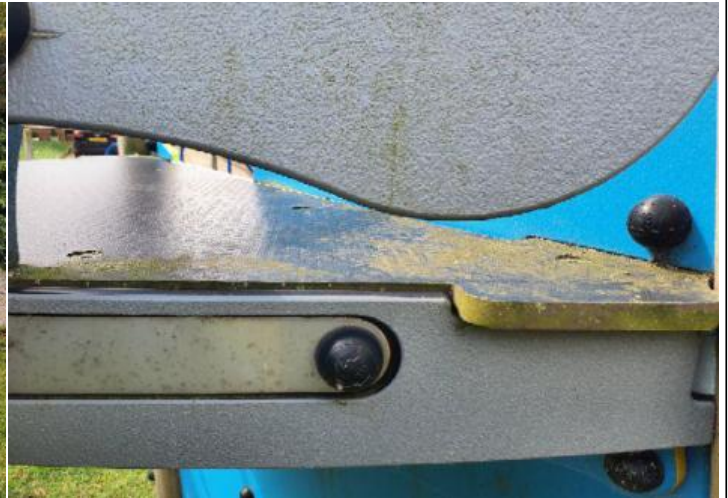
**Item:** Activity Equipment - Multi Play (Junior)  
**Manufacturer:** Playforce

**Finding:** There is algae or moss on the surface of the equipment

**Action:** Clean and treat appropriately

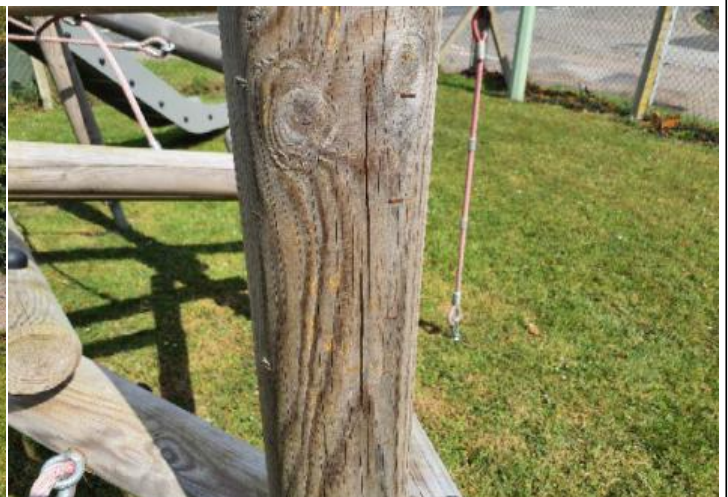
**Item:** Activity Equipment - Multi Play (Junior)  
**Manufacturer:** Playforce

**Finding:** There are a number of redundant staples attached to the equipment

**Action:** Remove redundant staples

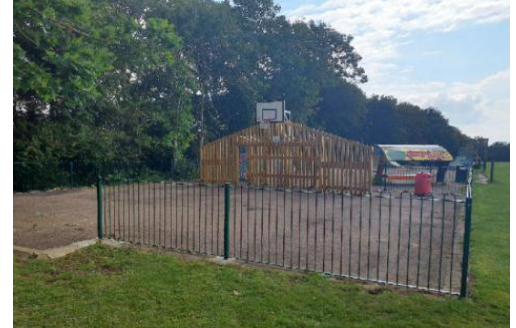
**Item:** Site General  
**Manufacturer:** Owner/Operator  
**Surface Type:** N/A  
**Item Quantity:** 1  
**Equipment Compliance:** N/A  
**Surface Area Compliance:** N/A

There is moderate damage to the surface - Repair the damaged areas of surfacing

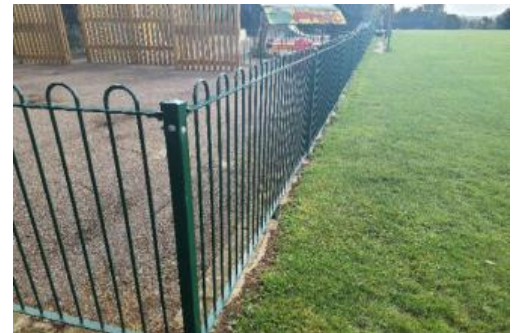
**Item:** Fence - Bow Top  
**Manufacturer:** Not Identified  
**Surface Type:** Bitmac  
**Item Quantity:** 1  
**Equipment Compliance:** N/A  
**Surface Area Compliance:** N/A

This item is satisfactory - no work required -

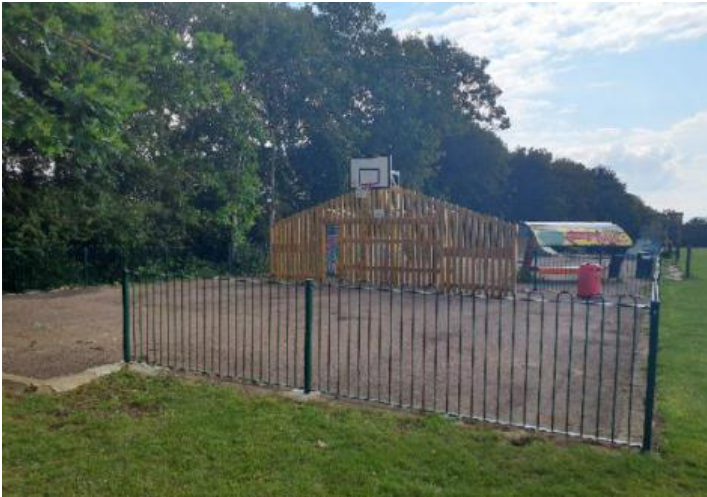
**Item:** Ancillary Items - Site General  
**Manufacturer:** Owner/Operator

**Finding:** There is moderate damage to the surface

**Action:** Repair the damaged areas of surfacing

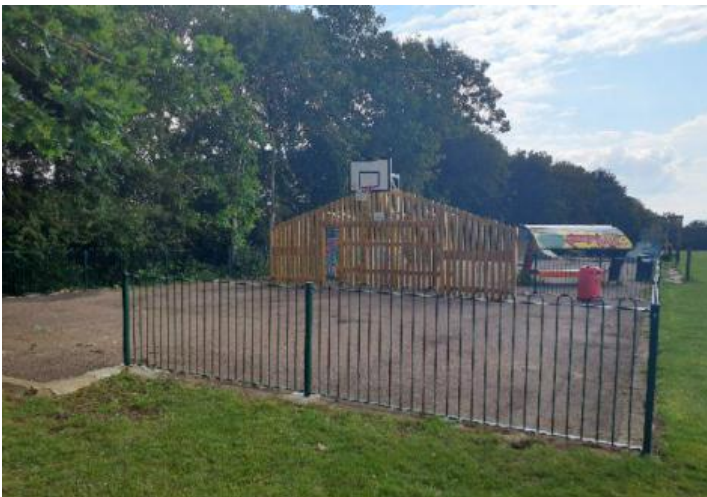
**Item:** Ancillary Items - Site General  
**Manufacturer:** Owner/Operator

**Finding:** The concrete is breaking up around the edges of the surface

**Action:** Repair the damaged concrete

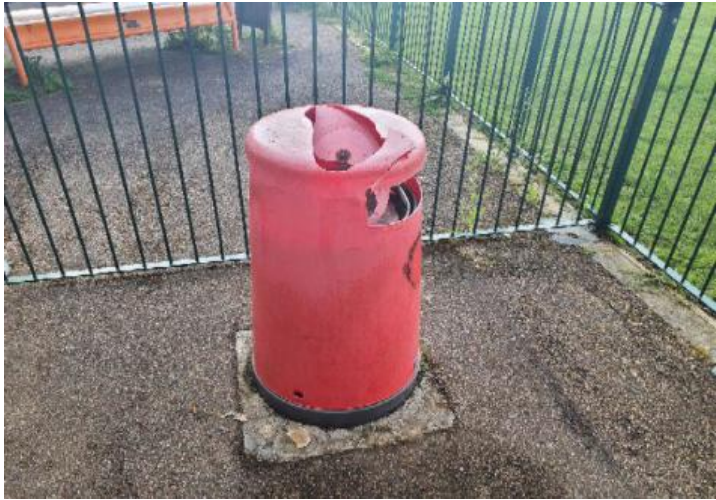
**Item:** Ancillary Items - Litter Bin  
**Manufacturer:** Not Identified

**Finding:** The bin is severely damaged

**Action:** Replace bin

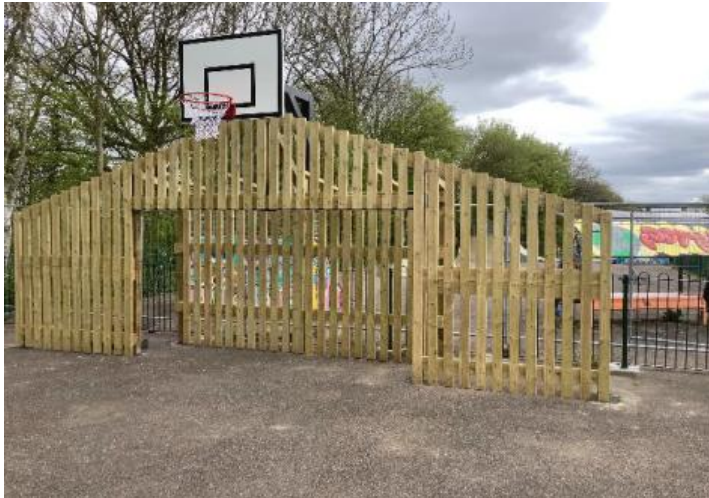
**Item:** Multi Use Games Area - Ball Games Area  
**Manufacturer:** Sovereign Leisure

**Finding:** A clearly visible facility sign should be provided in a prominent position with the wording as detailed BS EN 15312- the equipment is not intended for children less than 3 years old- the warning - Do not climb on the framework or nets- the warning - Do not hang on the ring (if provided)- the warning - Do not wear rings or other jewellery- name and telephone number of the administrator- number to call in case of accident

**Action:** Provide signage to BS EN 15312

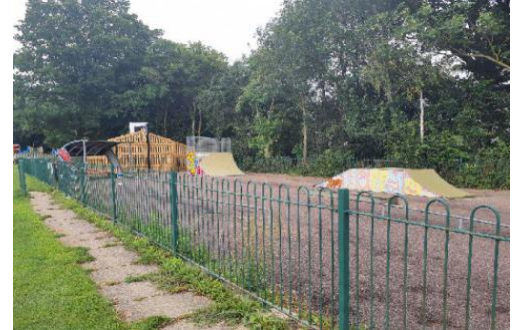
**Item:** Site General  
**Manufacturer:** Owner/Operator  
**Surface Type:** N/A  
**Item Quantity:** 1  
**Equipment Compliance:** N/A  
**Surface Area Compliance:** N/A

Signage of the wheeled sports area should be provided as recommended in BS EN 14974; this will include, but not exclusively, the use of the area, a recommendation to wear protective equipment, emergency contact details etc. - Provide signage as recommended by BS EN 14974 for wheeled sports areas

There is root damage to the surfacing creating unforeseen changes in levels - Repair the damaged areas of tarmac to provide a uniform surface

There is some damage apparent to the riding surface - Monitor for any further deterioration and repair as required

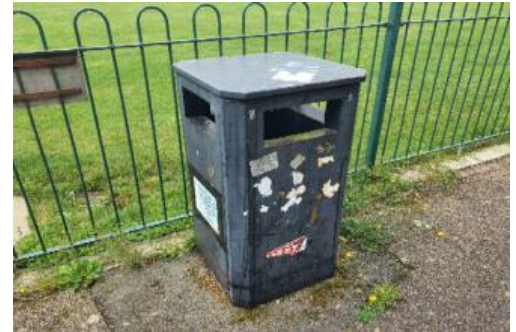
**Item:** Litter Bin  
**Manufacturer:** Not Identified  
**Surface Type:** Bitmac  
**Item Part Number:**  
**Item Quantity:** 1  
**Equipment Compliance:** N/A  
**Surface Area Compliance:** N/A  
**Total Findings:** 1

This item is satisfactory - no work required -

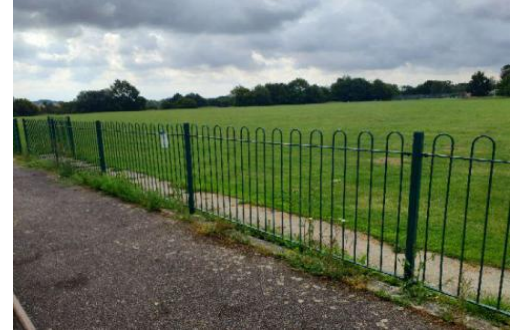
**Item:** Fence - Bow Top  
**Manufacturer:** Not Identified  
**Surface Type:** Bitmac  
**Item Quantity:** 1  
**Equipment Compliance:** N/A  
**Surface Area Compliance:** N/A

There is some damage to the fence sections - Monitor for any further deterioration and repair as required

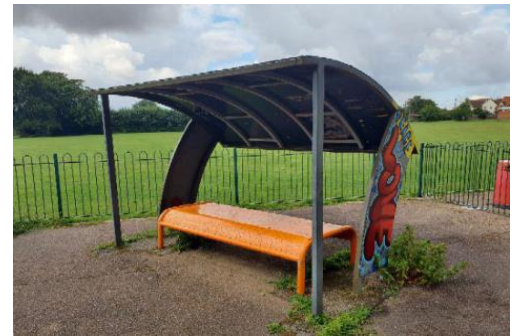
**Item:** Shelter  
**Manufacturer:** Not Identified  
**Surface Type:** Tarmac  
**Item Quantity:** 1  
**Equipment Compliance:** N/A  
**Surface Area Compliance:** N/A

There is some evidence of fire damage to the item - Monitor for any further deterioration and repair as required

Pop rivet fixings have failed on the seat - Replace the failed pop rivets

There is surface corrosion / rust present on the item - Consider treating the item

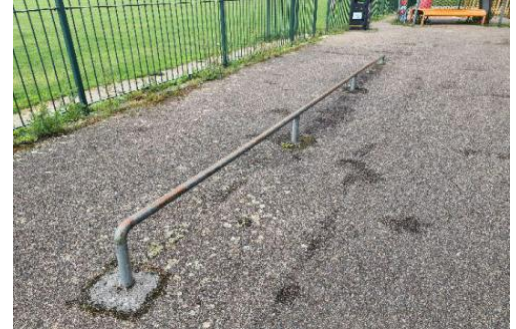
**Item:** Grind Rail  
**Manufacturer:** Eibe Play Ltd  
**Surface Type:** Tarmac  
**Item Quantity:** 1  
**Equipment Compliance:** Yes  
**Surface Area Compliance:** Yes

There is surface corrosion / rust present on the item - Consider treating the item

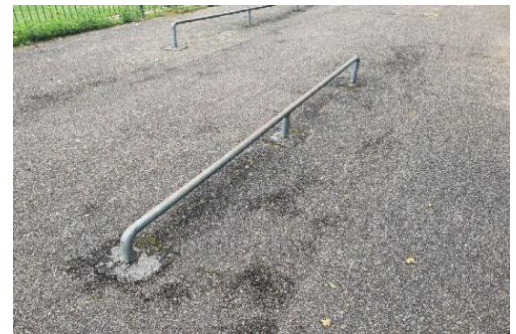
**Item:** Grind Rail  
**Manufacturer:** Eibe Play Ltd  
**Surface Type:** Tarmac  
**Item Quantity:** 1  
**Equipment Compliance:** Yes  
**Surface Area Compliance:** Yes

There is surface corrosion / rust present on the item - Consider treating the item

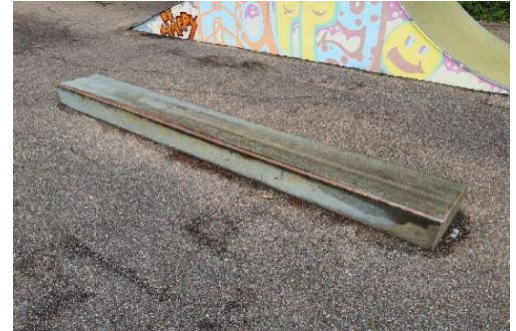
**Item:** Grind Box  
**Manufacturer:** Eibe Play Ltd  
**Surface Type:** Tarmac  
**Item Quantity:** 1  
**Equipment Compliance:** Yes  
**Surface Area Compliance:** Yes

There is surface corrosion / rust present on the item - Consider treating the item

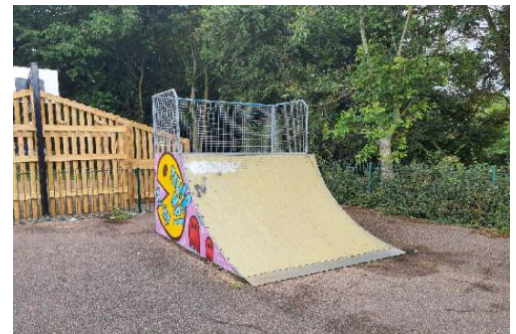
**Item:** Quarter Pipe  
**Manufacturer:** Eibe Play Ltd  
**Surface Type:** Tarmac  
**Item Quantity:** 1  
**Equipment Compliance:** No  
**Surface Area Compliance:** Yes

The kicker plate protrudes more than 5mm above the surrounding surface level, BS EN 14974 recommends a maximum of 5mm with 3mm preferred - Adjust height to ensure a maximum of 5mm change in level

The height of the barrier is less than 1200mm and fails the requirements of BS EN 14974 - Monitor - No remedial work recommended

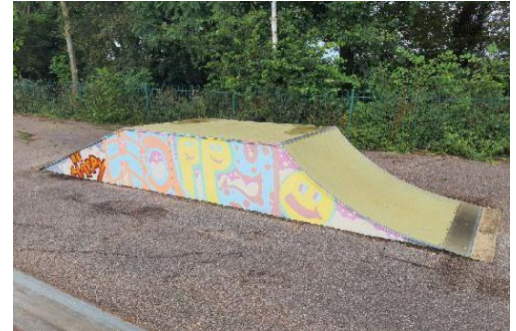
**Item:** Platform Ramp  
**Manufacturer:** Eibe Play Ltd  
**Surface Type:** Tarmac  
**Item Quantity:** 1  
**Equipment Compliance:** No  
**Surface Area Compliance:** Yes

The kicker plate has sunk more than 5mm below the surrounding surface level, BS EN 14974 recommends a maximum of 5mm with 3mm preferred - Adjust height to ensure a maximum of 5mm change in level

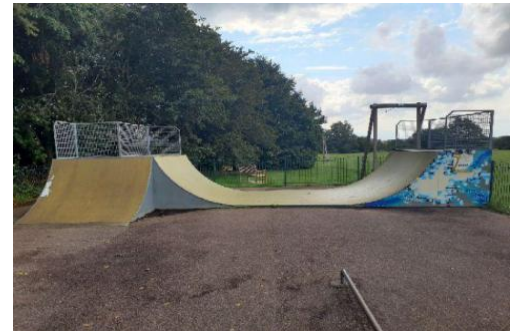
**Item:** Half Pipe  
**Manufacturer:** Eibe Play Ltd  
**Surface Type:** Tarmac  
**Item Quantity:** 1  
**Equipment Compliance:** No  
**Surface Area Compliance:** Yes

The height of the barrier is less than 1200mm and fails the requirements of BS EN 14974 - Monitor - No remedial work recommended

There is a change in the level of the rolling surface in excess of 3mm and the item fails the requirements of BS EN 14974 Clause 5.1.2.3 - Monitor - No remedial work recommended

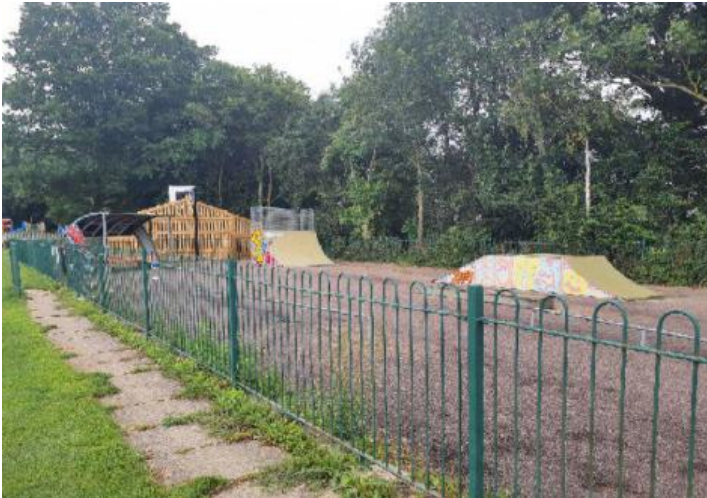
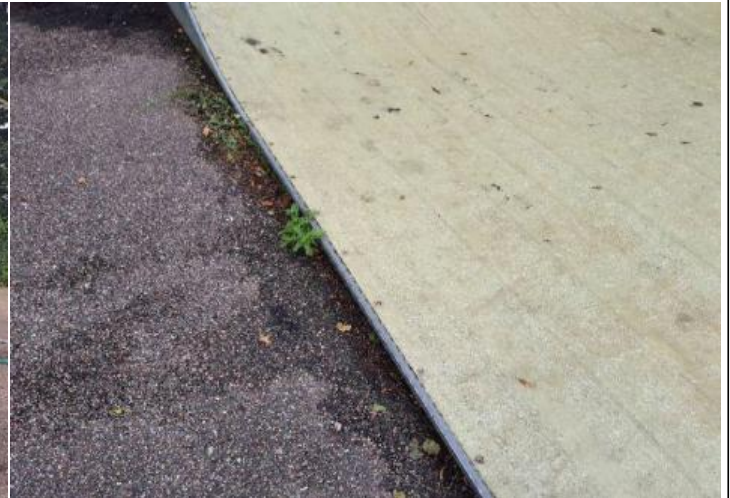
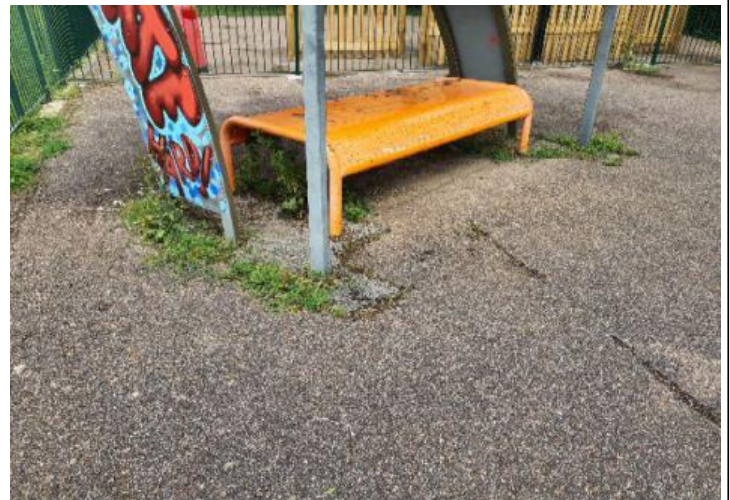
**Finding:** There is weed / vegetation growth on, between, or around the edges of the surfacing  
**Action:** Remove weed / vegetation growth

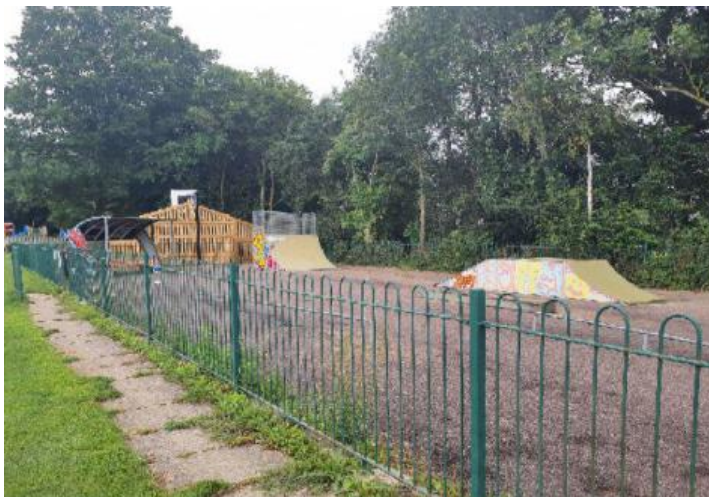
**Finding:** There is some damage apparent to the riding surface

**Action:** Monitor for any further deterioration and repair as required

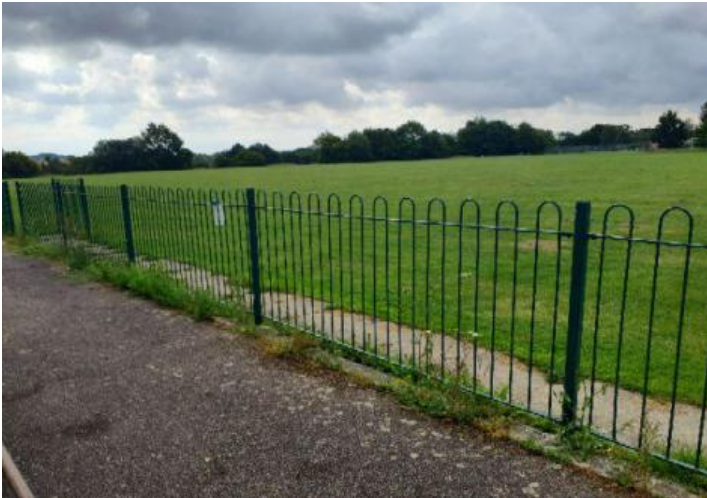
**Finding:** There is some damage to the fence sections

**Action:** Monitor for any further deterioration and repair as required

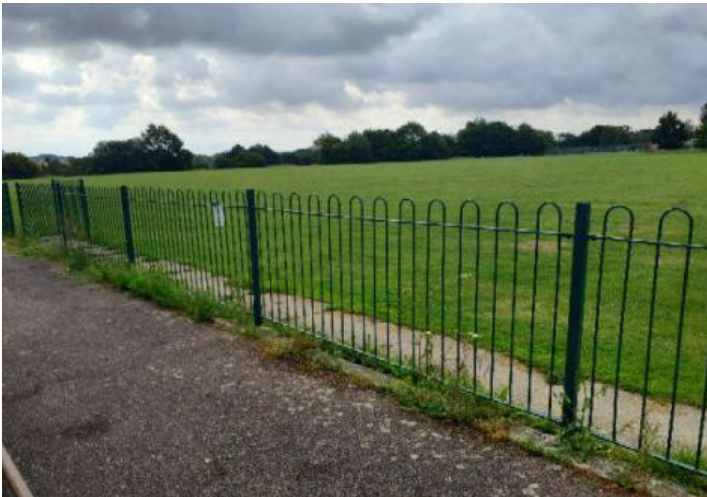
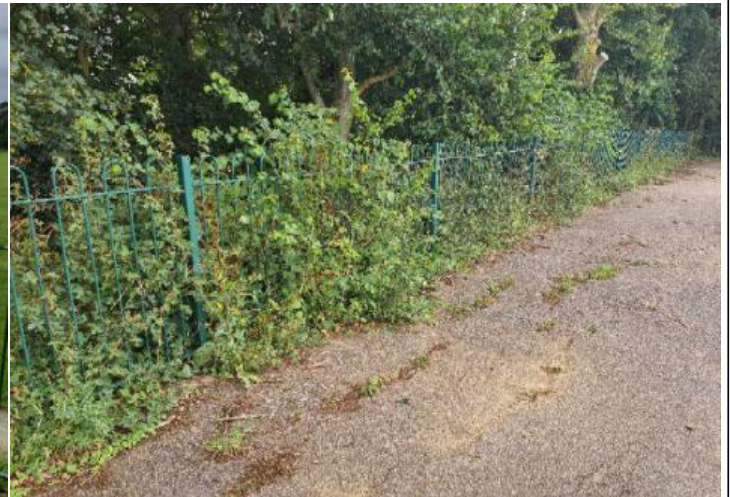
**Finding:** The adjacent foliage is overhanging

**Action:** Cut back and maintain

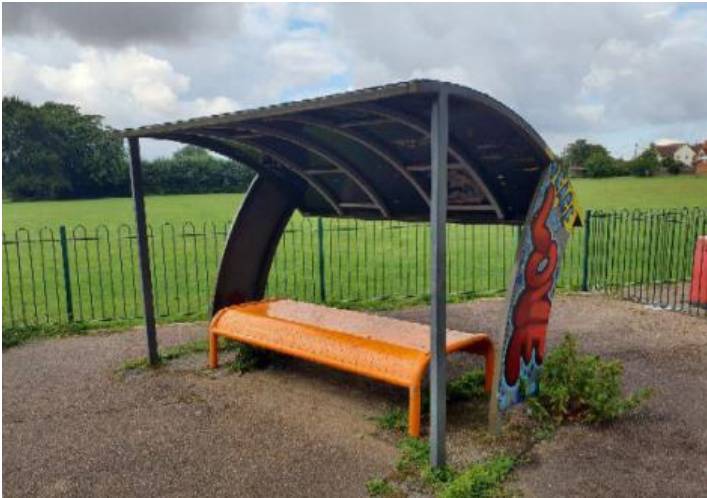
**Finding:** There is some evidence of fire damage to the item **Action:** Monitor for any further deterioration and repair as required

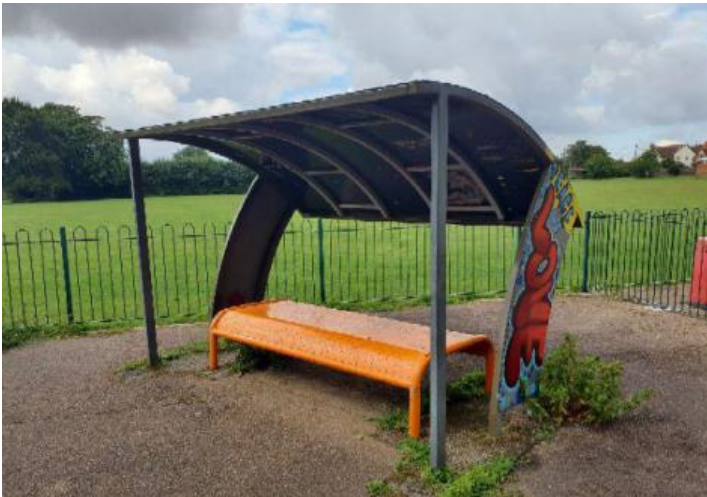
**Finding:** Pop rivet fixings have failed on the seat **Action:** Replace the failed pop rivets

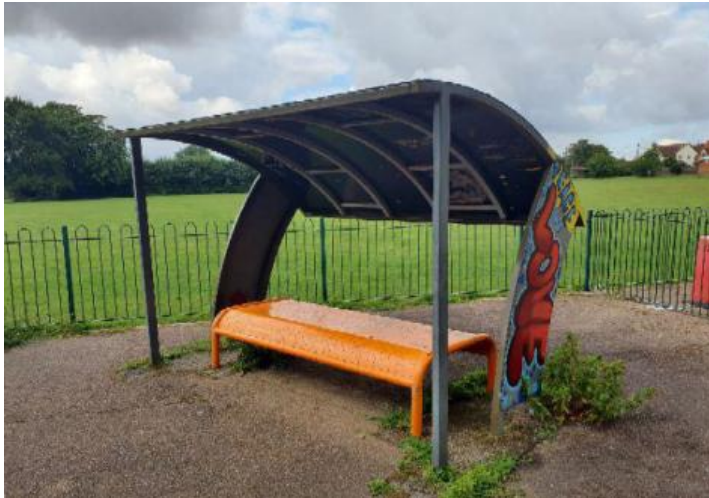
**Finding:** There is surface corrosion / rust present on the item

**Action:** Consider treating the item

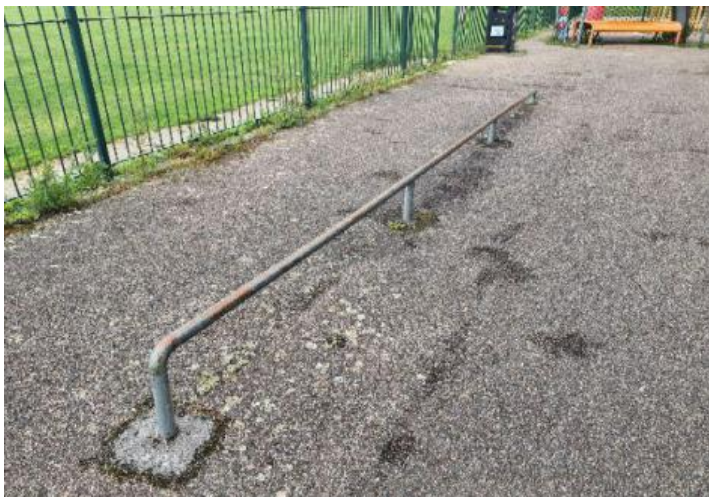
**Finding:** There is surface corrosion / rust present on the item

**Action:** Consider treating the item

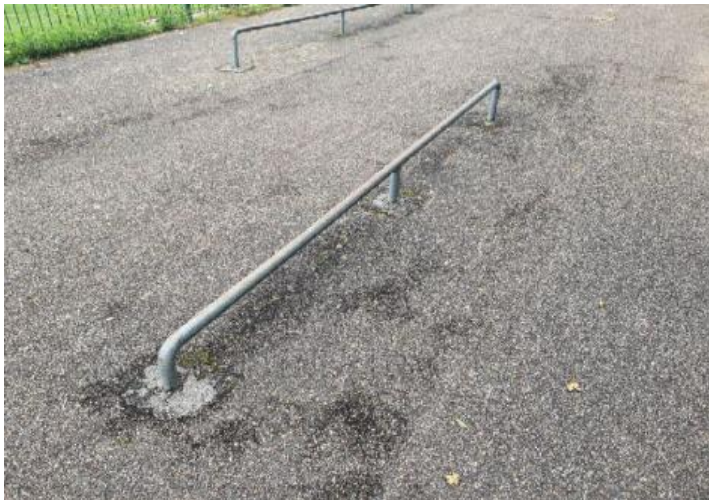
**Finding:** There is surface corrosion / rust present on the item  
**Action:** Consider treating the item

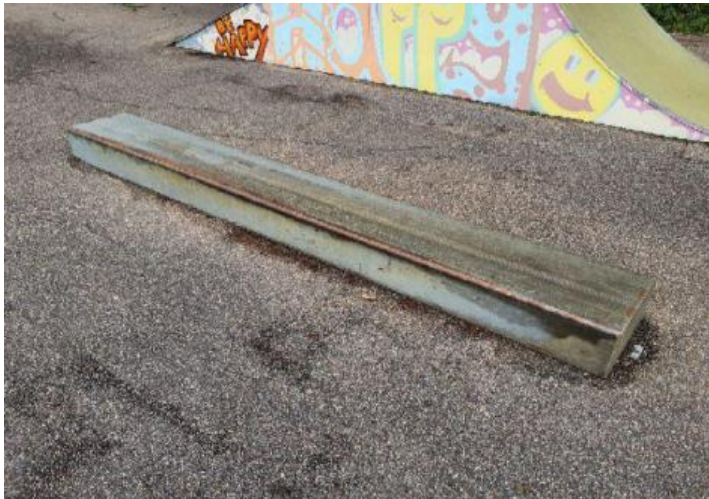
**Finding:** There is surface corrosion / rust present on the item  
**Action:** Consider treating the item

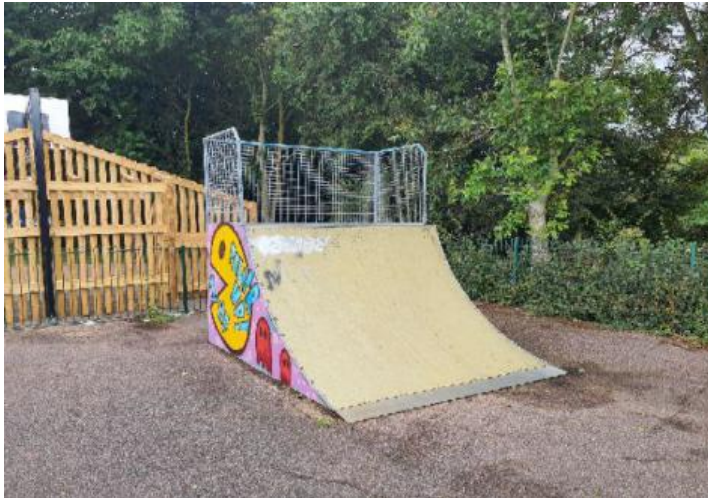
**Finding:** The kicker plate protrudes more than 5mm above the surrounding surface level, BS EN 14974 recommends a maximum of 5mm with 3mm preferred

**Action:** Adjust height to ensure a maximum of 5mm change in level

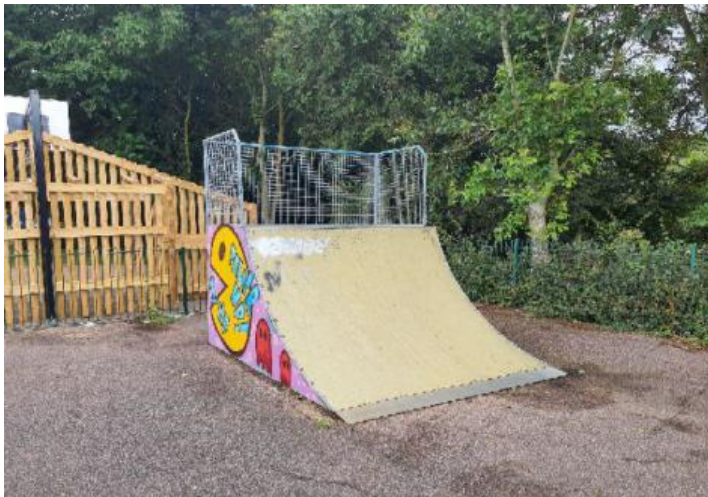
**Finding:** The height of the barrier is less than 1200mm and fails the requirements of BS EN 14974

**Action:** Monitor - No remedial work recommended

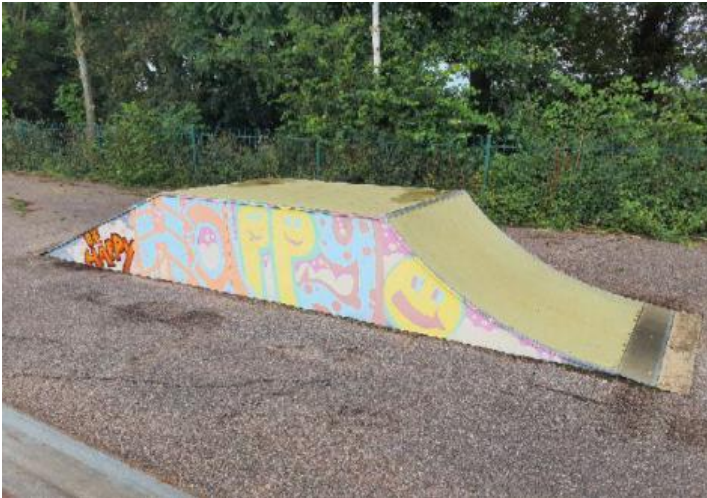
**Finding:** The kicker plate has sunk more than 5mm below the surrounding surface level, BS EN 14974 recommends a maximum of 5mm with 3mm preferred

**Action:** Adjust height to ensure a maximum of 5mm change in level

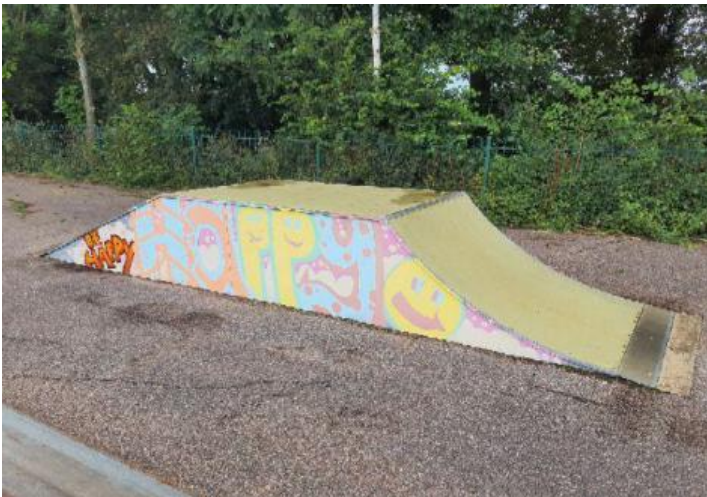
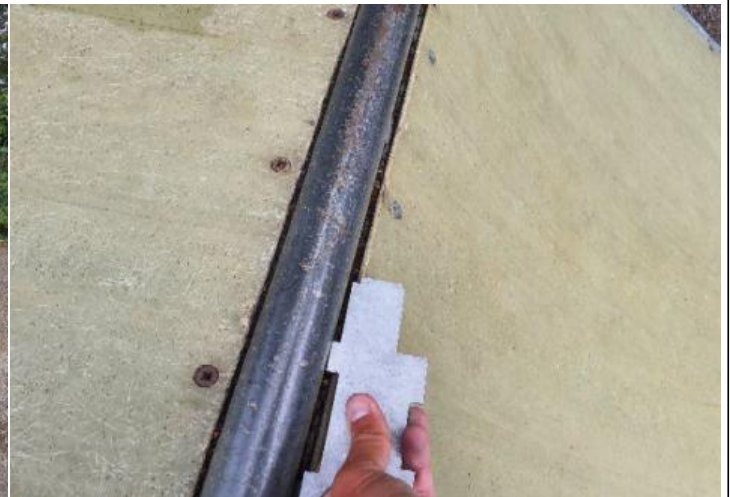
**Finding:** Joints between the riding surfaces should not be greater than 5mm to meet the requirements of BS EN 14974

**Action:** Take corrective action to ensure that the gaps between the joints do not exceed 5mm

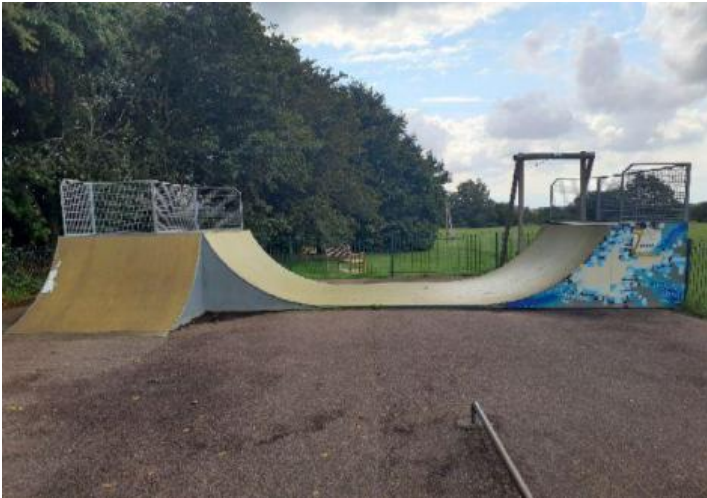
**Finding:** The height of the barrier is less than 1200mm and fails the requirements of BS EN 14974  
**Action:** Monitor - No remedial work recommended

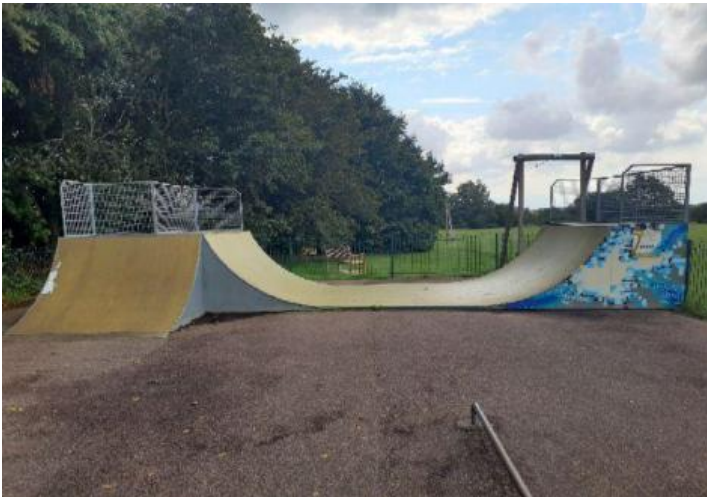
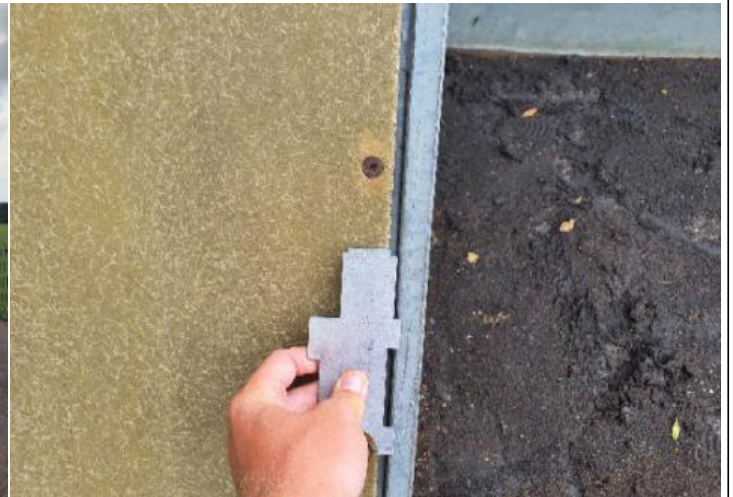
**Finding:** Joints between the riding surfaces should not be greater than 5mm to meet the requirements of BS EN 14974  
**Action:** Take corrective action to ensure that the gaps between the joints do not exceed 5mm

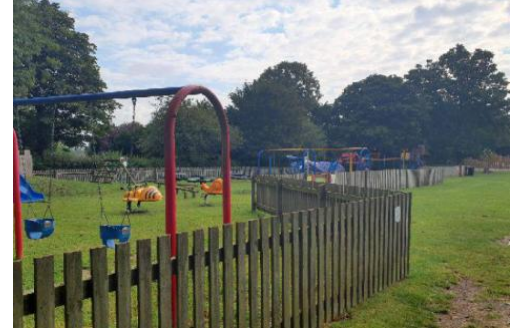
**Item:** Site General  
**Manufacturer:** Owner/Operator  
**Surface Type:** N/A  
**Item Quantity:** 1  
**Equipment Compliance:** N/A  
**Surface Area Compliance:** N/A

There is a redundant concrete base causing trip hazards in the play area - Remove the concrete and reinstate

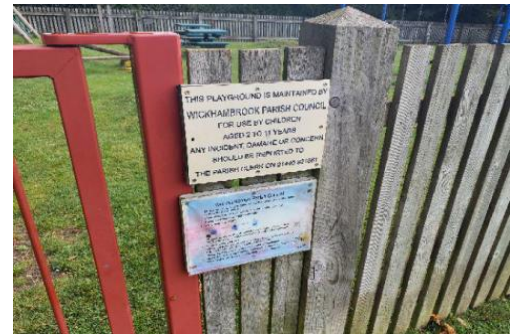
**Item:** Sign  
**Manufacturer:** Owner/Operator  
**Surface Type:** N/A  
**Item Part Number:**  
**Item Quantity:** 1  
**Equipment Compliance:** N/A  
**Surface Area Compliance:** N/A  
**Total Findings:** 1

It is recommended that signage, with information including the site address, contact information for maintenance issues and emergency contact details are provided for the facility - Provide in accordance with the recommendations

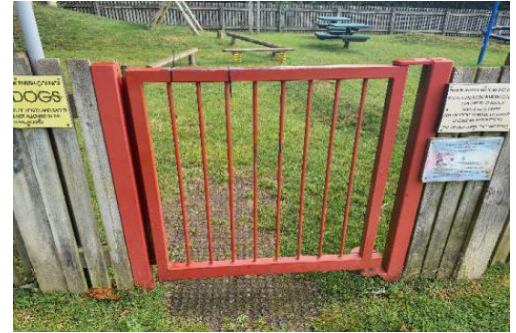
**Item:** Gate - Self Closing  
**Manufacturer:** Easy Gate Ltd  
**Surface Type:** Grass Matrix Tiles  
**Item Quantity:** 2  
**Equipment Compliance:** N/A  
**Surface Area Compliance:** N/A

There are trip hazards at the edges of the surface - Reinstate surrounding surface levels to remove the trip points

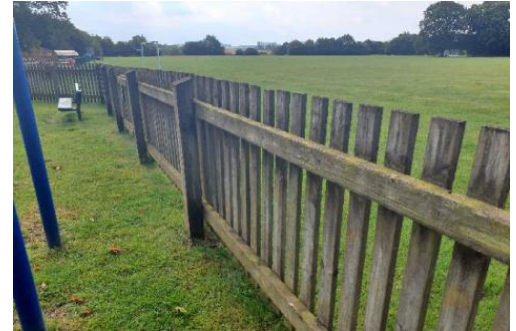
**Item:** Fencing - Timber  
**Manufacturer:** Not Identified  
**Surface Type:** Grass  
**Item Quantity:** 1  
**Equipment Compliance:** N/A  
**Surface Area Compliance:** N/A

There is some strimmer / machinery damage apparent on the posts, this can penetrate the preservative applied to the timber and accelerate the rotting process - Monitor for any deterioration (rot) and replace as required

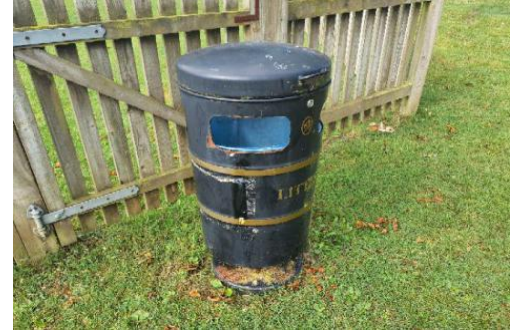
The paintwork on this item has been damaged or worn exposing the metal underneath which is rusting / corroding - Treat affected areas and repaint
