## Update on Estates Issues

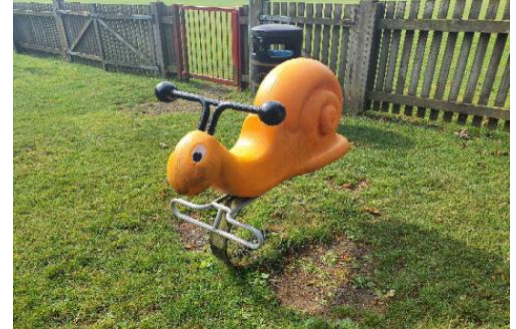
A number of fixing(s) have worked loose - Secure all loose fixings

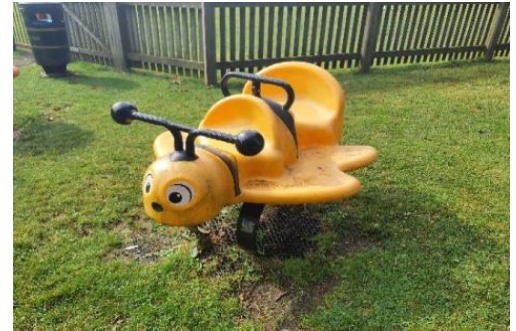
A number of fixing(s) have worked loose - Secure all loose fixings

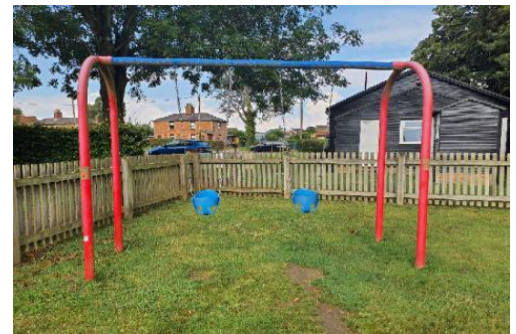
The grass mats are silted up and the soil is compacted; this may have an effect on the impact absorbing properties of the surface - Consider HIC testing impact absorbing properties to ensure the correct surface qualities are maintained for the equipment and replace as required

The connecting links are in excess of 8.6mm and less than 12mm and fail the requirements of BS EN 1176 Part 1; clause 4.2.13, Chains - Monitor use and replace with compliant links at the next maintenance cycle

The chain openings are in excess of 8.6mm and do not meet the recommendations of BS EN 1176 Part 1 - Monitor - No remedial work recommended

There is some notable evidence of chain wear - Monitor for any further deterioration and replace when 40% worn

The swing seat connectors have some wear present - Monitor for further deterioration and replace when 40% worn

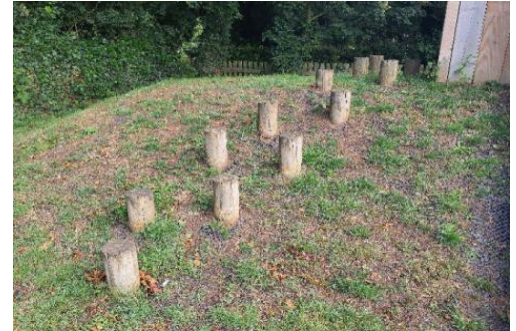
There is some strimmer / machinery damage apparent on the posts, this can penetrate the preservative applied to the timber and accelerate the rotting process - Monitor for any deterioration (rot) and replace as required

The timber has a number of splits/shakes or air cracks and this may affect the stability or allow water ingress which will accelerate the rotting process - Monitor to ensure the splits do not cross through fixing points of the structure and/or cause any instability

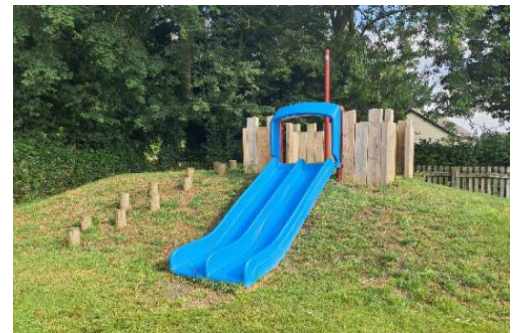
The edges of the grass mat surface have not been installed in accordance with the API Code of Practice - Tuck in edges of grass mat to remove trip hazards

There is/are finger entrapment/s in the slide starting section and the item fails to meet the requirements of BS EN 1176 Part 1 4.2.7.6 Entrapment of fingers - Monitor - No remedial work recommended

The surface has eroded in some areas and may be slippery in wet conditions - Reinstate the surface

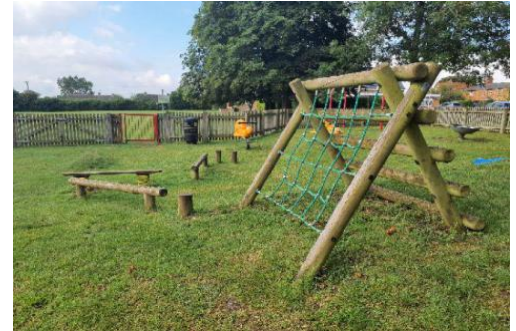
There is/are bolt cap covers missing or damaged on the item - Replace missing or damaged bolt cap covers

The step between the items is quite large and users may not be able to complete the step without touching ground, the items could therefore be considered to be within the falling space of each other, however the intention of the play activity continuity is easily apparent and foreseeable to the user - Monitor - No remedial work recommended

There is some strimmer / machinery damage apparent on the posts, this can penetrate the preservative applied to the timber and accelerate the rotting process - Monitor for any deterioration (rot) and replace as required

The timber stepping post forms a hard object within the falling space of the A frame climber in contravention of the requirements of BS EN 1176 Part 1 - Monitor - No remedial work recommended

The timber has a number of splits/shakes or air cracks and this may affect the stability or allow water ingress which will accelerate the rotting process - Monitor to ensure the splits do not cross through fixing points of the structure and/or cause any instability

The ropes/nets are worn/damaged in places - Monitor for any further deterioration and repair or replace as required

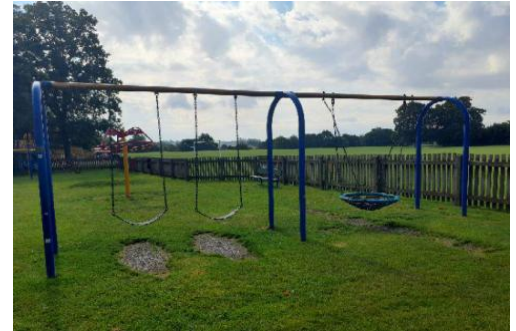
There is moderate damage to the surface - Repair the damaged areas of surfacing

The swing seat connectors have some wear present - Monitor for further deterioration and replace when 40% worn

There is some notable evidence of chain wear - Monitor for any further deterioration and replace when 40% worn

The seat has minor damage or wear - Monitor for any further deterioration and replace as required

The seats are too close to each other as defined in BS EN 1176 Part 2; this is a low risk failure and no remedial action is required - Monitor - No remedial work recommended

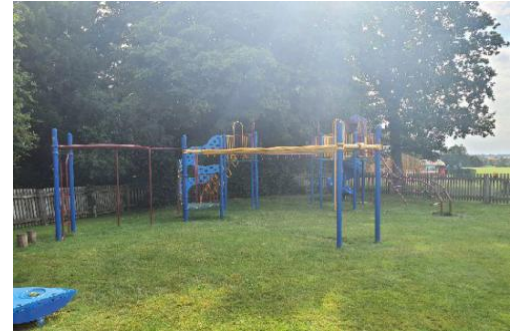
There are falls in excess of 600mm between adjacent components on the structure, in contravention of the recommendations set out in BS EN 1176 Part 1; 4.2.8.4 - Monitor - No remedial work recommended

The height of the slide runout is in excess of 350mm and does not meet the requirements of BS EN 1176: Part 3 - Monitor - No remedial work recommended

There is/are finger entrapment/s in the frame and the item fails to meet the requirements of BS EN 1176 Part 1 4.2.7.6 Entrapment of fingers - Monitor - No remedial work recommended

A number of fixing(s) have worked loose - Secure all loose fixings

There are a number of dents in the slide surface - Monitor for any further deterioration and repair as required

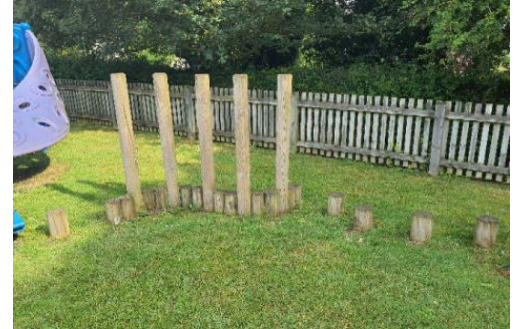
The timber has a number of splits/shakes or air cracks and this may affect the stability or allow water ingress which will accelerate the rotting process - Monitor to ensure the splits do not cross through fixing points of the structure and/or cause any instability

There is some strimmer / machinery damage apparent on the posts, this can penetrate the preservative applied to the timber and accelerate the rotting process - Monitor for any deterioration (rot) and replace as required

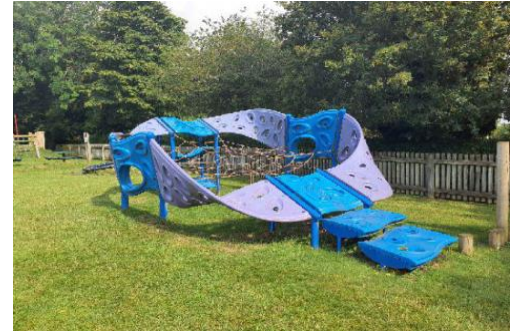
There is/are bolt cap covers missing or damaged on the item - Replace missing or damaged bolt cap covers

The connecting links are in excess of 8.6mm and less than 12mm and fail the requirements of BS EN 1176 Part 1; clause 4.2.13, Chains - Monitor use and replace with compliant links at the next maintenance cycle

The connecting lugs are showing signs of wear - Monitor for any further deterioration and repair as required

The log walk forms a hard object within the falling space of the equipment in contravention of the requirements of BS EN 1176 Part 1 - Monitor - No remedial work recommended

There is/are finger entrapment/s in the frame and the item fails to meet the requirements of BS EN 1176 Part 1 4.2.7.6 Entrapment of fingers - Monitor - No remedial work recommended

The ropes/nets are worn/damaged in places - Monitor for any further deterioration and repair or replace as required

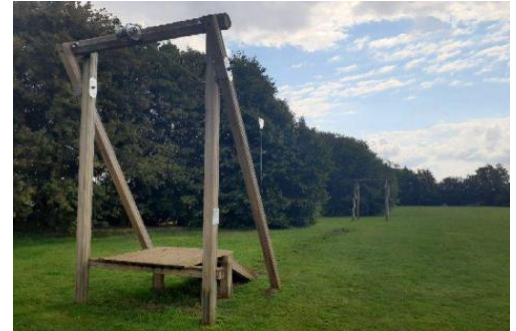
We have completed a visual inspection of the suspension links, cable and fixing points from ground level, however it is not possible to fully inspect these areas without either hiring equipment to gain access or removing the cable and suspension and inspecting at ground level. We recommend that the main cable and fixing security is thoroughly inspected at least in accordance with the manufacturers recommendations to check for wear, damage, security or internal rusting; this will help to ensure the continued safe use of the equipment - Inspect in accordance with the manufacturers recommendations

The seat connection cannot be inspected without dismantling the seat - Dismantle the seat to inspect the seat connection for wear

The cableway seat has been damaged - Monitor for any further deterioration and replace as required

The nylon inserts are worn or missing at the point the cable enters the traveller - Replace worn or missing inserts as required

There is some strimmer / machinery damage apparent on the posts, this can penetrate the preservative applied to the timber and accelerate the rotting process - Monitor for any deterioration (rot) and replace as required

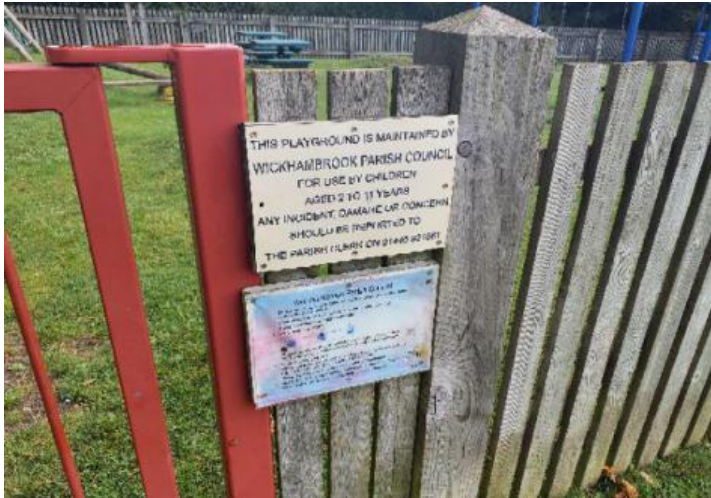
**Finding:** It is recommended that signage, with information including the site address, contact information for maintenance issues and emergency contact details are provided for the facility

**Action:** Provide in accordance with the recommendations

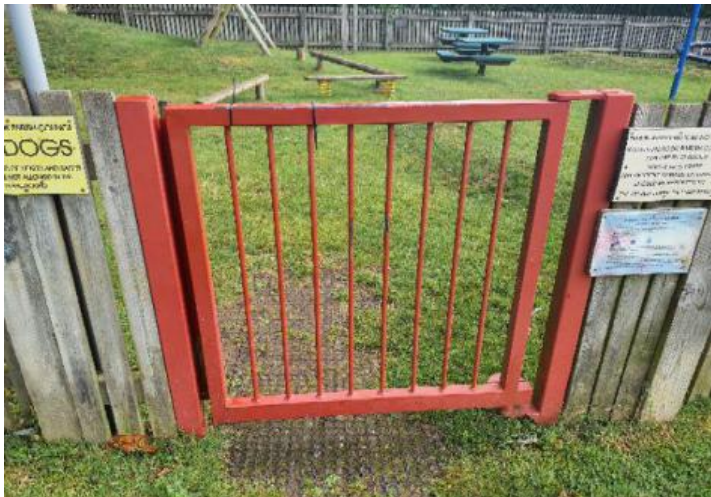
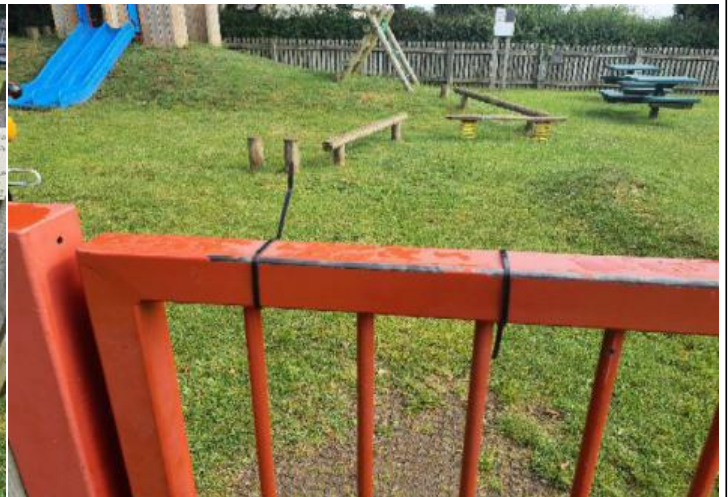
**Finding:** There are a number of redundant cable ties attached to the gate

**Action:** Remove redundant cable ties

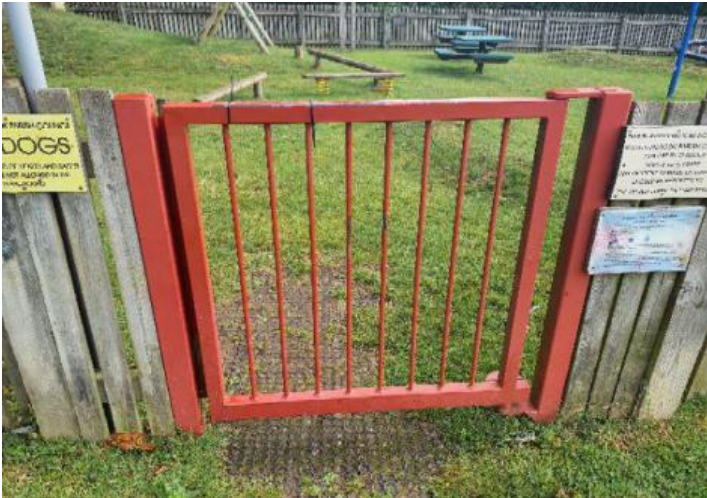
**Finding:** There are trip hazards at the edges of the surface

**Action:** Reinstate surrounding surface levels to remove the trip points

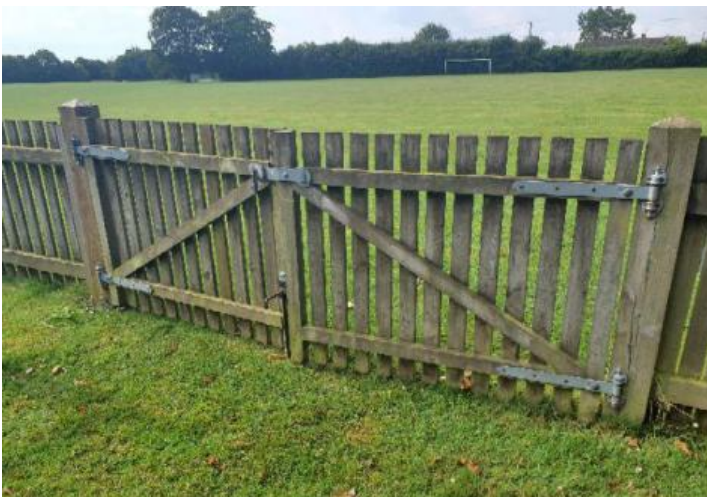
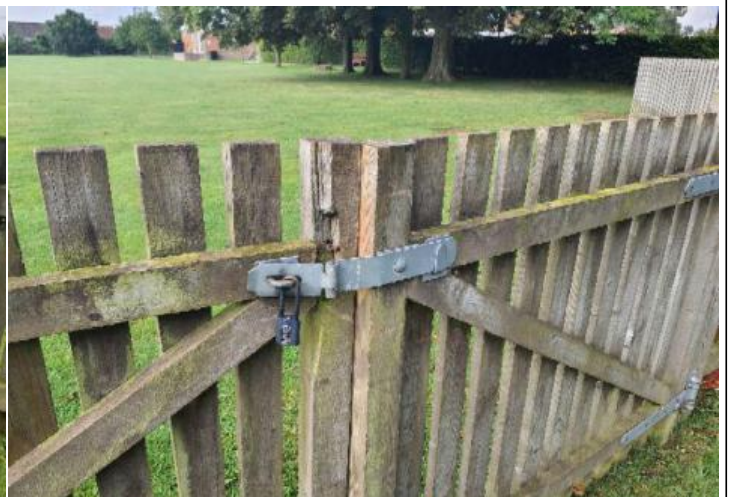
**Finding:** The maintenance gate was correctly padlocked at the time of inspection, however this means that the inspector was unable to fully assess the gate

**Action:** Ensure that there are 12mm gaps throughout the full range of motion on gate/s and between leaves where relevant

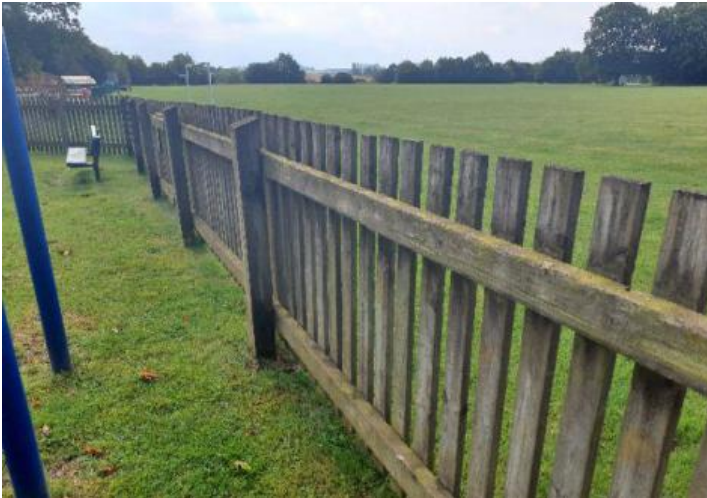
**Finding:** There is some strimmer / machinery damage apparent on the posts, this can penetrate the preservative applied to the timber and accelerate the rotting process

**Action:** Monitor for any deterioration (rot) and replace as required

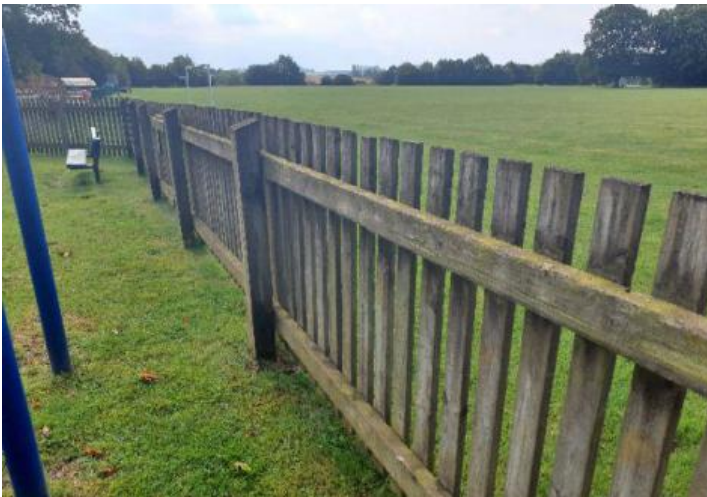
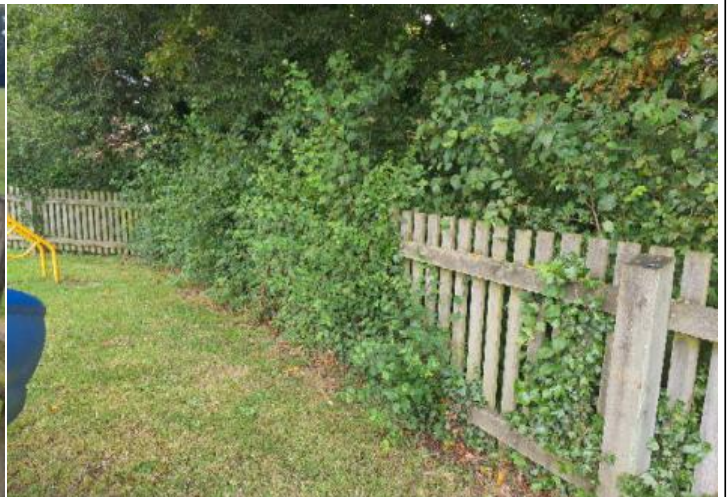
**Finding:** The adjacent foliage is overhanging

**Action:** Cut back and maintain

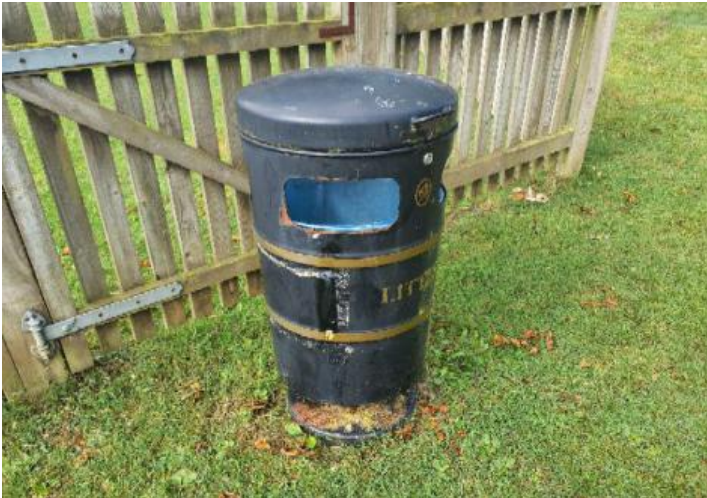
**Finding:** The paintwork on this item has been damaged or worn exposing the metal underneath which is rusting / corroding

**Action:** Treat affected areas and repaint

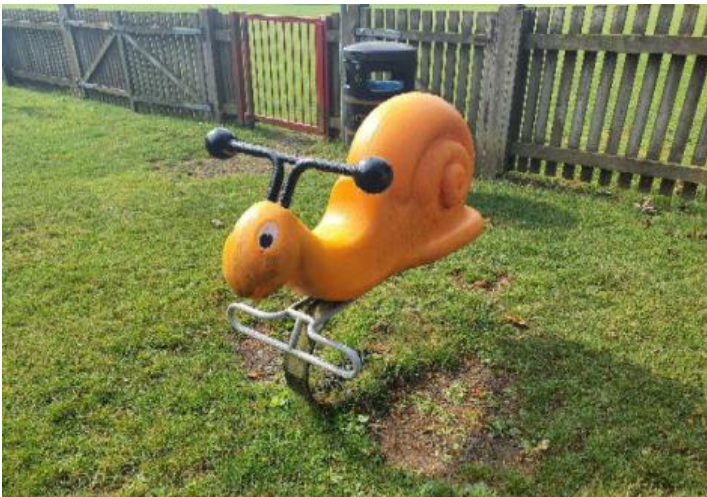
**Finding:** A number of fixing(s) have worked loose

**Action:** Secure all loose fixings

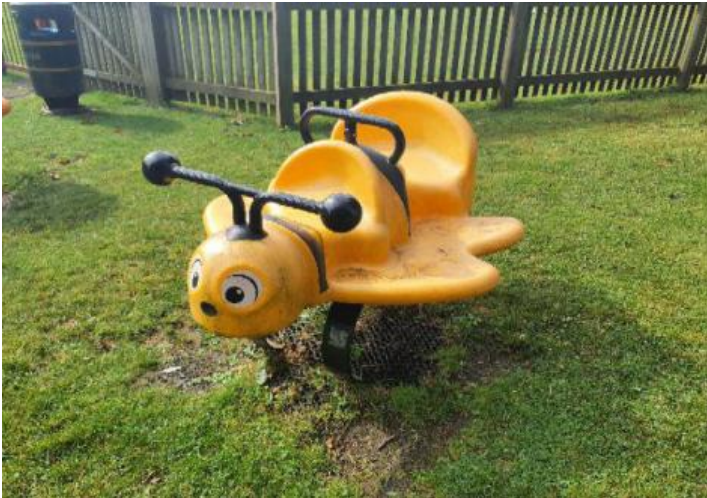
**Finding:** A number of fixing(s) have worked loose

**Action:** Secure all loose fixings

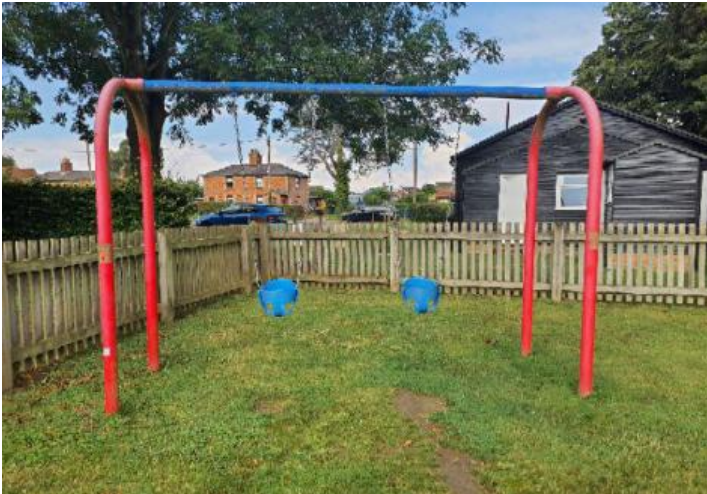
**Finding:** The grass mats are silted up and the soil is compacted; this may have an effect on the impact absorbing properties of the surface

**Action:** Consider HIC testing impact absorbing properties to ensure the correct surface qualities are maintained for the equipment and replace as required

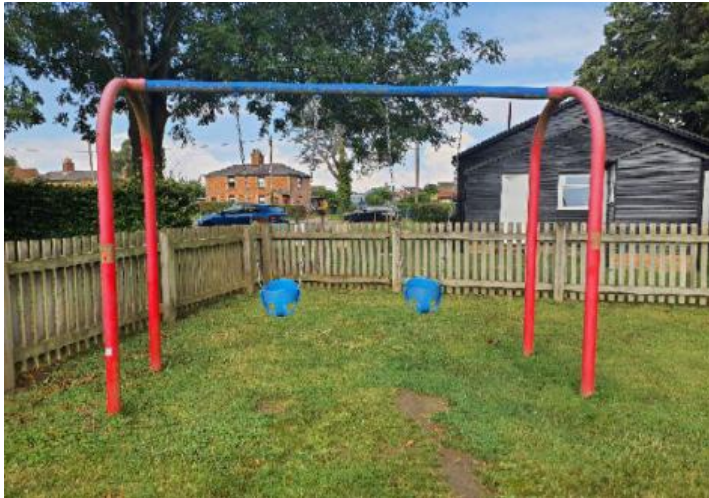
**Finding:** The connecting links are in excess of 8.6mm and less than 12mm and fail the requirements of BS EN 1176 Part 1; clause 4.2.13, Chains

**Action:** Monitor use and replace with compliant links at the next maintenance cycle

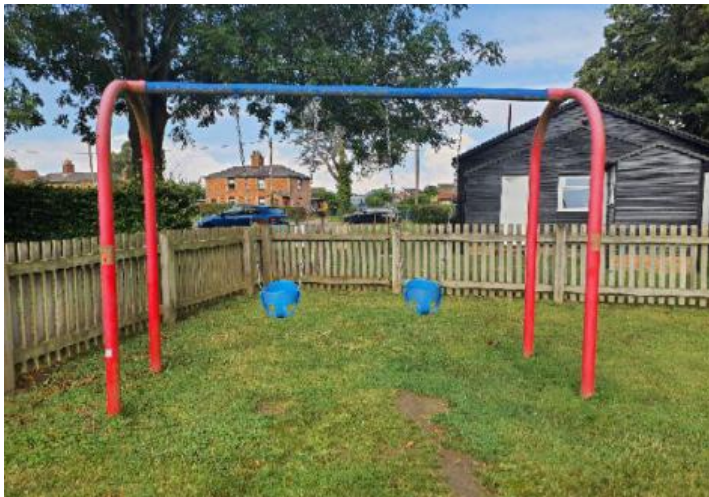
**Finding:** The chain openings are in excess of 8.6mm and do not meet the recommendations of BS EN 1176 Part 1

**Action:** Monitor - No remedial work recommended

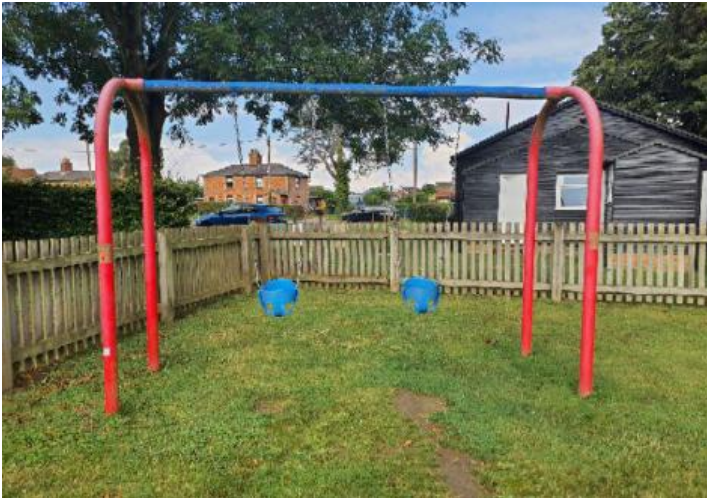
**Finding:** There is some notable evidence of chain wear

**Action:** Monitor for any further deterioration and replace when 40% worn

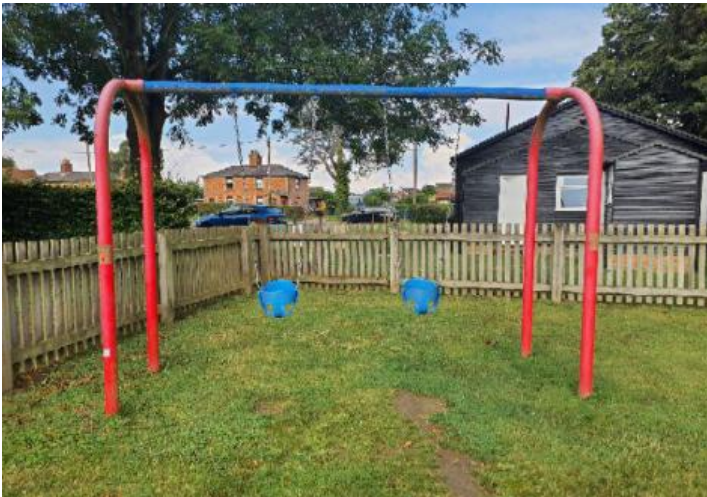
**Finding:** The swing seat connectors have some wear present

**Action:** Monitor for further deterioration and replace when 40% worn

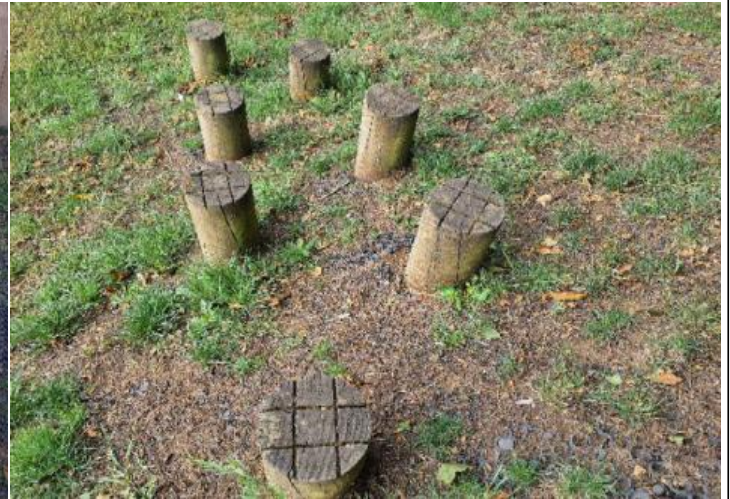
**Finding:** There is algae or moss on the surface of the equipment

**Action:** Clean and treat appropriately

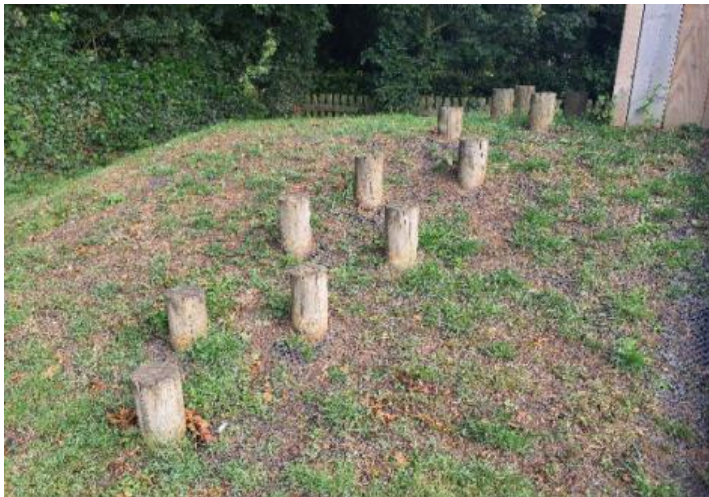
**Finding:** There is some strimmer / machinery damage apparent on the posts, this can penetrate the preservative applied to the timber and accelerate the rotting process

**Action:** Monitor for any deterioration (rot) and replace as required

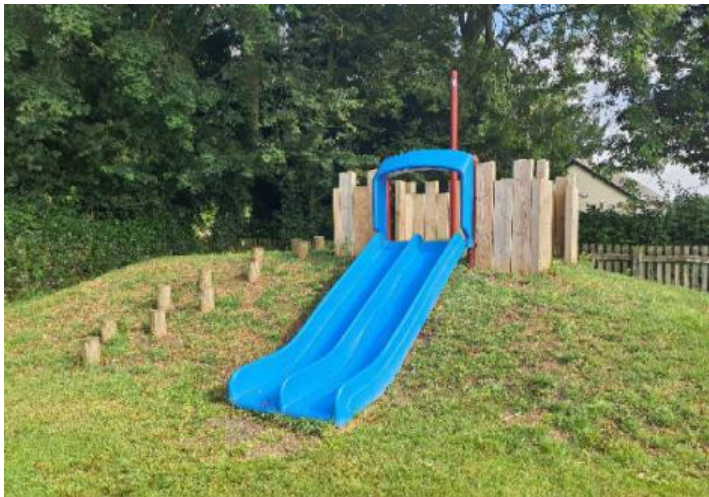
**Finding:** The edges of the grass mat surface have not been installed in accordance with the API Code of Practice  
**Action:** Tuck in edges of grass mat to remove trip hazards

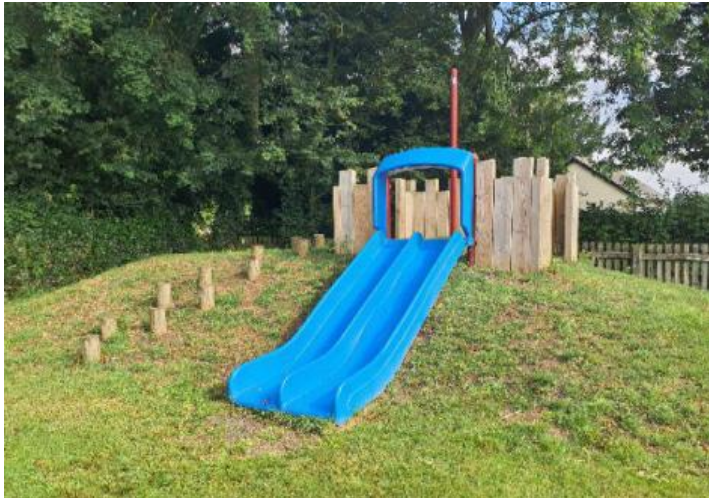
**Finding:** There is/are finger entrapment/s in the slide starting section and the item fails to meet the requirements of BS EN 1176 Part 1 4.2.7.6 Entrapment of fingers

**Action:** Monitor - No remedial work recommended

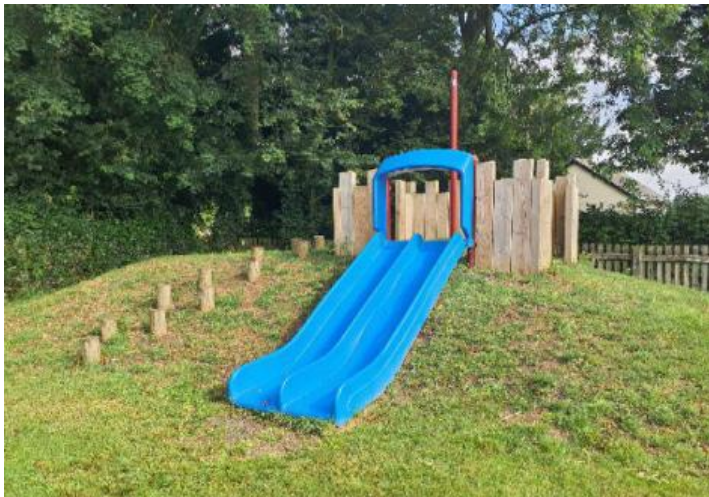
**Finding:** The surface has eroded in some areas and may be slippery in wet conditions

**Action:** Reinstate the surface

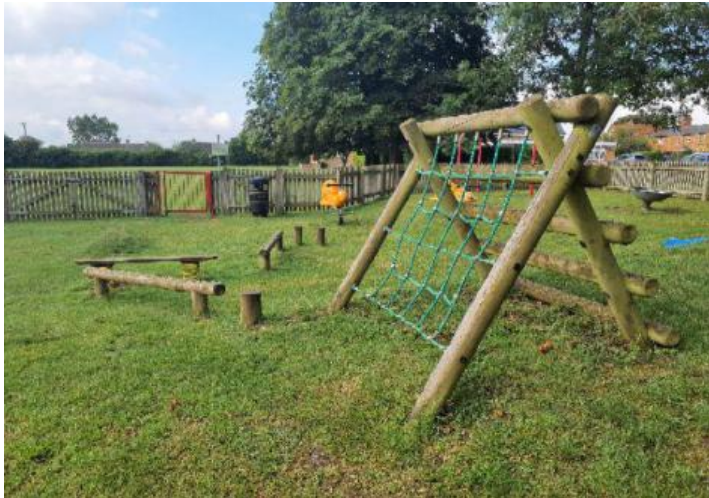
**Finding:** There is/are bolt cap covers missing or damaged on the item

**Action:** Replace missing or damaged bolt cap covers

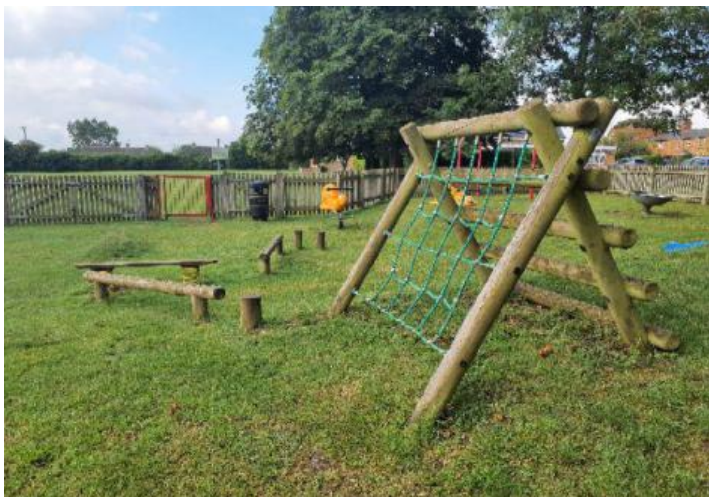
**Finding:** The step between the items is quite large and users may not be able to complete the step without touching ground, the items could therefore be considered to be within the falling space of each other, however the intention of the play activity continuity is easily apparent and foreseeable to the user

**Action:** Monitor - No remedial work recommended

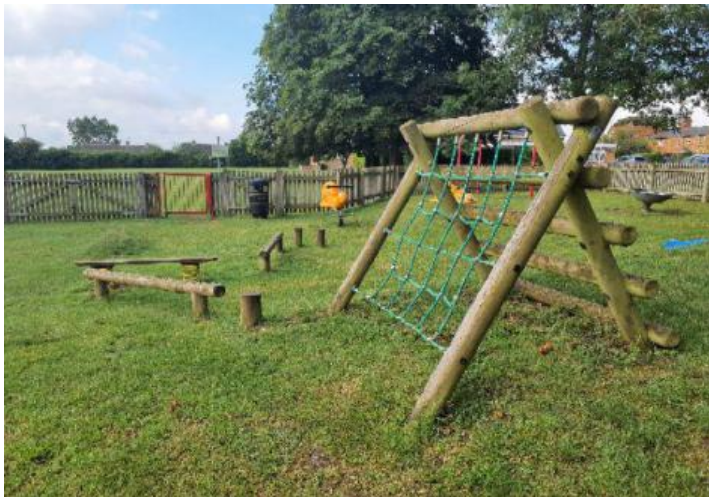
**Finding:** The timber stepping post forms a hard object within the falling space of the A frame climber in contravention of the requirements of BS EN 1176 Part 1

**Action:** Monitor - No remedial work recommended

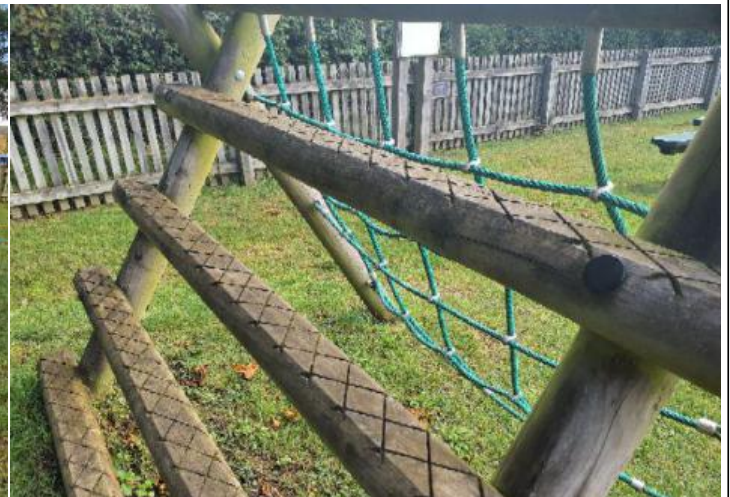
**Finding:** There is algae or moss on the surface of the equipment  
**Action:** Clean and treat appropriately

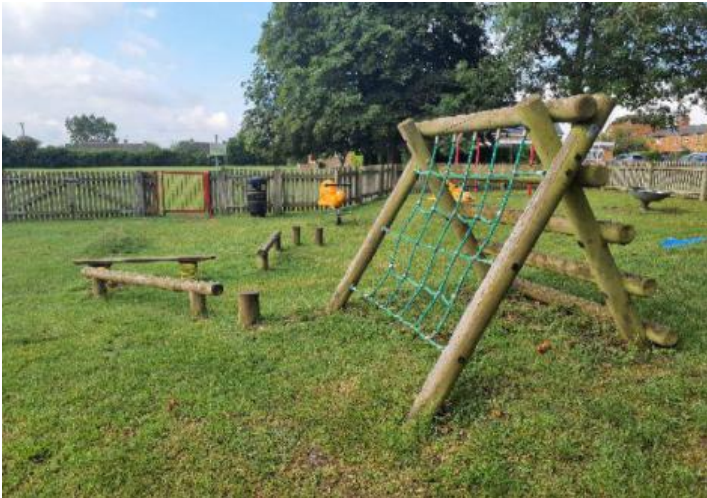
**Finding:** The ropes/nets are worn/damaged in places

**Action:** Monitor for any further deterioration and repair or replace as required

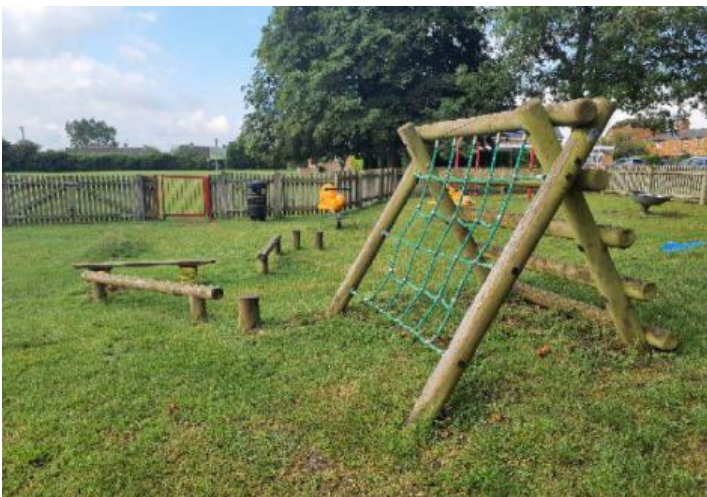
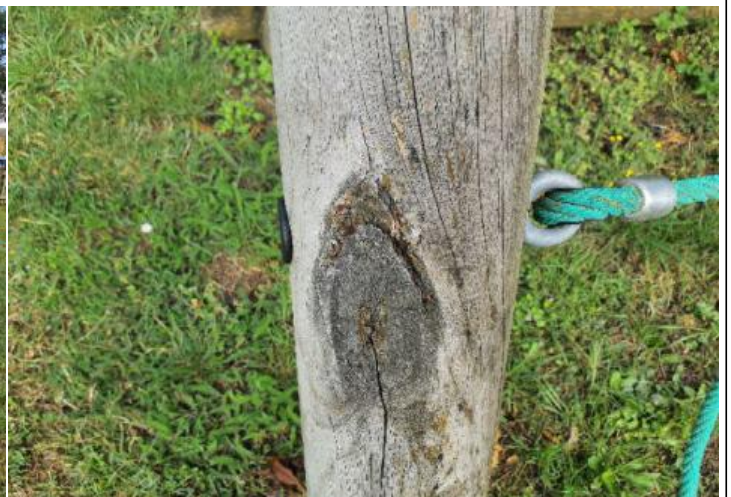
**Finding:** Parts of the timber are rough or splintered

**Action:** Remove all rough or sharp edges

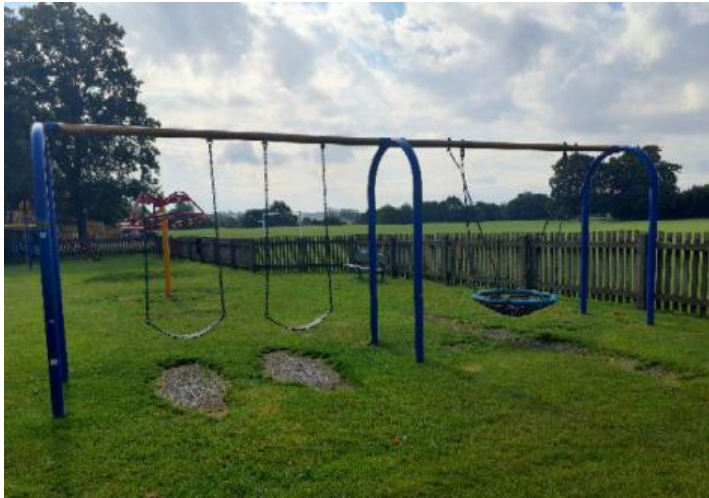
**Finding:** There is moderate damage to the surface

**Action:** Repair the damaged areas of surfacing

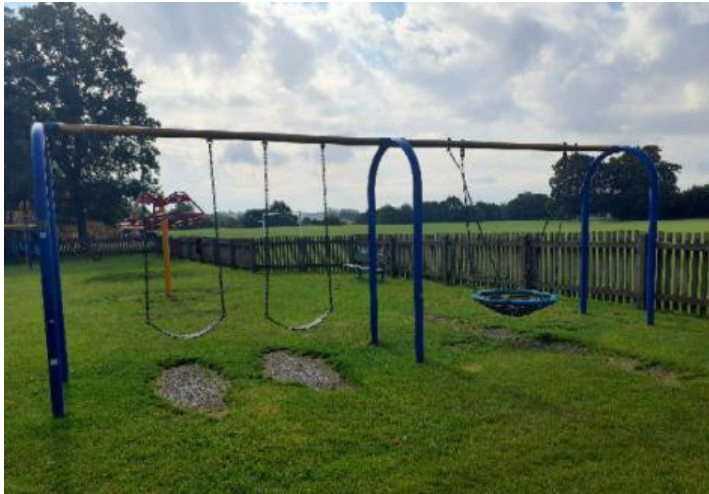
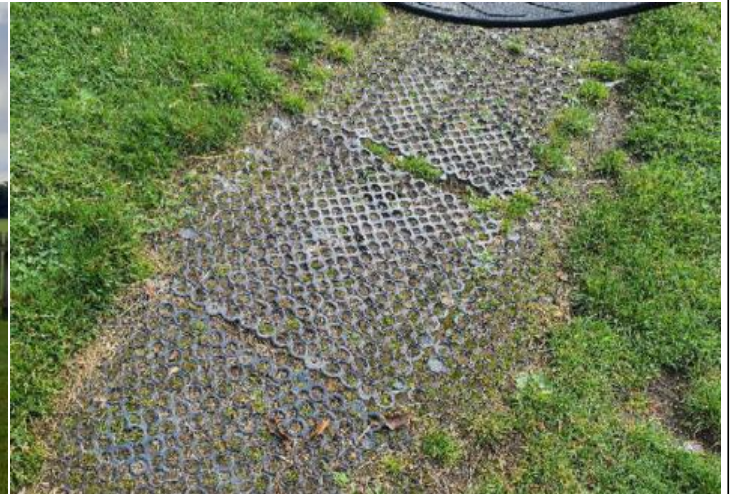
**Finding:** There are gaps opening between the grass mat tiles

**Action:** Provide additional ties or secure / reinstate surface

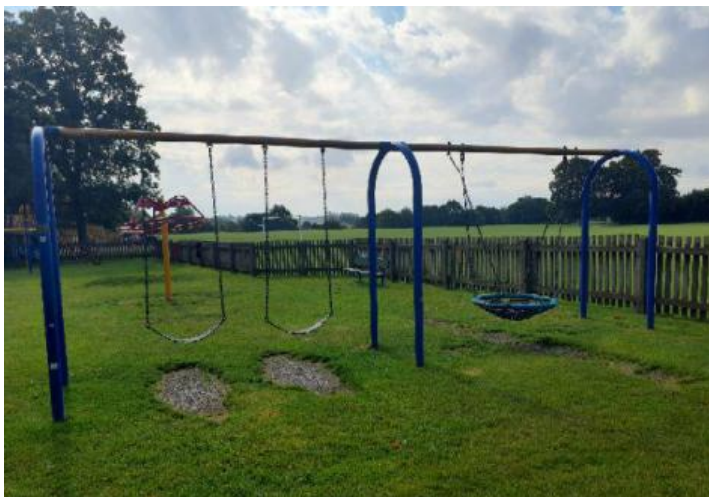
**Finding:** There is some notable evidence of chain wear

**Action:** Monitor for any further deterioration and replace when 40% worn

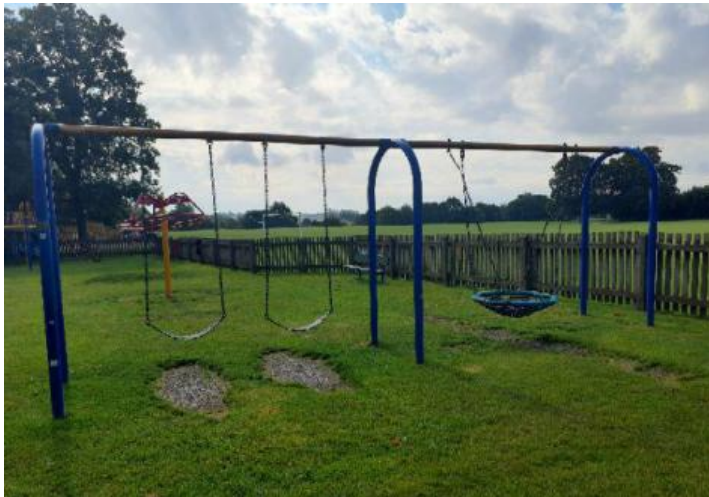
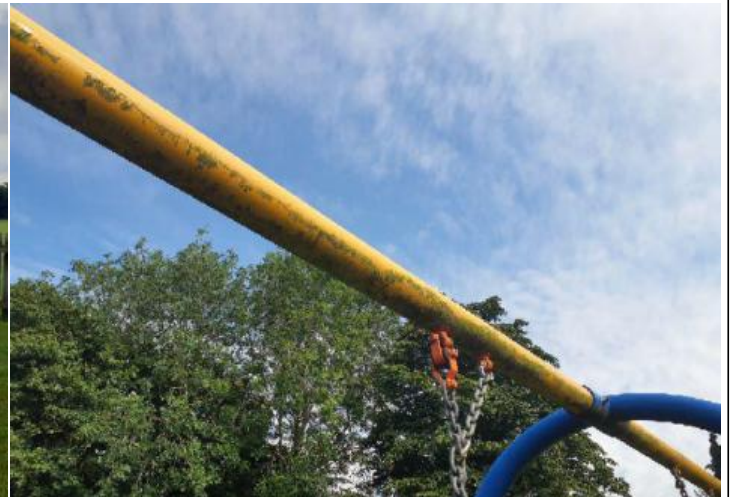
**Finding:** There is algae or moss on the surface of the equipment

**Action:** Clean and treat appropriately

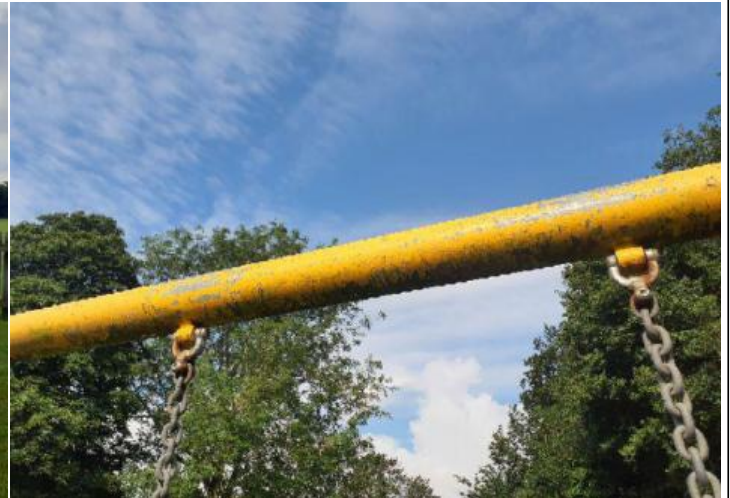
**Finding:** The paint is flaking off the metalwork  
**Action:** Rub down and re-paint

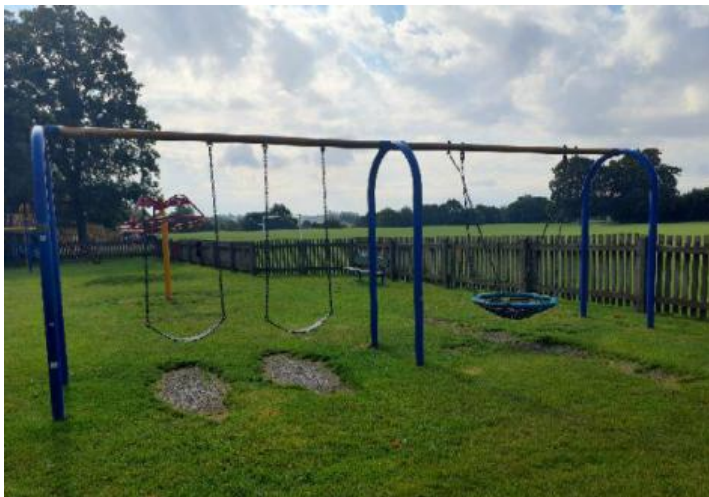
**Finding:** The seats are too close to each other as defined in BS EN 1176 Part 2; this is a low risk failure and no remedial action is required  
**Action:** Monitor - No remedial work recommended

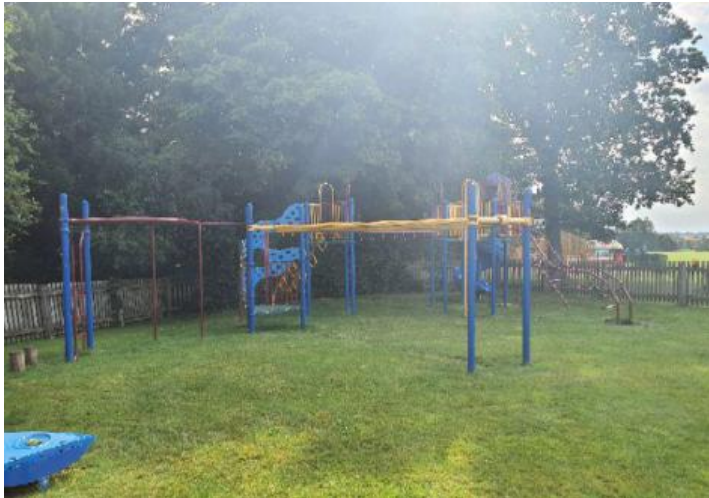
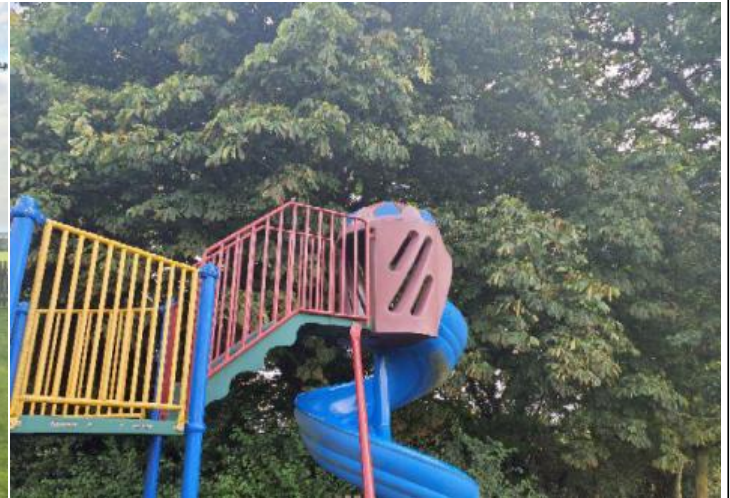
**Finding:** This item of equipment has a fall height in excess of 2.5m and grass mats have been installed as an impact absorbing surface; these mats rely heavily on the underlying surface to achieve their critical fall height properties.

**Action:** Ensure surfacing certification is sought and consider HIC testing to ensure the surfacing is performing adequately

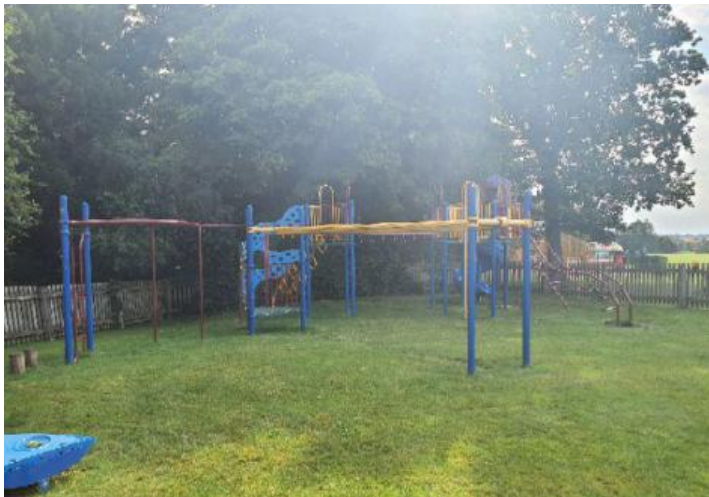
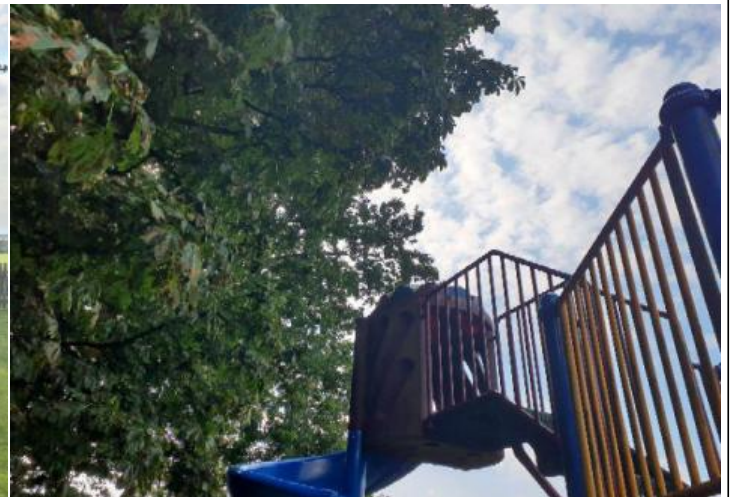
**Finding:** The tree canopy overhangs the equipment and is less than 2.0m away

**Action:** Lift tree canopy to ensure a minimum clearance of 2.0m from the equipment

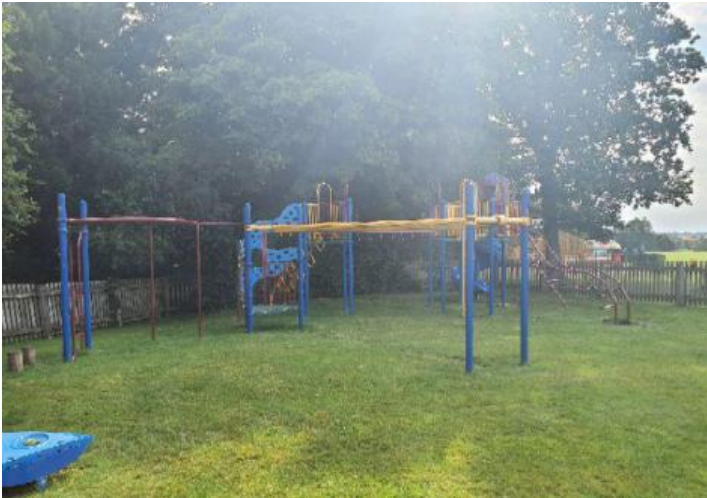
**Finding:** There are falls in excess of 600mm between adjacent components on the structure, in contravention of the recommendations set out in BS EN 1176 Part 1; 4.2.8.4

**Action:** Monitor - No remedial work recommended

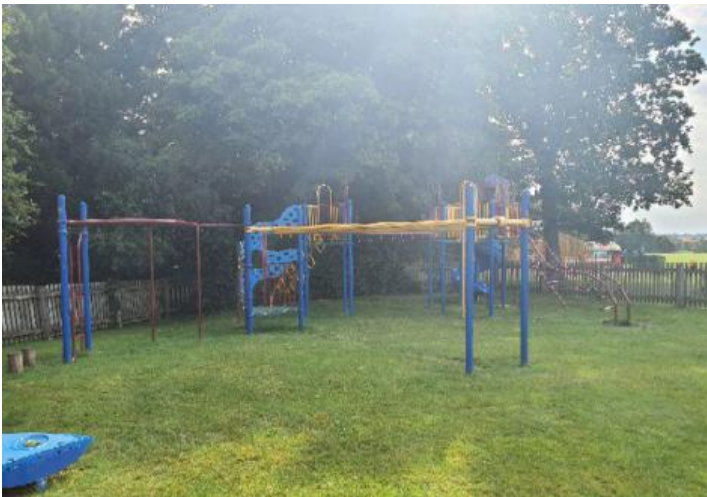
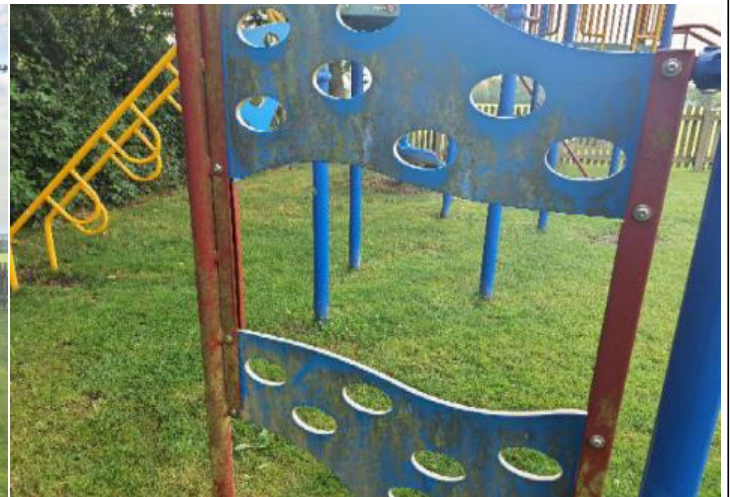
**Finding:** There is algae or moss on the surface of the equipment

**Action:** Clean and treat appropriately

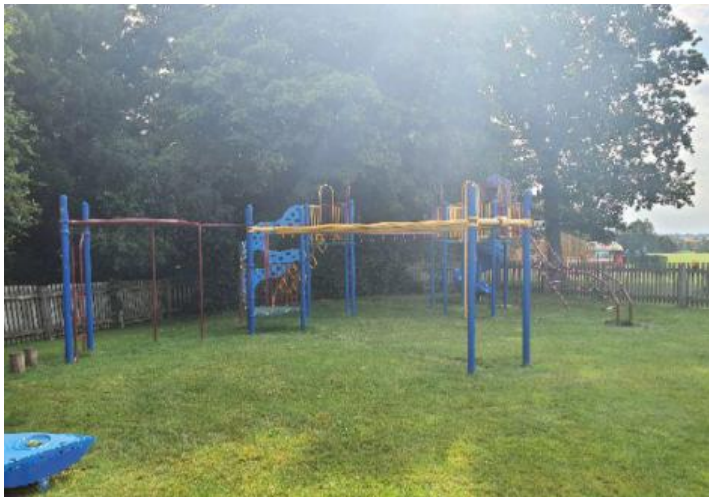
**Finding:** There is/are finger entrapment/s in the frame and the item fails to meet the requirements of BS EN 1176 Part 1 4.2.7.6 Entrapment of fingers

**Action:** Monitor - No remedial work recommended

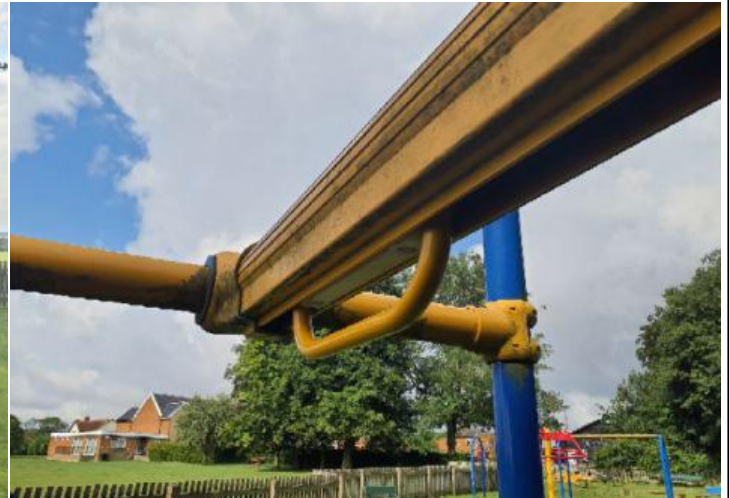
**Finding:** There are no buffers fitted to the mono rail

**Action:** Provide buffers

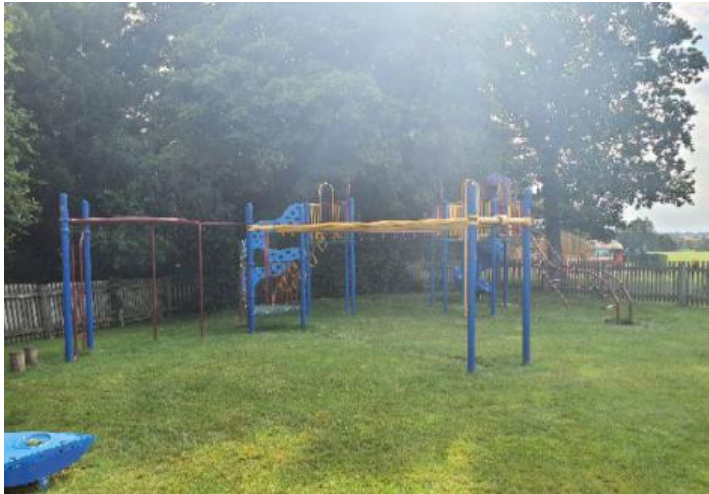
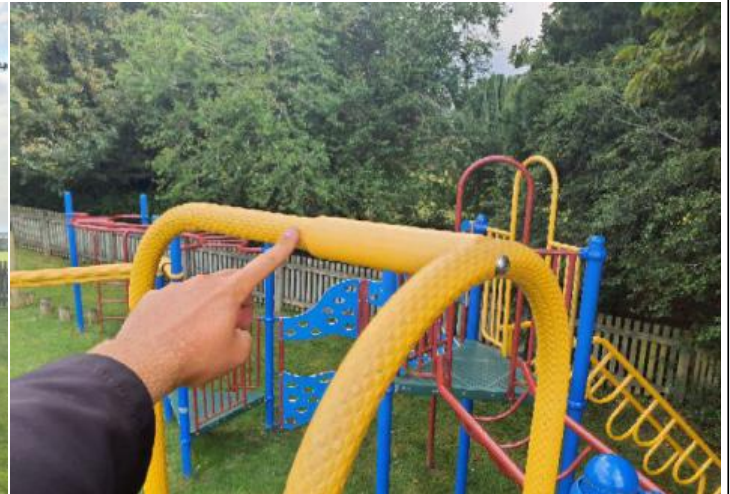
**Finding:** A number of fixing(s) have worked loose

**Action:** Secure all loose fixings
