## Update on Estates Issues

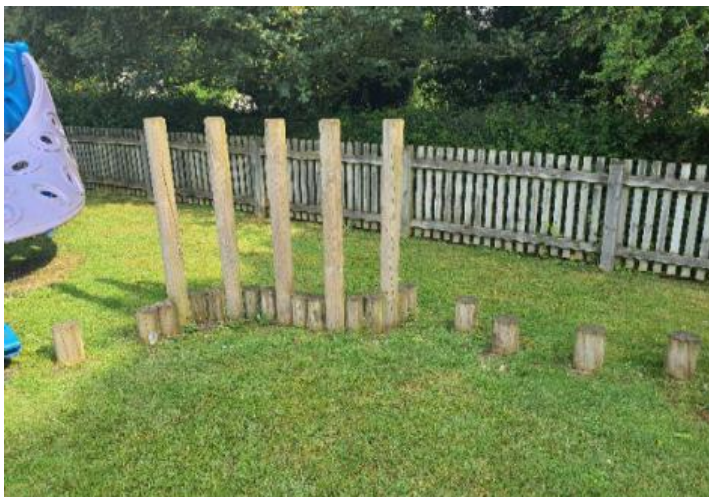
**Finding:** The timber has a number of splits/shakes or air cracks and this may affect the stability or allow water ingress which will accelerate the rotting process

**Action:** Monitor to ensure the splits do not cross through fixing points of the structure and/or cause any instability

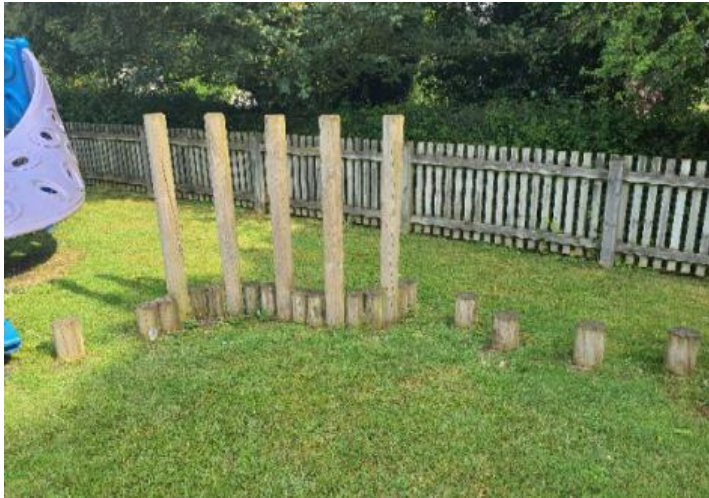
**Finding:** There is some strimmer / machinery damage apparent on the posts, this can penetrate the preservative applied to the timber and accelerate the rotting process

**Action:** Monitor for any deterioration (rot) and replace as required

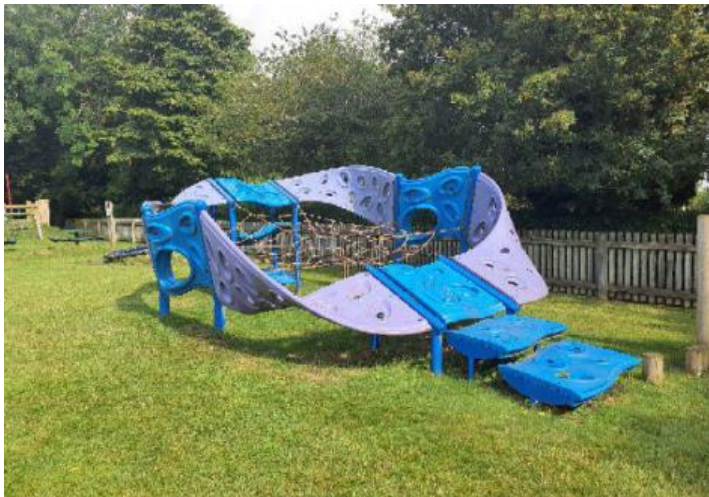
**Finding:** There is/are bolt cap covers missing or damaged on the item

**Action:** Replace missing or damaged bolt cap covers

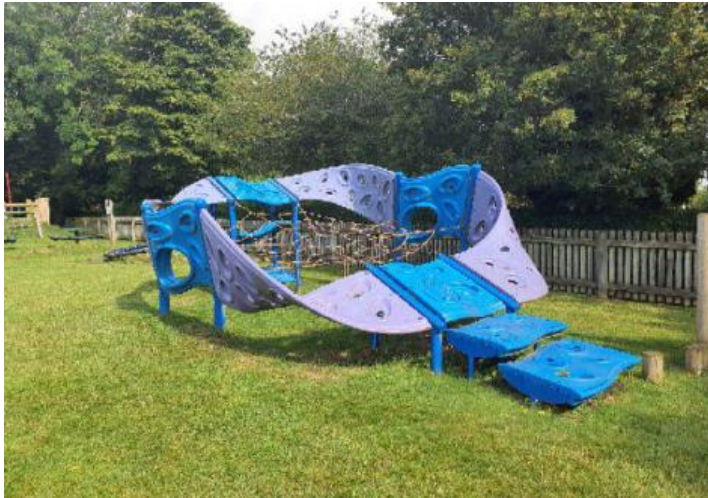
**Finding:** The log walk forms a hard object within the falling space of the equipment in contravention of the requirements of BS EN 1176 Part 1

**Action:** Monitor - No remedial work recommended

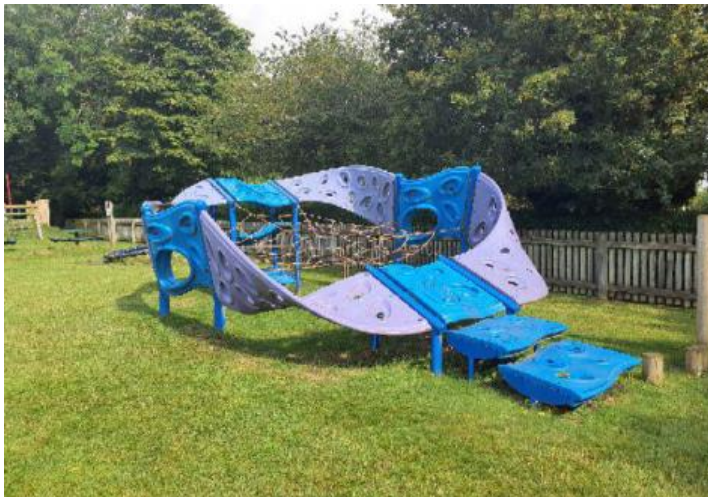
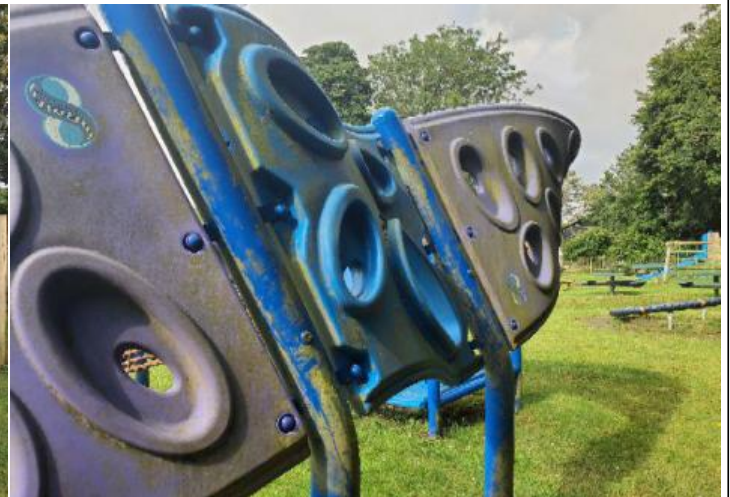
**Finding:** There is algae or moss on the surface of the equipment

**Action:** Clean and treat appropriately

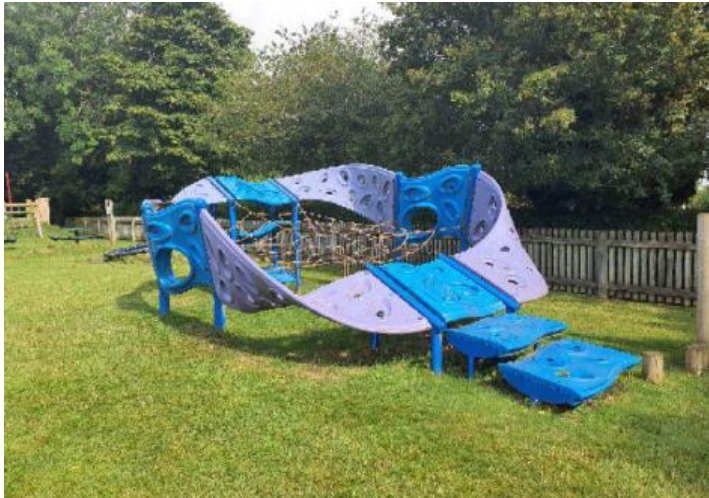
**Finding:** There is/are finger entrapment/s in the frame and the item fails to meet the requirements of BS EN 1176 Part 1 4.2.7.6 Entrapment of fingers  
**Action:** Monitor - No remedial work recommended

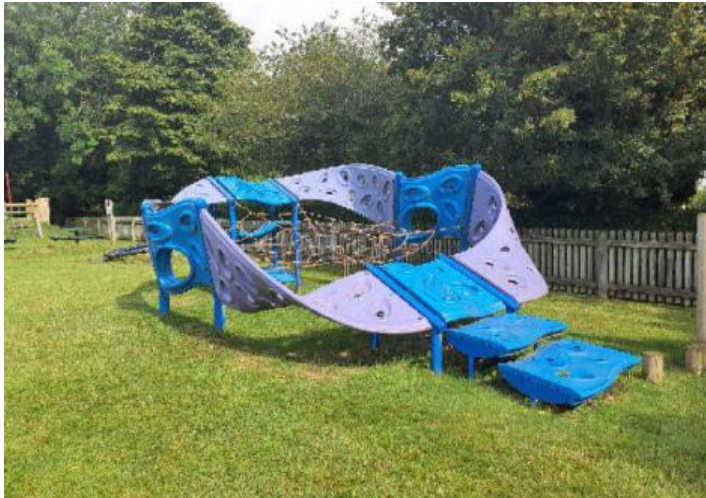
**Finding:** The ropes/nets are worn/damaged in places

**Action:** Monitor for any further deterioration and repair or replace as required

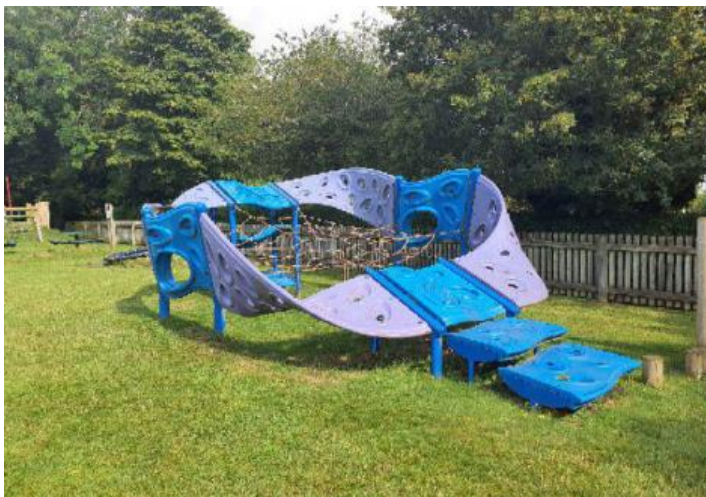
**Finding:** The connecting lugs are showing signs of wear

**Action:** Monitor for any further deterioration and repair as required

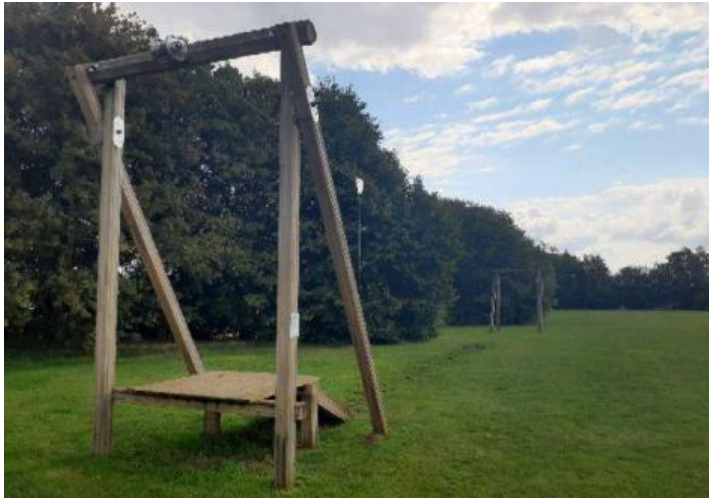
**Finding:** We have completed a visual inspection of the suspension links, cable and fixing points from ground level, however it is not possible to fully inspect these areas without either hiring equipment to gain access or removing the cable and suspension and inspecting at ground level. We recommend that the main cable and fixing security is thoroughly inspected at least in accordance with the manufacturers recommendations to check for wear, damage, security or internal rusting; this will help to ensure the continued safe use of the equipment

**Action:** Inspect in accordance with the manufacturers recommendations

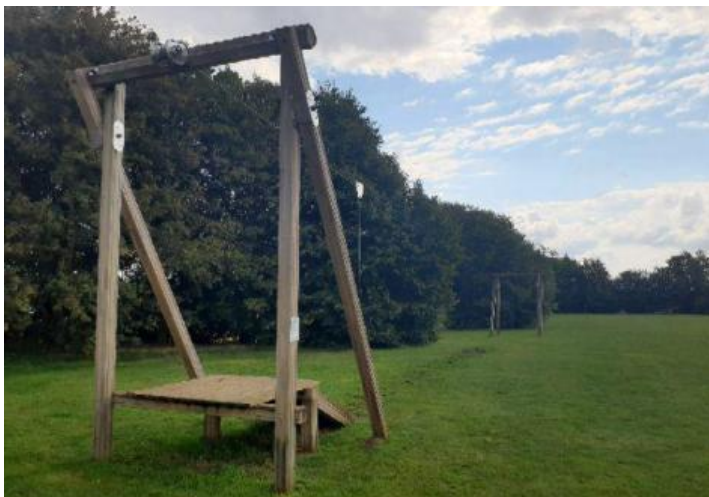
**Finding:** The cableway seat has been damaged

**Action:** Monitor for any further deterioration and replace as required

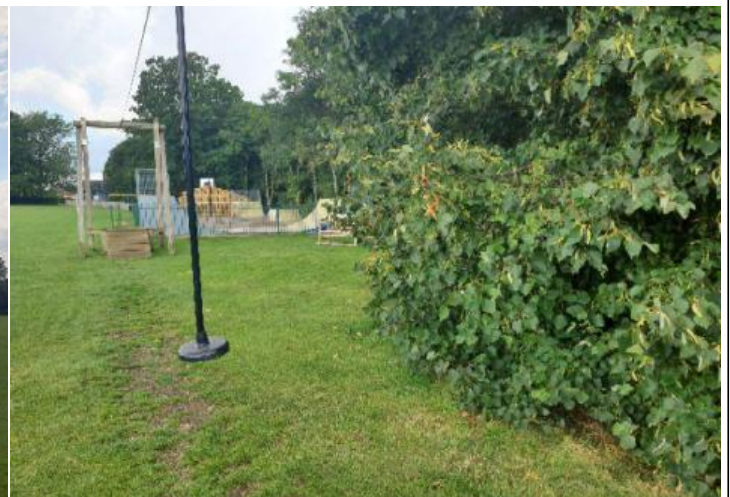
**Finding:** The overhanging foliage forms a hard object within the falling space of the equipment in contravention of the requirements of BS EN 1176 Part 1

**Action:** Cut back and maintain a 2m falling space

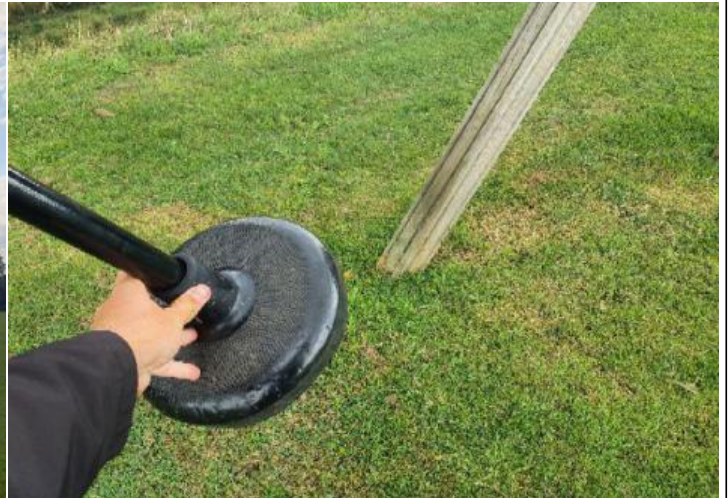
**Finding:** The seat is less than 2.0 metres from the post when extended at 45 degrees at the end of the area of travel and does not meet the requirements of BS EN 1176 Part 4  
**Action:** Adjust the cable stop position to ensure the minimum distance is maintained

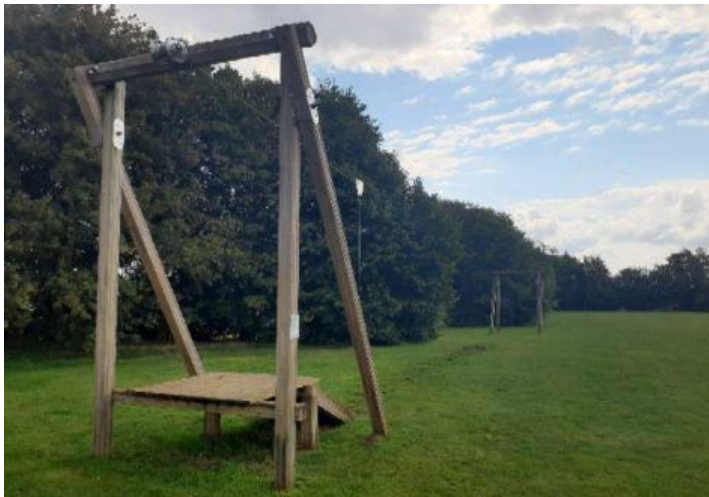
**Finding:** There is some strimmer / machinery damage apparent on the posts, this can penetrate the preservative applied to the timber and accelerate the rotting process  
**Action:** Monitor for any deterioration (rot) and replace as required

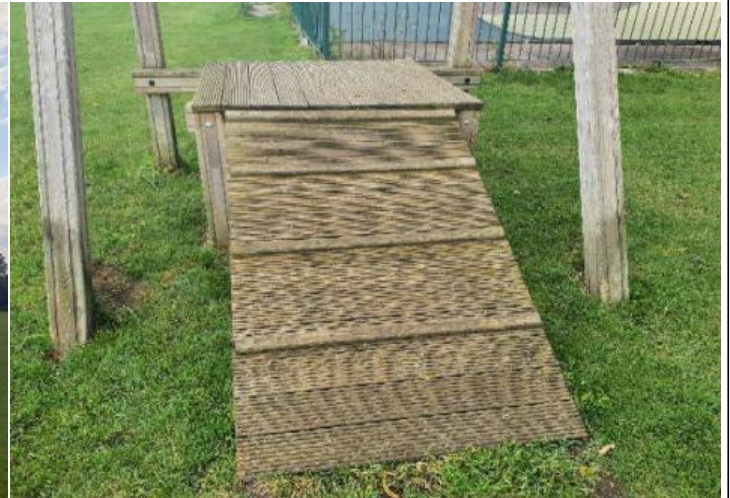
**Finding:** There is algae or moss on the surface of the equipment

**Action:** Clean and treat appropriately

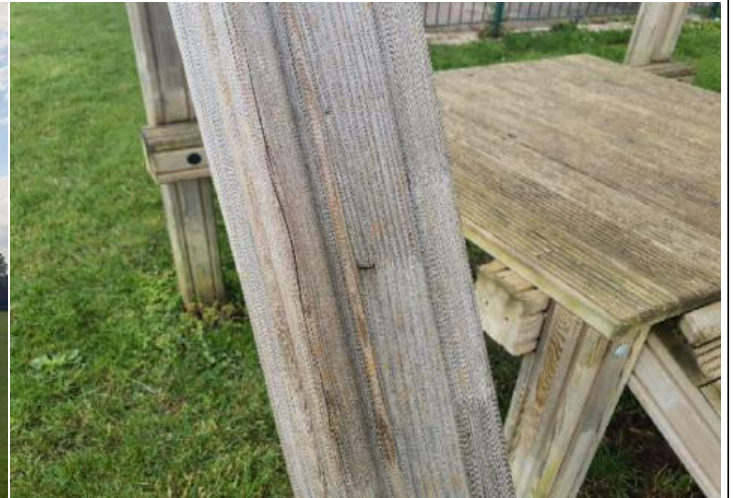
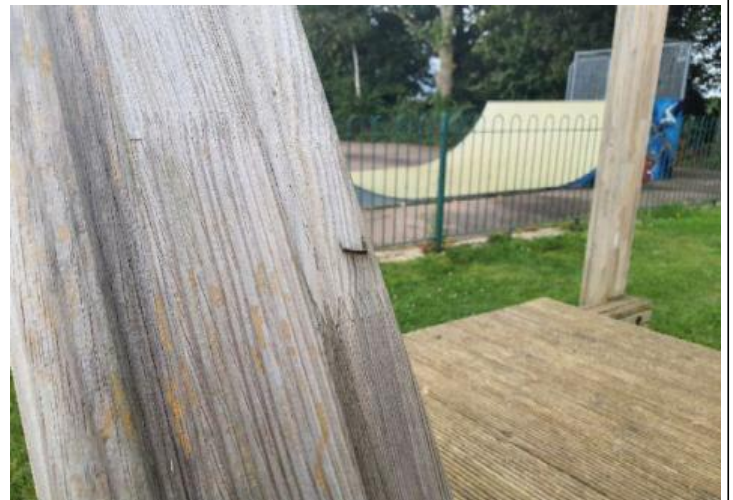
**Item:** Other - Cable Runway  
**Manufacturer:** Fenland Leisure Products

**Finding:** There are a number of redundant staples attached to the equipment **Action:** Remove redundant staples
