WPC.EC.24.02.03 – Play Inspection Reports & Remedial Work

Play Area Inspection Reports & Remedial Work

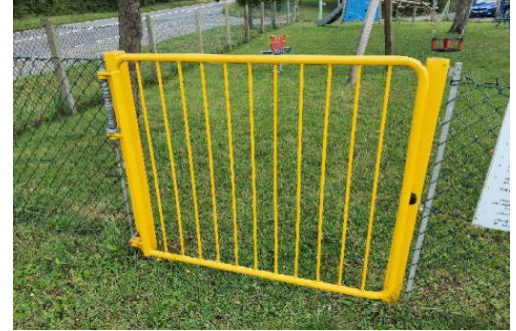
Item: Gate - Self Closing
Manufacturer: Not Identified
Surface Type: Grass
Item Quantity: 1
Equipment Compliance: N/A
Surface Area Compliance: N/A

There is some damage to the item - Monitor for any further deterioration and repair as required

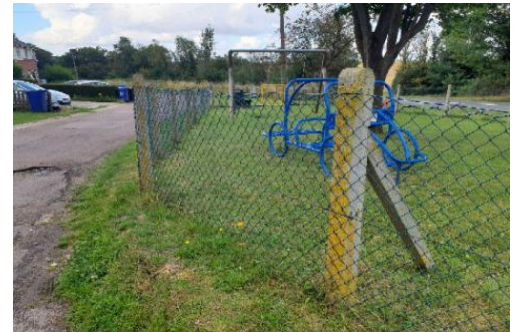
Item: Fence - Chainlink
Manufacturer: Not Identified
Surface Type: Grass
Item Quantity: 1
Equipment Compliance: N/A
Surface Area Compliance: N/A

There is some damage to the fence sections - Monitor for any further deterioration and repair as required

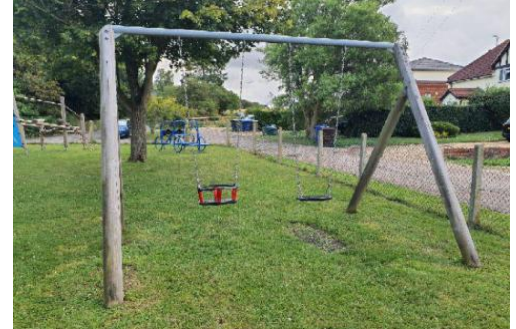
Item: 1 Bay Mixed Seat, 1 Cradle, 1 Flat
Manufacturer: Playdale Playgrounds Ltd
Surface Type: Grass Matrix Tiles
Item Quantity: 1
Equipment Compliance: Yes
Surface Area Compliance: Yes

There is some strimmer / machinery damage apparent on the posts, this can penetrate the preservative applied to the timber and accelerate the rotting process - Monitor for any deterioration (rot) and replace as required

There is some wear to the shackles - Monitor for any further deterioration and replace when 40% worn

There is some notable evidence of chain wear - Monitor for any further deterioration and replace when 40% worn

The seat has minor damage or wear - Monitor for any further deterioration and replace as required

The bushes are showing signs of wear - Monitor for any further deterioration and replace as required

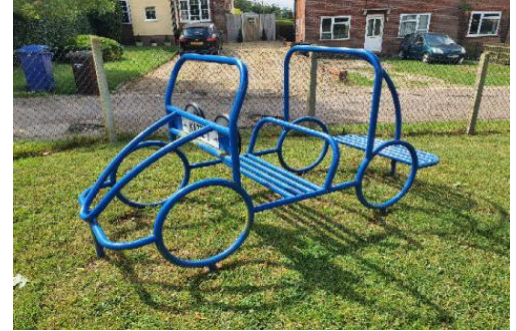
Item: Jeep
Manufacturer: Not Identified
Surface Type: Grass
Item Quantity: 1
Equipment Compliance: Yes
Surface Area Compliance: Yes

There is some damage to the item - Monitor for any further deterioration and repair as required

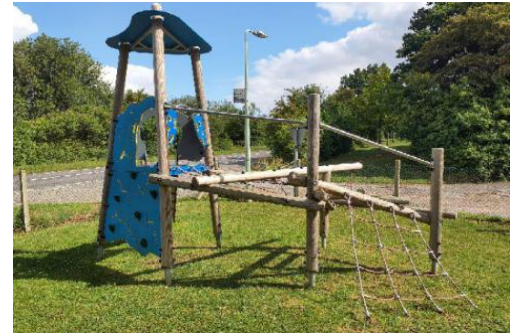
Item: Multi Play (Junior)
Manufacturer: Playforce
Surface Type: Grass Matrix Tiles
Item Part Number: Jungle tops
Item Quantity: 1
Equipment Compliance: Yes
Surface Area Compliance: Yes
Total Findings: 3

The timber has a number of splits/shakes or air cracks and this may affect the stability or allow water ingress which will accelerate the rotting process - Monitor to ensure the splits do not cross through fixing points of the structure and/or cause any instability

The ropes/nets are worn/damaged in places - Monitor for any further deterioration and repair or replace as required

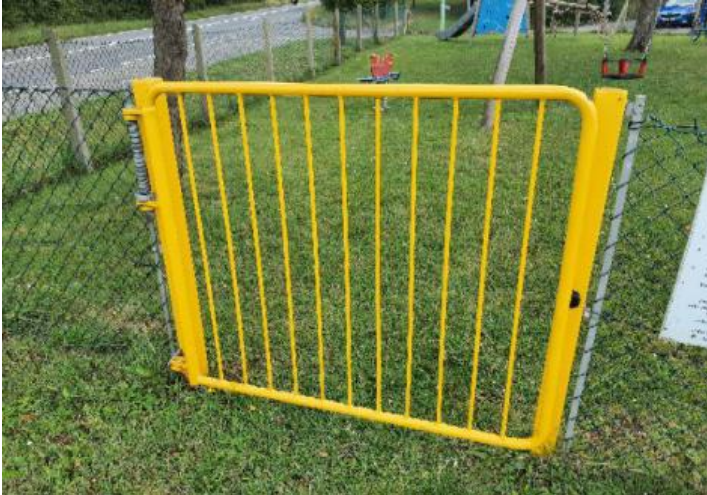
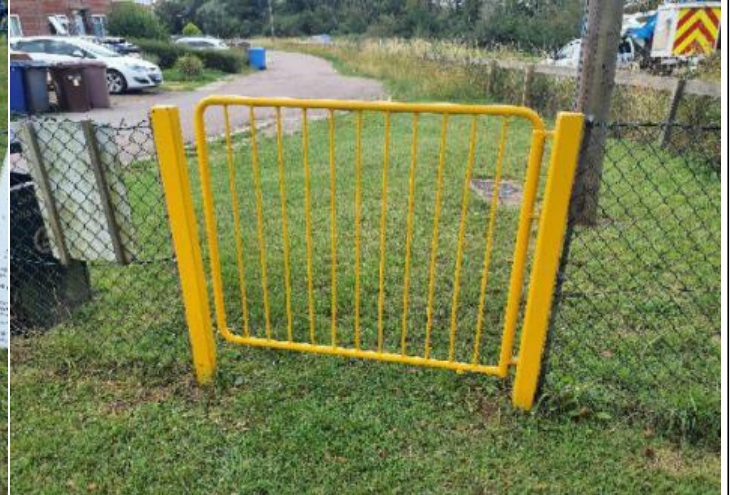
Item: Gates - Gate - Self Closing
Manufacturer: Not Identified

Finding: The gate is closing too quickly (less than 4 seconds)

Action: Take corrective action to ensure that the gate closes in 4-8 seconds

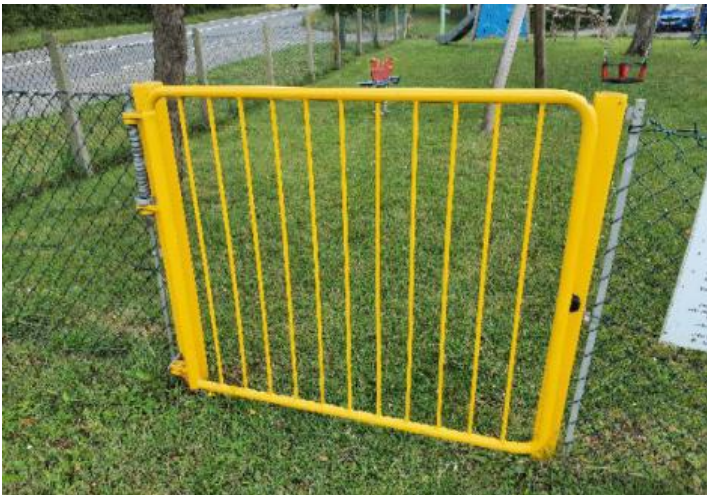
Item: Gates - Gate - Self Closing
Manufacturer: Not Identified

Finding: There is some damage to the item

Action: Monitor for any further deterioration and repair as required

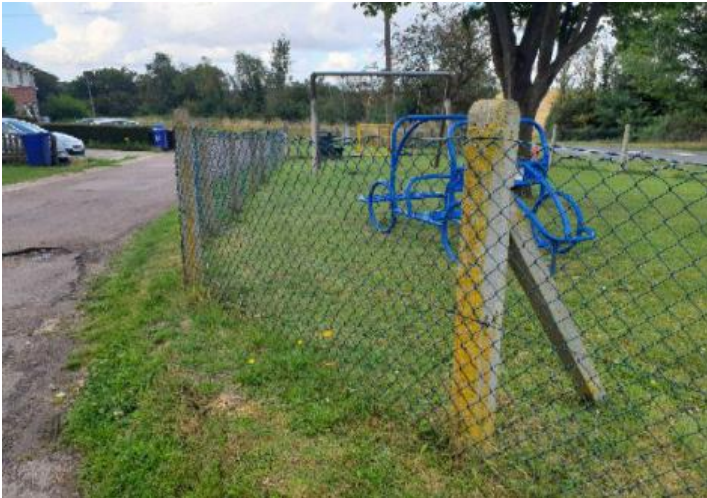
Item: Fences - Fence - Chainlink
Manufacturer: Not Identified

Finding: There is some damage to the fence sections

Action: Monitor for any further deterioration and repair as required

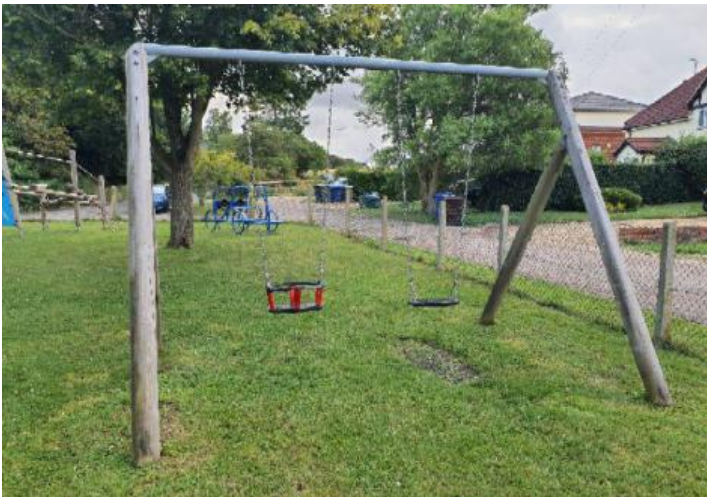
Item: Swings - 1 Bay Mixed Seat, 1 Cradle, 1 Flat
Manufacturer: Playdale Playgrounds Ltd

Finding: There is some strimmer / machinery damage apparent on the posts, this can penetrate the preservative applied to the timber and accelerate the rotting process

Action: Monitor for any deterioration (rot) and replace as required

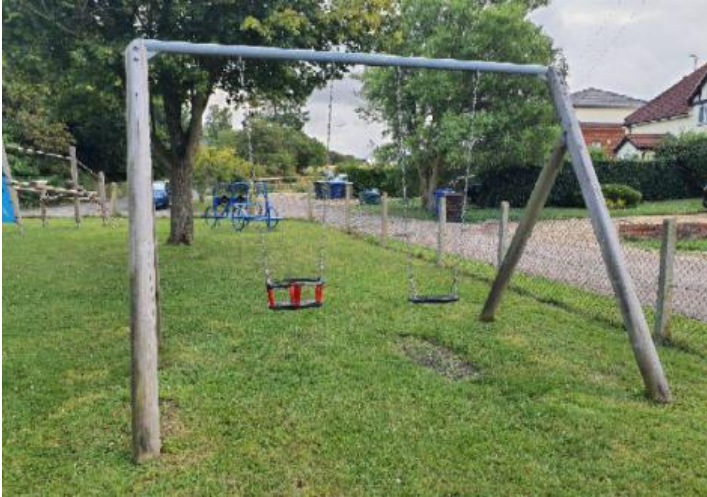
Item: Swings - 1 Bay Mixed Seat, 1 Cradle, 1 Flat
Manufacturer: Playdale Playgrounds Ltd

Finding: The seat has minor damage or wear

Action: Monitor for any further deterioration and replace as required

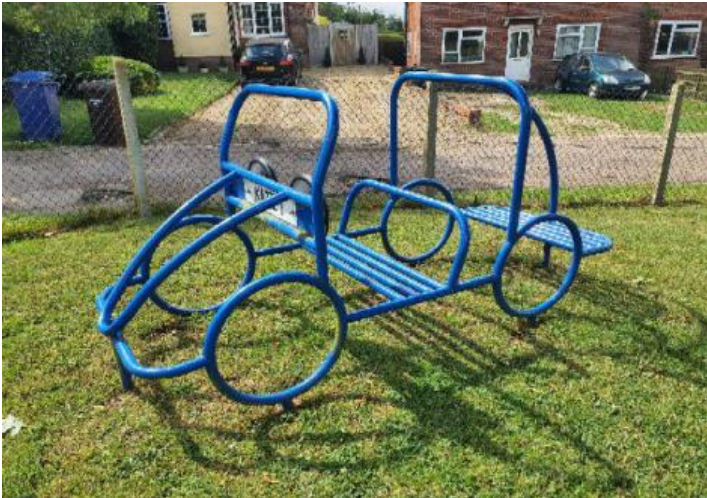
Item: Other - Jeep
Manufacturer: Not Identified

Finding: There is some damage to the item

Action: Monitor for any further deterioration and repair as required

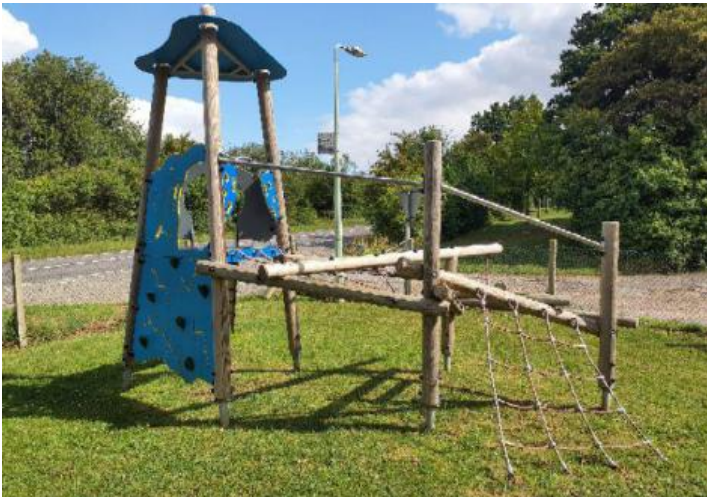
Item: Activity Equipment - Multi Play (Junior)
Manufacturer: Playforce

Finding: The timber has a number of splits/shakes or air cracks and this may affect the stability or allow water ingress which will accelerate the rotting process

Action: Monitor to ensure the splits do not cross through fixing points of the structure and/or cause any instability

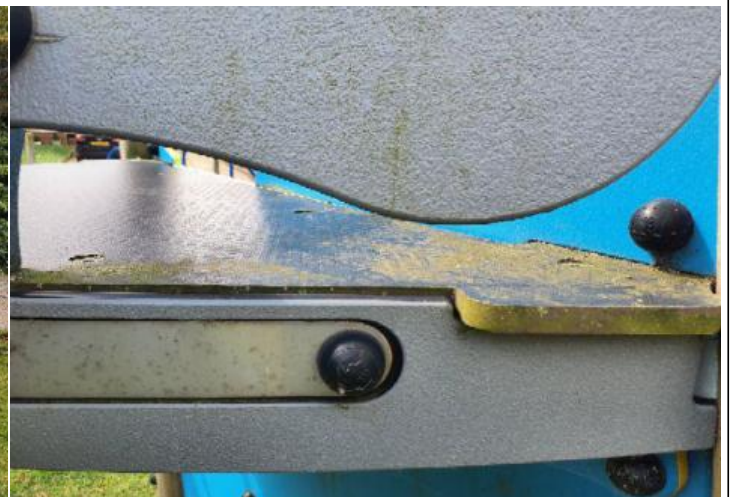
Item: Activity Equipment - Multi Play (Junior)
Manufacturer: Playforce

Finding: There is algae or moss on the surface of the equipment

Action: Clean and treat appropriately

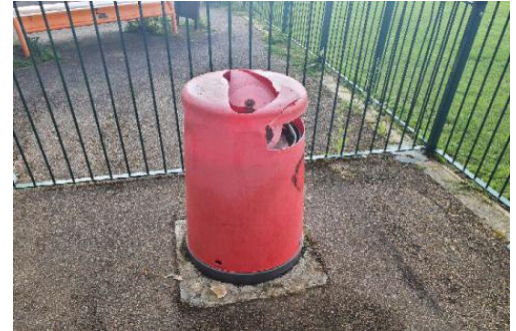
Item: Litter Bin
Manufacturer: Not Identified
Surface Type: N/A
Item Quantity: 1
Equipment Compliance: N/A
Surface Area Compliance: N/A

There is some damage to the item exposing sharp edges - Replace

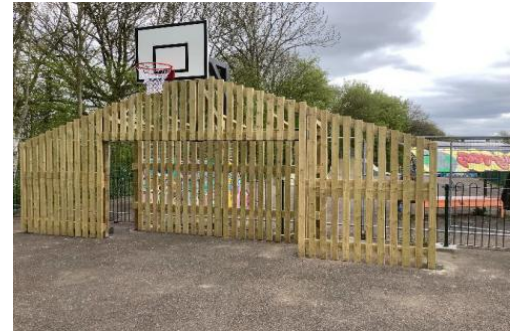
Item: Ball Games Area
Manufacturer: Sovereign Leisure
Surface Type: Tarmac
Item Quantity: 1
Equipment Compliance: Yes
Surface Area Compliance: N/A

The net has become detached - Repair

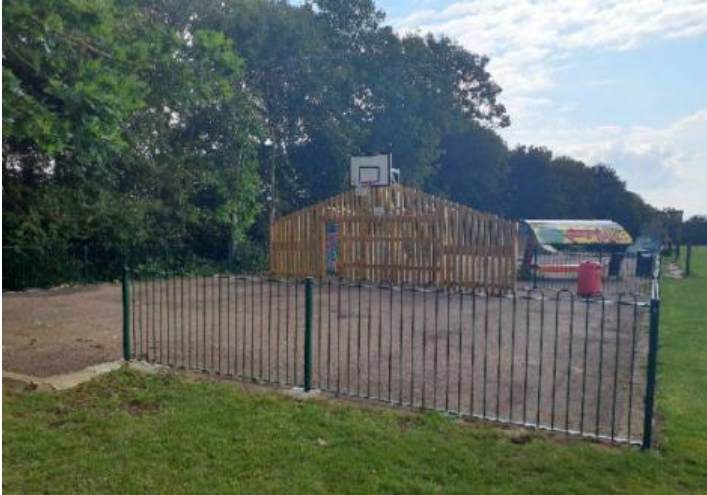
Item: Ancillary Items - Site General
Manufacturer: Owner/Operator

Finding: There is moderate damage to the surface

Action: Repair the damaged areas of surfacing

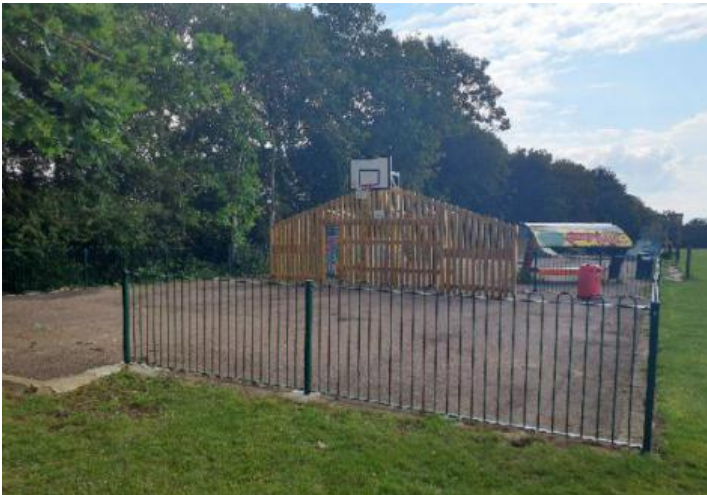
Item: Ancillary Items - Site General
Manufacturer: Owner/Operator

Finding: The concrete is breaking up around the edges of the surface

Action: Repair the damaged concrete

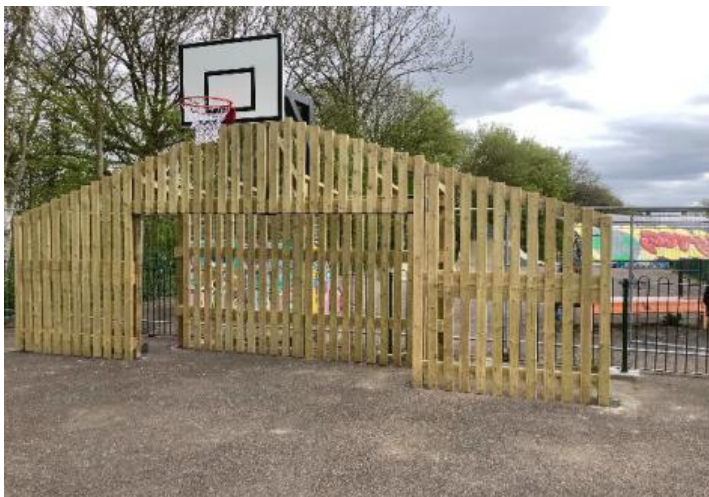
Item: Multi Use Games Area - Ball Games Area
Manufacturer: Sovereign Leisure

Finding: The net has become detached
Action: Repair

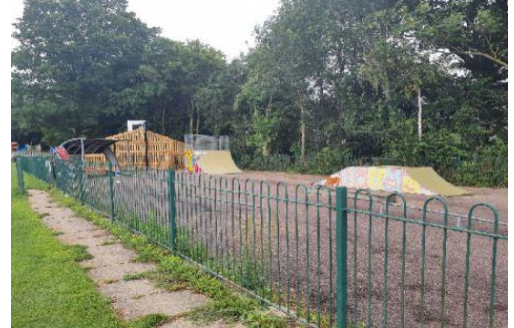
Item: Site General
Manufacturer: Owner/Operator
Surface Type: N/A
Item Quantity: 1
Equipment Compliance: N/A
Surface Area Compliance: N/A

There is weed / vegetation growth on, between, or around the edges of the surfacing - Remove weed / vegetation growth

There is root damage to the surfacing creating unforeseen changes in levels - Repair the damaged areas of tarmac to provide a uniform surface

There is some damage apparent to the riding surface - Monitor for any further deterioration and repair as required

There is algae, silt or moss growth on the surface resulting in slippery conditions - Clean and treat appropriately

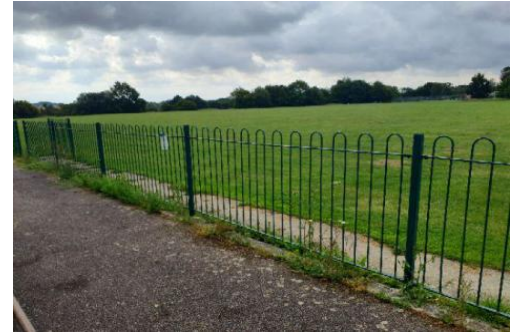
Item: Fence - Bow Top
Manufacturer: Not Identified
Surface Type: Bitmac
Item Quantity: 1
Equipment Compliance: N/A
Surface Area Compliance: N/A

There is some damage to the fence sections - Monitor for any further deterioration and repair as required

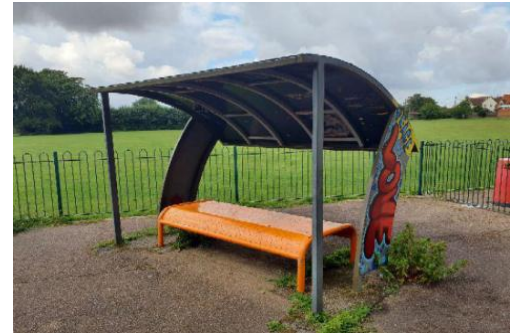
Item: Shelter
Manufacturer: Not Identified
Surface Type: Tarmac
Item Quantity: 1
Equipment Compliance: N/A
Surface Area Compliance: N/A

There is some evidence of fire damage to the item - Monitor for any further deterioration and repair as required

Pop rivet fixings have failed on the seat - Replace the failed pop rivets

There is surface corrosion / rust present on the item - Consider treating the item

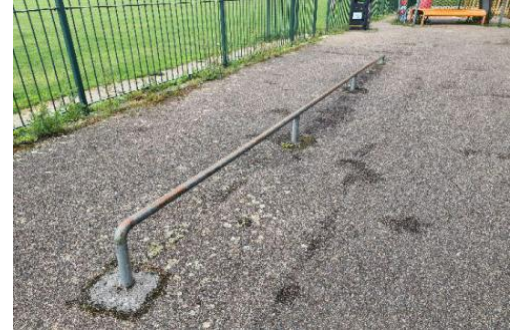
Item: Grind Rail
Manufacturer: Eibe Play Ltd
Surface Type: Tarmac
Item Quantity: 1
Equipment Compliance: Yes
Surface Area Compliance: Yes

There is surface corrosion / rust present on the item - Consider treating the item

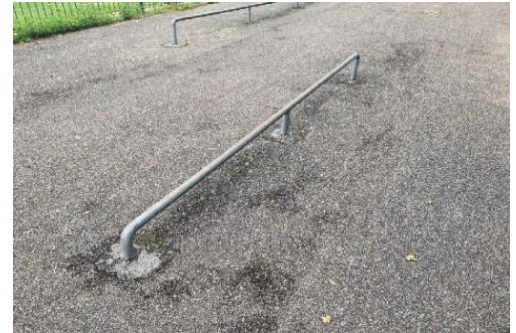
Item: Grind Rail
Manufacturer: Eibe Play Ltd
Surface Type: Tarmac
Item Quantity: 1
Equipment Compliance: Yes
Surface Area Compliance: Yes

There is surface corrosion / rust present on the item - Consider treating the item

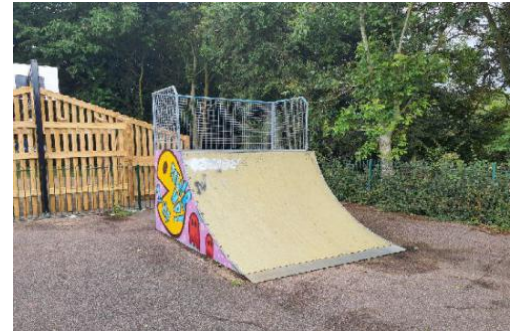
Item: Quarter Pipe
Manufacturer: Eibe Play Ltd
Surface Type: Tarmac
Item Quantity: 1
Equipment Compliance: No
Surface Area Compliance: Yes

The item has been damaged - Monitor for any further deterioration and replace as required

The riding surface of the ramp has some damage apparent - Monitor for any further deterioration and repair as required

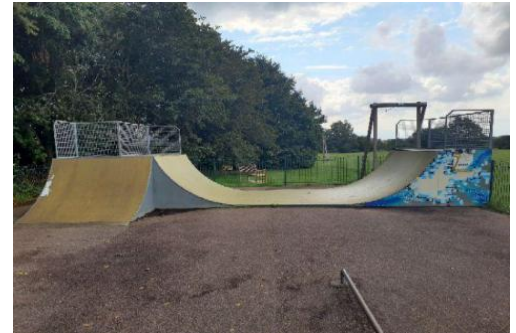
Item: Half Pipe
Manufacturer: Eibe Play Ltd
Surface Type: Tarmac
Item Quantity: 1
Equipment Compliance: No
Surface Area Compliance: Yes

A number of fixing(s) have worked loose - Secure all loose fixings

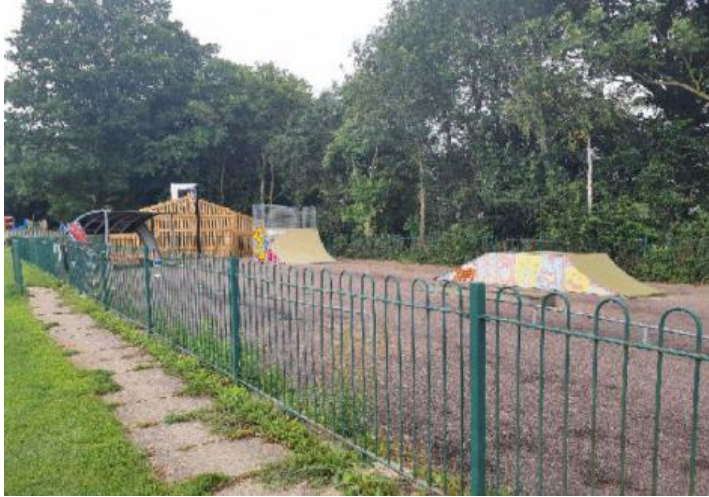
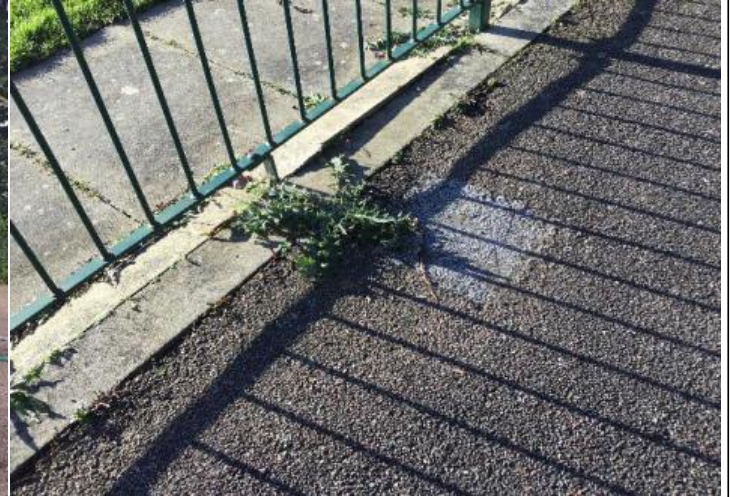
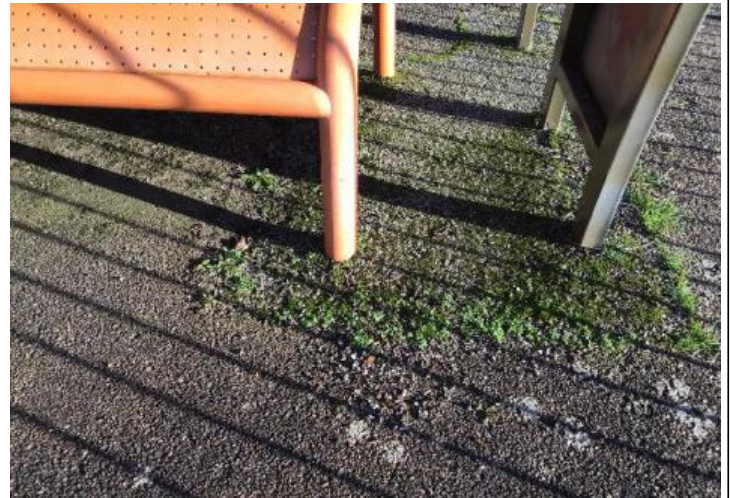
Finding: There is weed / vegetation growth on, between, or around the edges of the surfacing **Action:** Remove weed / vegetation growth

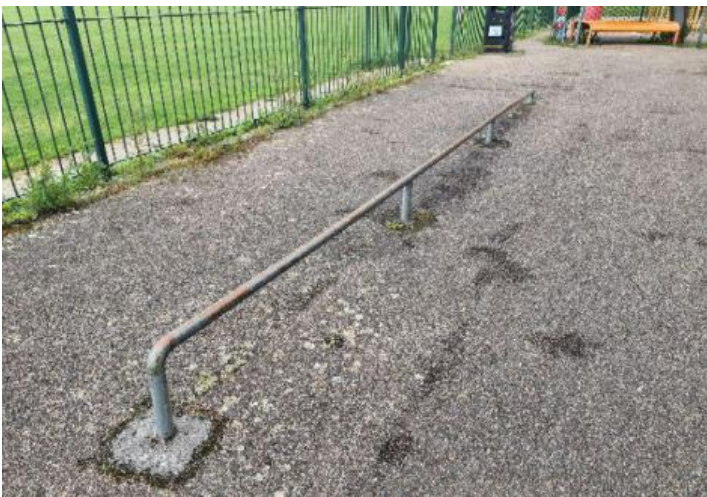
Finding: There is surface corrosion / rust present on the item

Action: Consider treating the item

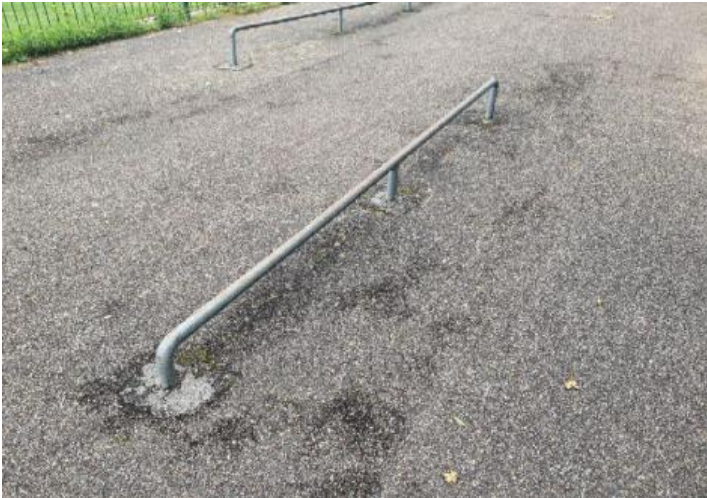
Finding: There is surface corrosion / rust present on the item

Action: Consider treating the item

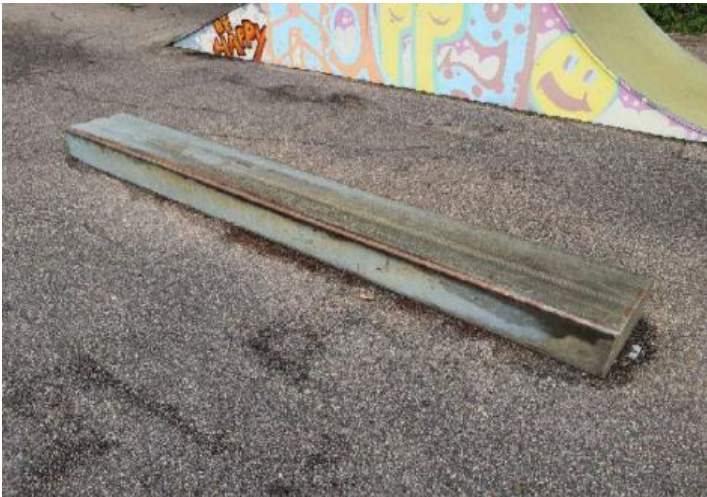
Finding: There is surface corrosion / rust present on the item

Action: Consider treating the item

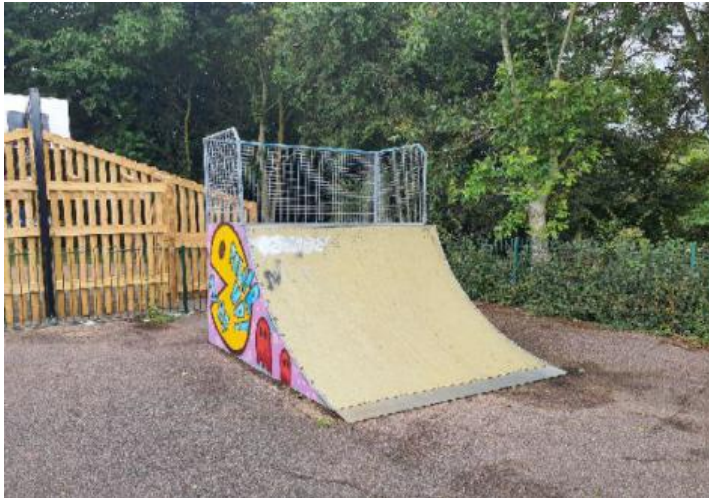
Finding: The item has been damaged

Action: Monitor for any further deterioration and replace as required

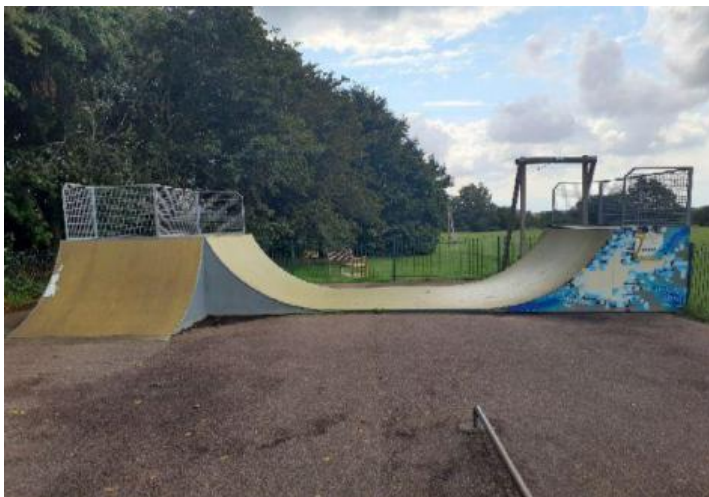
Finding: A number of fixing(s) have worked loose

Action: Secure all loose fixings

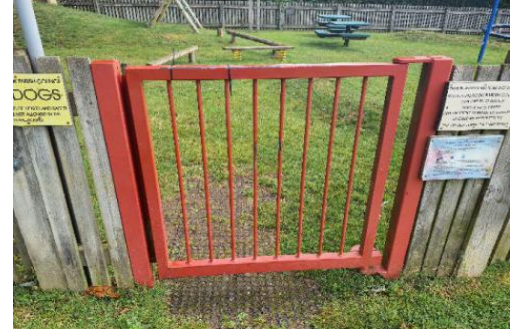
There are trip hazards at the edges of the surface - Reinstate surrounding surface levels to remove the trip points

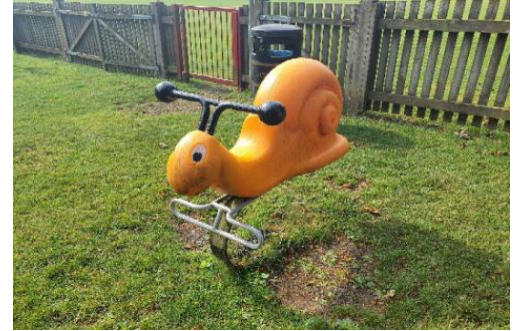
A number of fixing(s) have worked loose - Secure all loose fixings

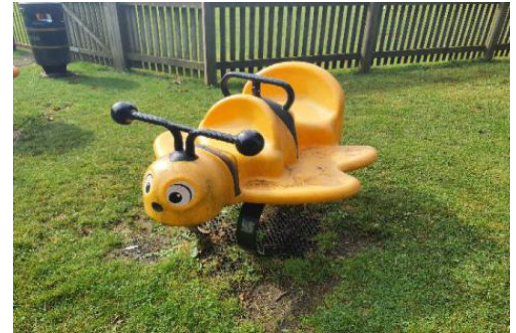
A number of fixing(s) have worked loose - Secure all loose fixings

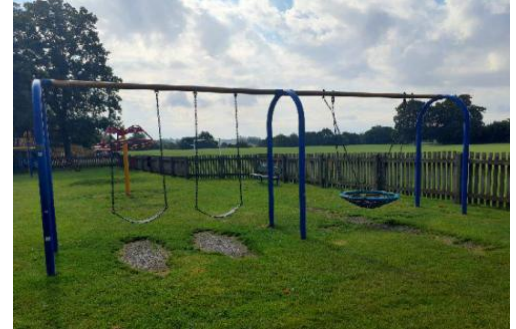
There is moderate damage to the surface - Repair the damaged areas of surfacing

The swing seat connectors have some wear present - Monitor for further deterioration and replace when 40% worn

There is some notable evidence of chain wear - Monitor for any further deterioration and replace when 40% worn

The seat has minor damage or wear - Monitor for any further deterioration and replace as required

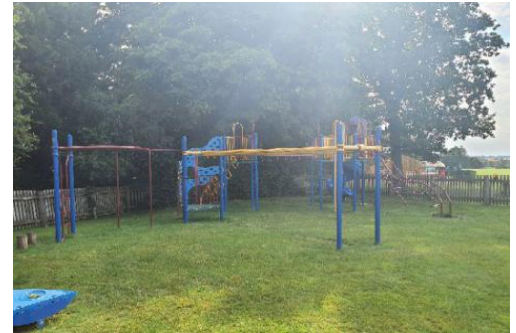
A number of fixing(s) have worked loose - Secure all loose fixings

There are a number of dents in the slide surface - Monitor for any further deterioration and repair as required

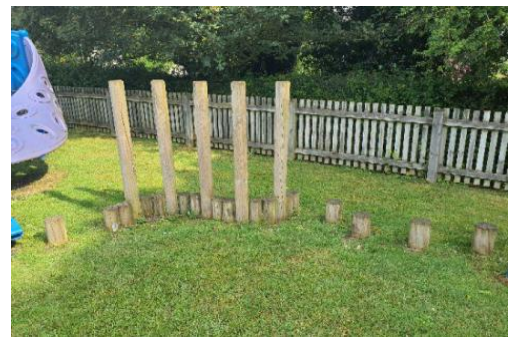
Finding 1
 The timber has a number of splits/shakes or air cracks and this may affect the stability or allow water ingress which will accelerate the rotting process - Monitor to ensure the splits do not cross through fixing points of the structure and/or cause any instability

Finding 2
 There is some strimmer / machinery damage apparent on the posts, this can penetrate the preservative applied to the timber and accelerate the rotting process - Monitor for any deterioration (rot) and replace as required

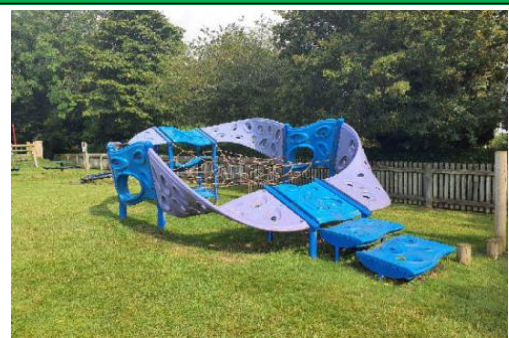
Finding 1
 There is/are bolt cap covers missing or damaged on the item - Replace missing or damaged bolt cap covers

Finding 2
 There is algae or moss on the surface of the equipment - Clean and treat appropriately

Finding 3
 The ropes/nets are worn/damaged in places - Monitor for any further deterioration and repair or replace as required

Finding 4
 The connecting lugs are showing signs of wear - Monitor for any further deterioration and repair as required

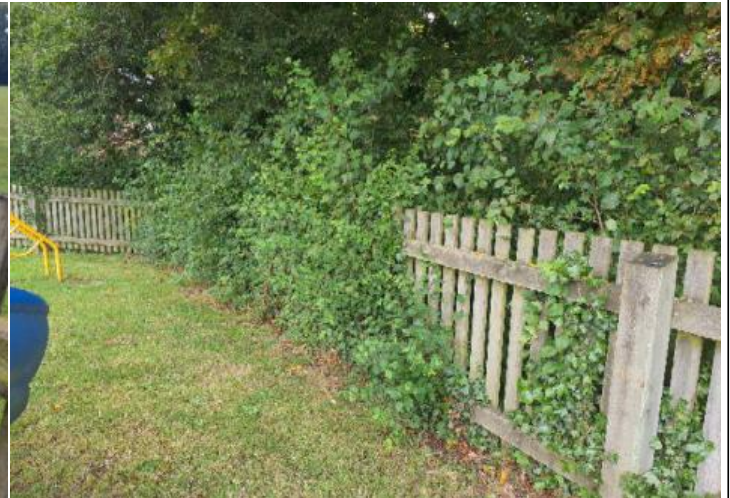
Finding: The adjacent foliage is overhanging

Action: Cut back and maintain

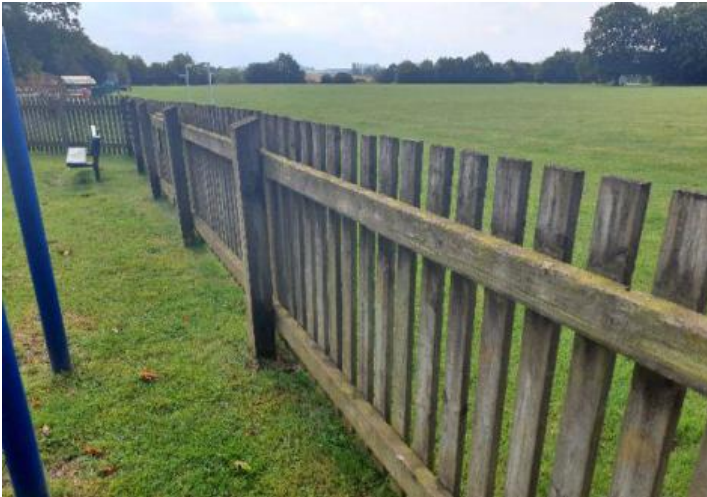
Item: Fences - Fencing - Timber
Manufacturer: Not Identified

Finding: There is some damage to the item

Action: Monitor for any further deterioration and repair as required

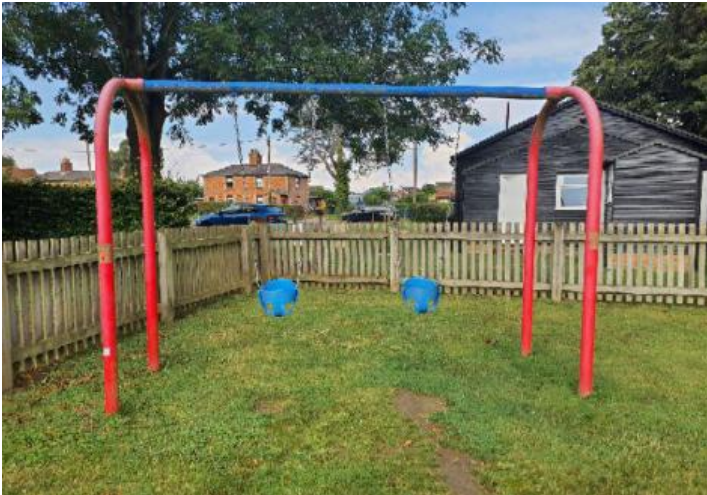
Item: Swings - 1 Bay 2 Seat (Cradle)
Manufacturer: Miracle Recreation Equipment Company

Finding: There is some notable evidence of chain wear

Action: Monitor for any further deterioration and replace when 40% worn

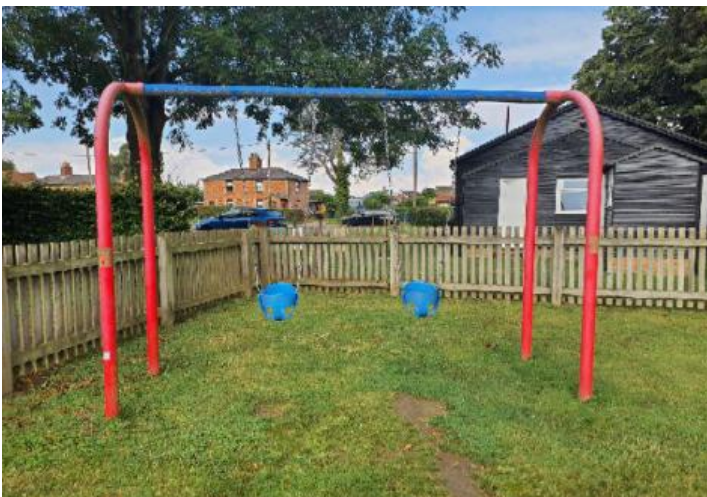
Item: Swings - 1 Bay 2 Seat (Cradle)
Manufacturer: Miracle Recreation Equipment Company

Finding: The swing seat connectors have some wear present

Action: Monitor for further deterioration and replace when 40% worn

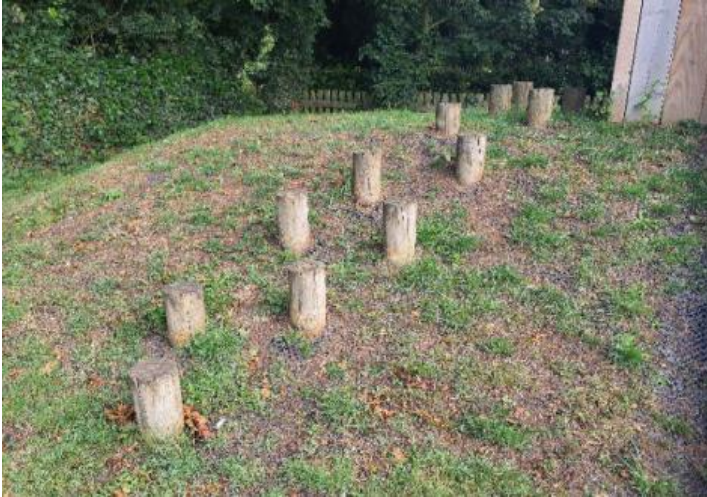
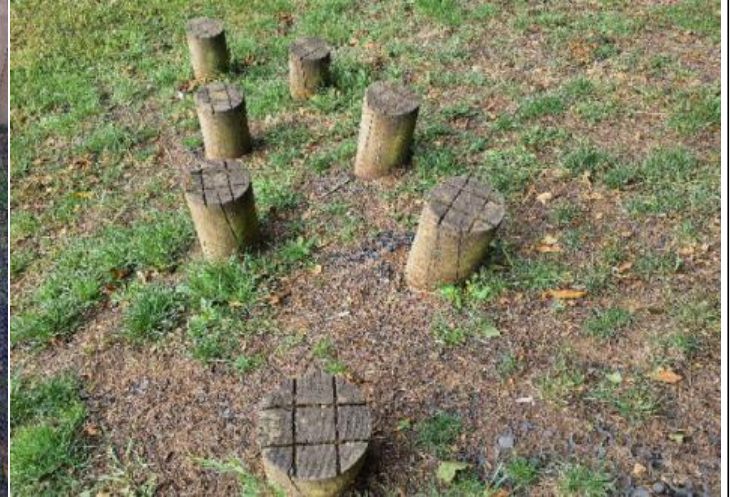
Item: Activity Equipment - Stepping Posts
 Timber
Manufacturer: Playworld Systems (Europe) Ltd

Finding: There is algae or moss on the surface of the equipment

Action: Clean and treat appropriately

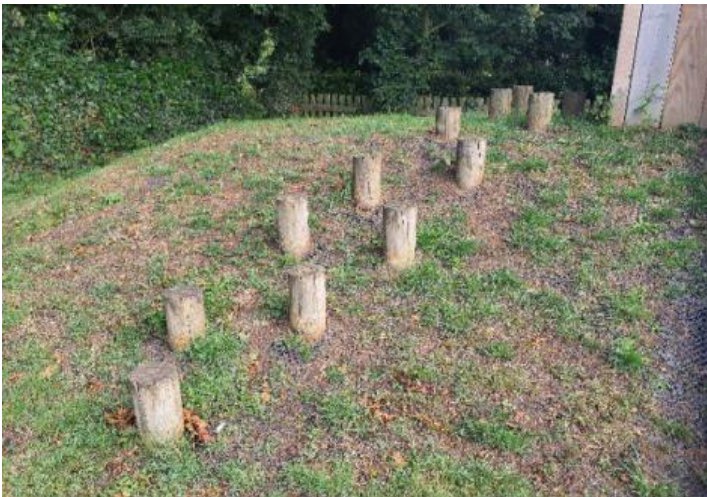
Item: Activity Equipment - Stepping Posts
 Timber
Manufacturer: Playworld Systems (Europe) Ltd

Finding: There is some strimmer / machinery damage apparent on the posts, this can penetrate the preservative applied to the timber and accelerate the rotting process

Action: Monitor for any deterioration (rot) and replace as required

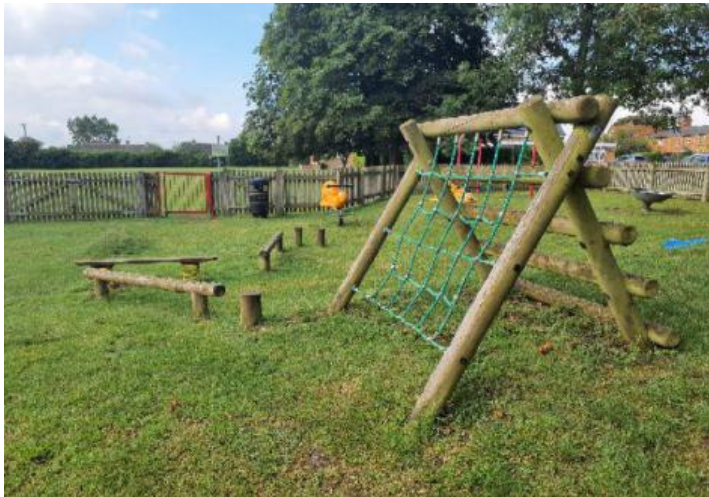
Item: Activity Equipment - Activity Trail
Manufacturer: Miracle Recreation Equipment Company

Finding: There is some strimmer / machinery damage apparent on the posts, this can penetrate the preservative applied to the timber and accelerate the rotting process

Action: Monitor for any deterioration (rot) and replace as required

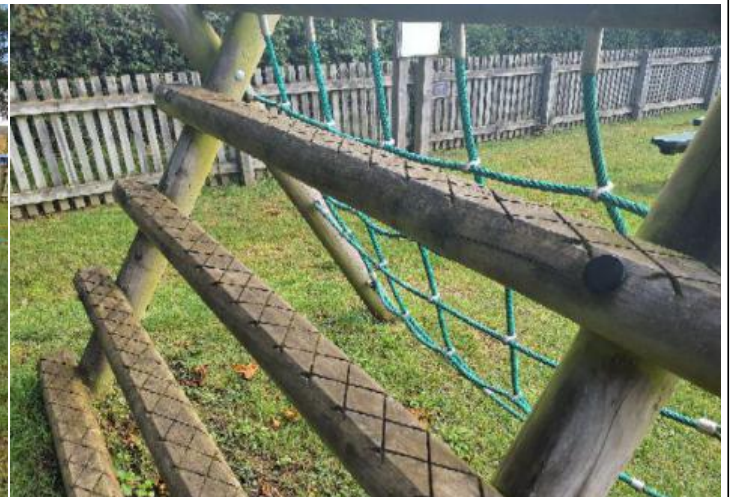
Item: Activity Equipment - Activity Trail
Manufacturer: Miracle Recreation Equipment Company

Finding: There is algae or moss on the surface of the equipment
Action: Clean and treat appropriately

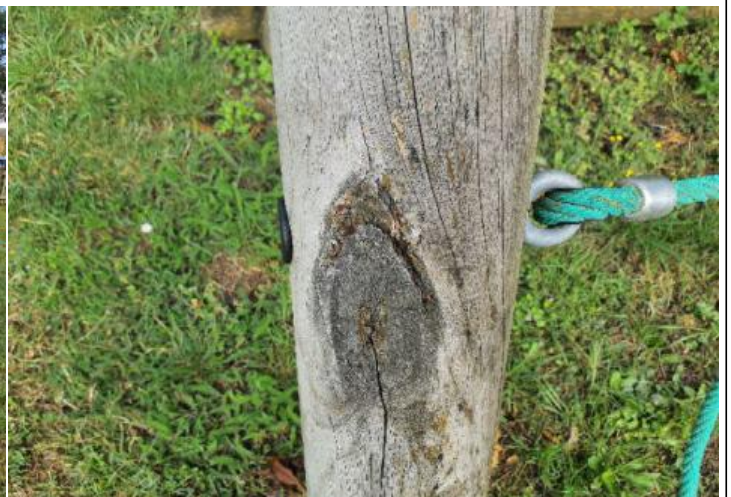
Item: Activity Equipment - Activity Trail
Manufacturer: Miracle Recreation Equipment Company

Finding: Parts of the timber are rough or splintered

Action: Remove all rough or sharp edges

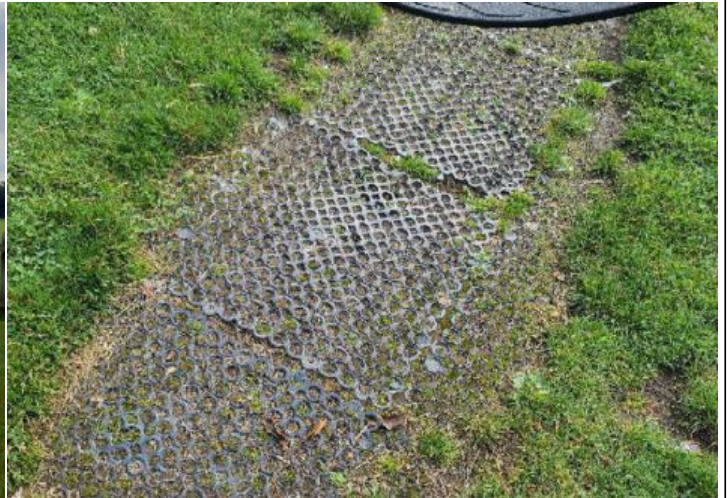
Item: Swings - 2 Bay 2 Flat 1 Basket Seat
Manufacturer: Miracle Recreation Equipment Company

Finding: There are gaps opening between the grass mat tiles

Action: Provide additional ties or secure / reinstate surface tiles

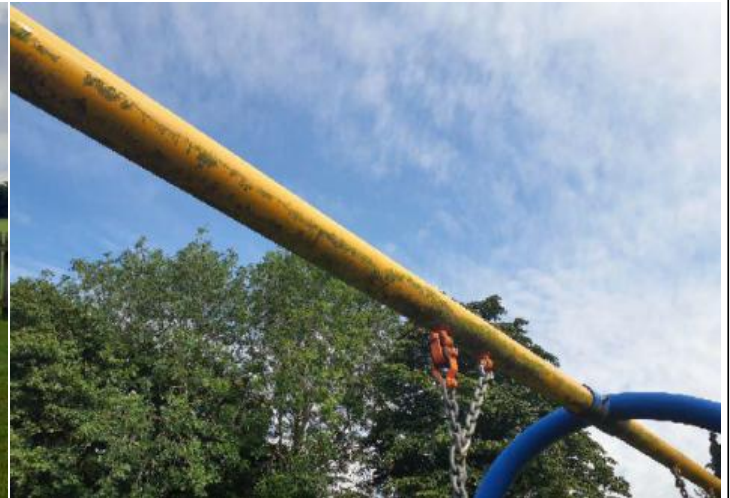
Item: Swings - 2 Bay 2 Flat 1 Basket Seat
Manufacturer: Miracle Recreation Equipment Company
Risk Level: L - Low Risk
Surface: Grass Matrix Tiles

Finding: There is algae or moss on the surface of the equipment
Action: Clean and treat appropriately

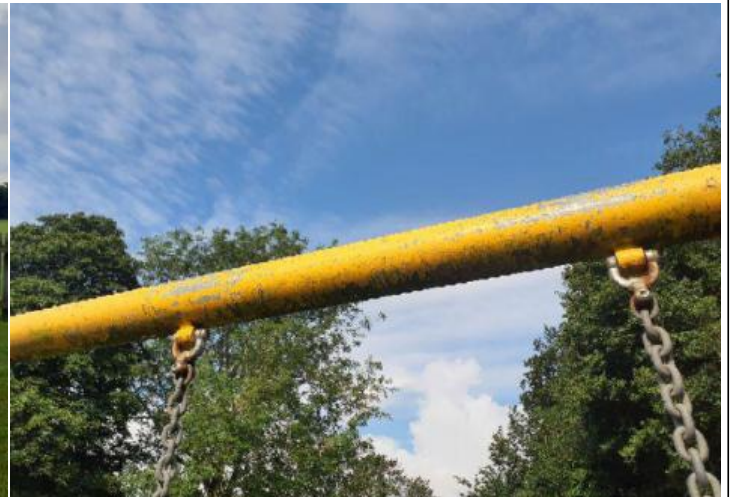
Item: Swings - 2 Bay 2 Flat 1 Basket Seat
Manufacturer: Miracle Recreation Equipment Company
Risk Level: L - Low Risk
Surface: Grass Matrix Tiles

Finding: The paint is flaking off the metalwork
Action: Rub down and re-paint

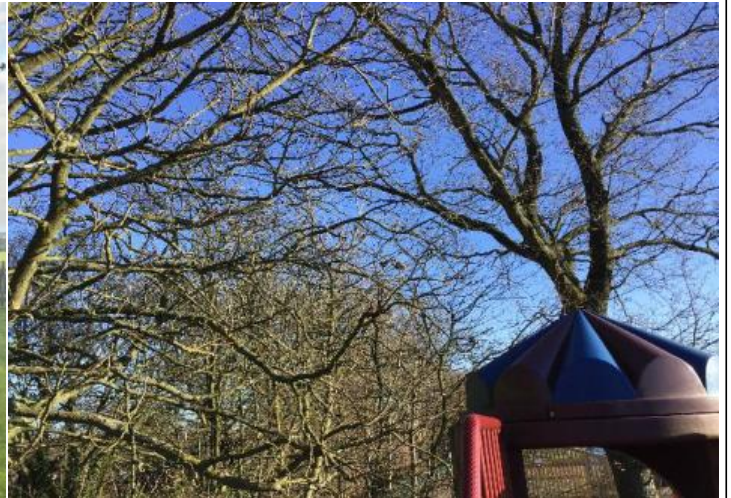
Item: Activity Equipment - Multi Play (Senior)
Manufacturer: Miracle Recreation Equipment Company

Finding: The tree canopy overhangs the equipment and is less than 2.0m away

Action: Lift tree canopy to ensure a minimum clearance of 2.0m from the equipment

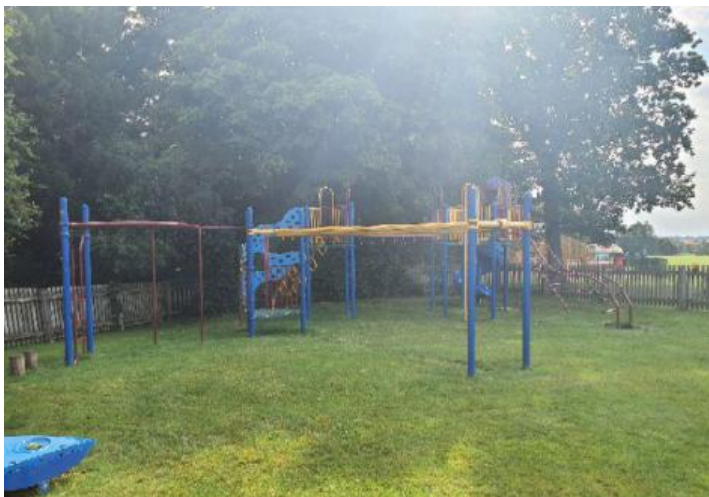
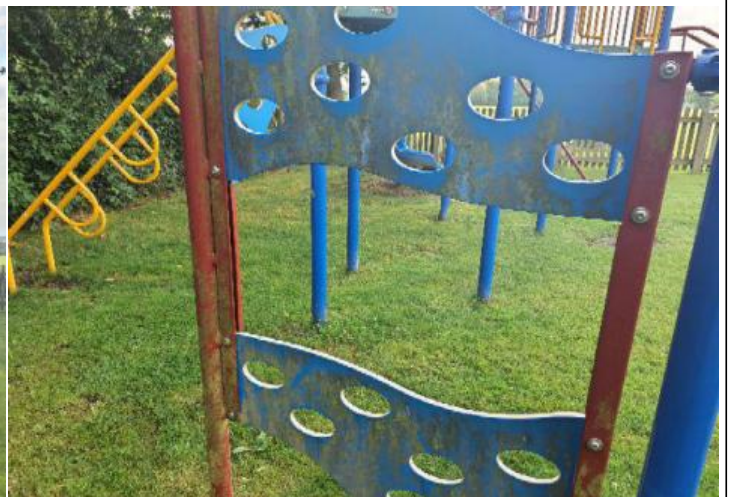
Item: Activity Equipment - Multi Play (Senior)
Manufacturer: Miracle Recreation Equipment Company

Finding: There is algae or moss on the surface of the equipment

Action: Clean and treat appropriately

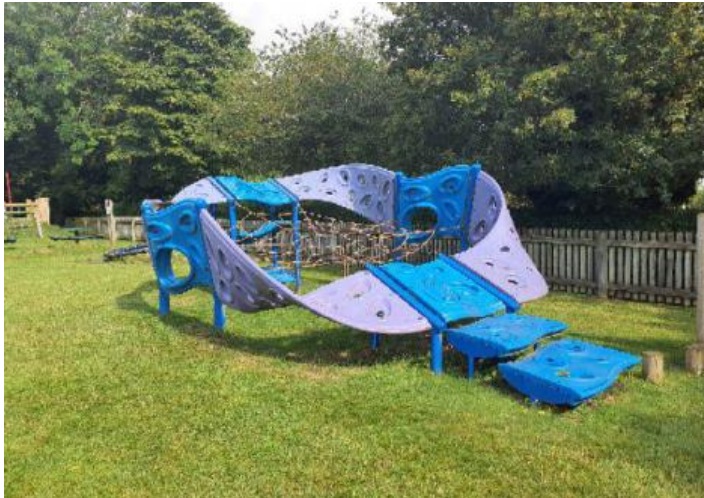
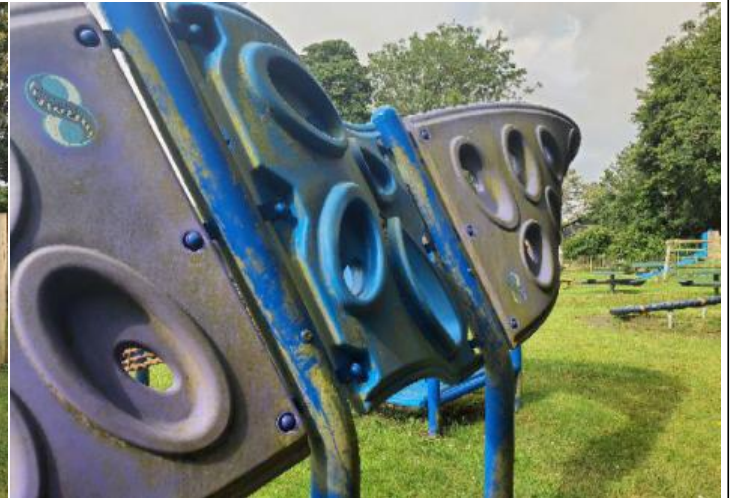
Item: Activity Equipment - Climbing Frame
Manufacturer: Not Identified

Finding: There is algae or moss on the surface of the equipment

Action: Clean and treat appropriately

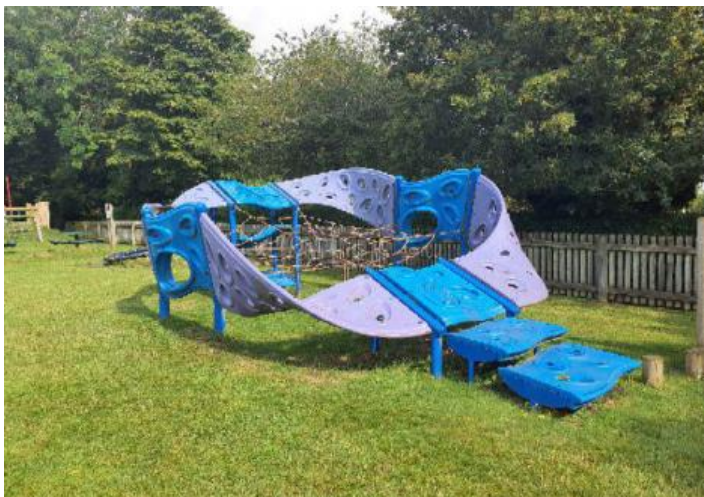
Item: Activity Equipment - Climbing Frame
Manufacturer: Not Identified

Finding: The ropes/nets are worn/damaged in places

Action: Monitor for any further deterioration and repair or replace as required

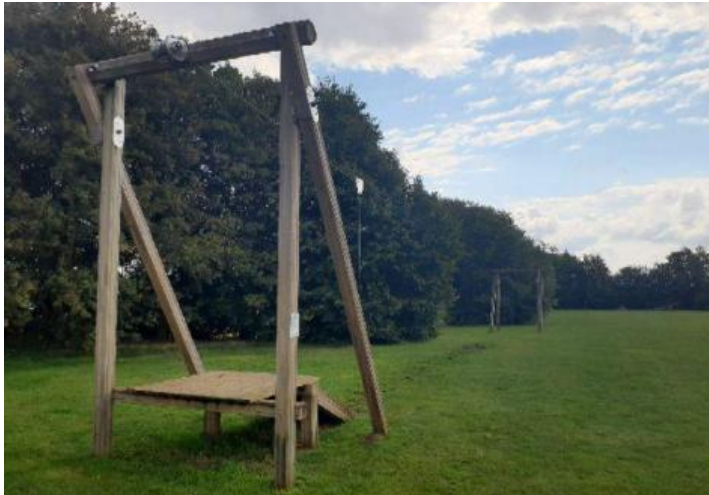
Item: Other - Cable Runway
Manufacturer: Fenland Leisure Products

Finding: The nylon inserts are worn or missing at the point the cable enters the traveller

Action: Replace worn or missing inserts as required

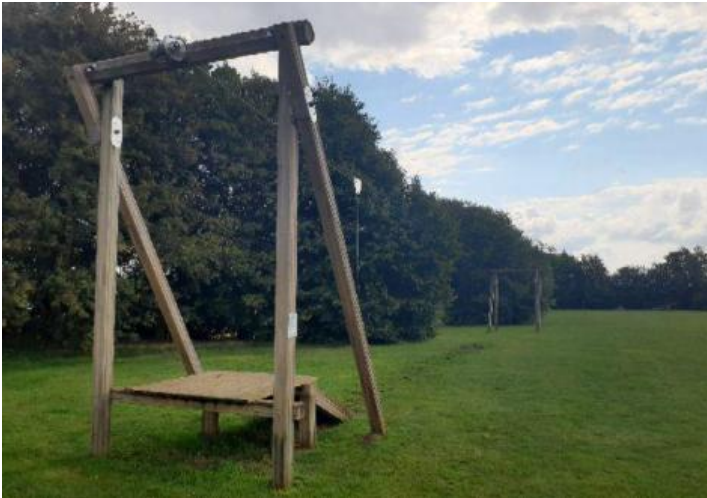
Item: Other - Cable Runway
Manufacturer: Fenland Leisure Products

Finding: There is some strimmer / machinery damage apparent on the posts, this can penetrate the preservative applied to the timber and accelerate the rotting process

Action: Monitor for any deterioration (rot) and replace as required

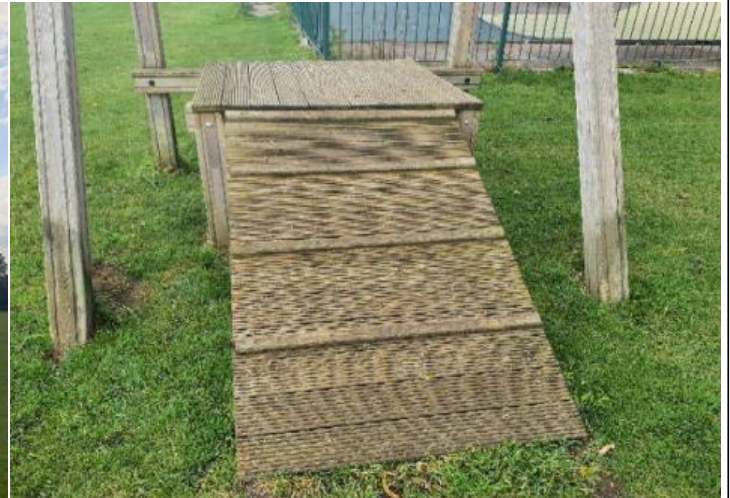
Item: Other - Cable Runway
Manufacturer: Fenland Leisure Products

Finding: There is algae or moss on the surface of the equipment

Action: Clean and treat appropriately
