WPC.EC.24.02.03 – Play Inspection Reports & Remedial Work

Play Area Inspection Reports & Remedial Work

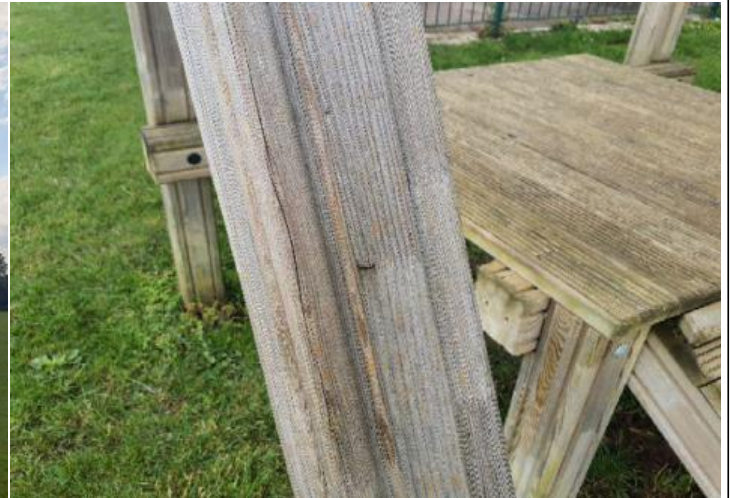
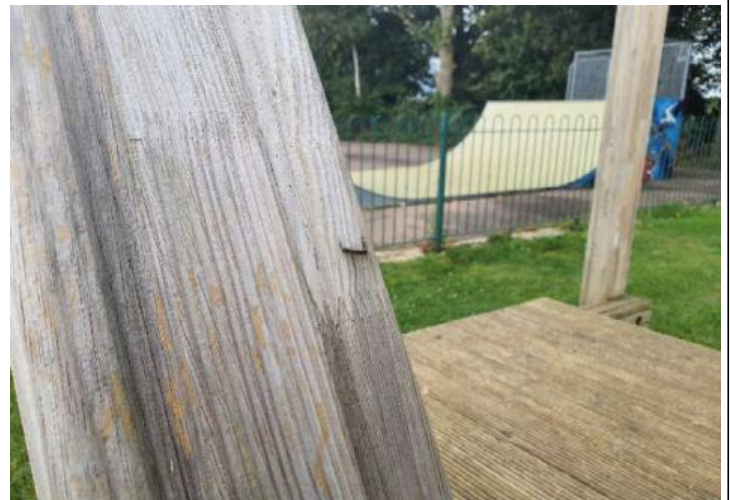
Item: Other - Cable Runway
Manufacturer: Fenland Leisure Products

Finding: There are a number of redundant staples attached to the equipment **Action:** Remove redundant staples

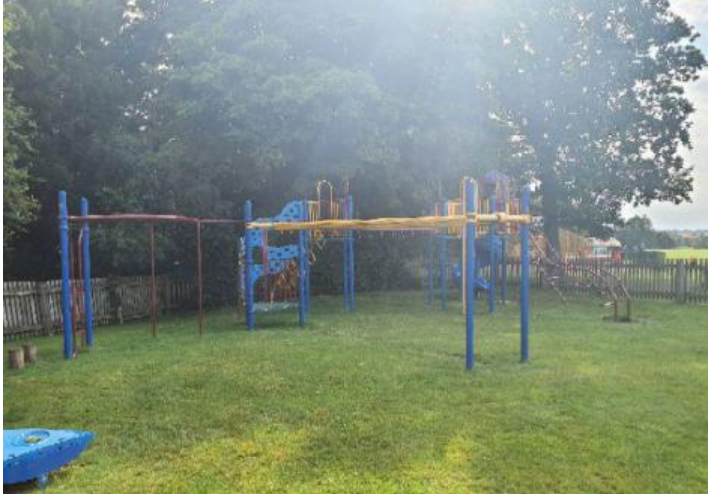
Item: Activity Equipment - Multi Play (Senior)
Manufacturer: Miracle Recreation Equipment Company

Risk Level: L - Low Risk
Surface: Grass Matrix Tiles

Finding: Sliding handle on monorail is stiff and hard to move **Action:** Investigate cause

Product Image	SKU Code	Product	Qty	Each GBP	Total GBP
Multi-Play - Monorail - Investigation of sliding handle					
		We will check monorail when on site – as this was repaired in September, possible inspector error	1.0	£0.00	£0.00
